LEON-PCI-UMC Development Board

Test Report

GAISLER RESEARCH / PENDER ELECTRONIC DESIGN Rev. 1.1, 2003- 12- 25

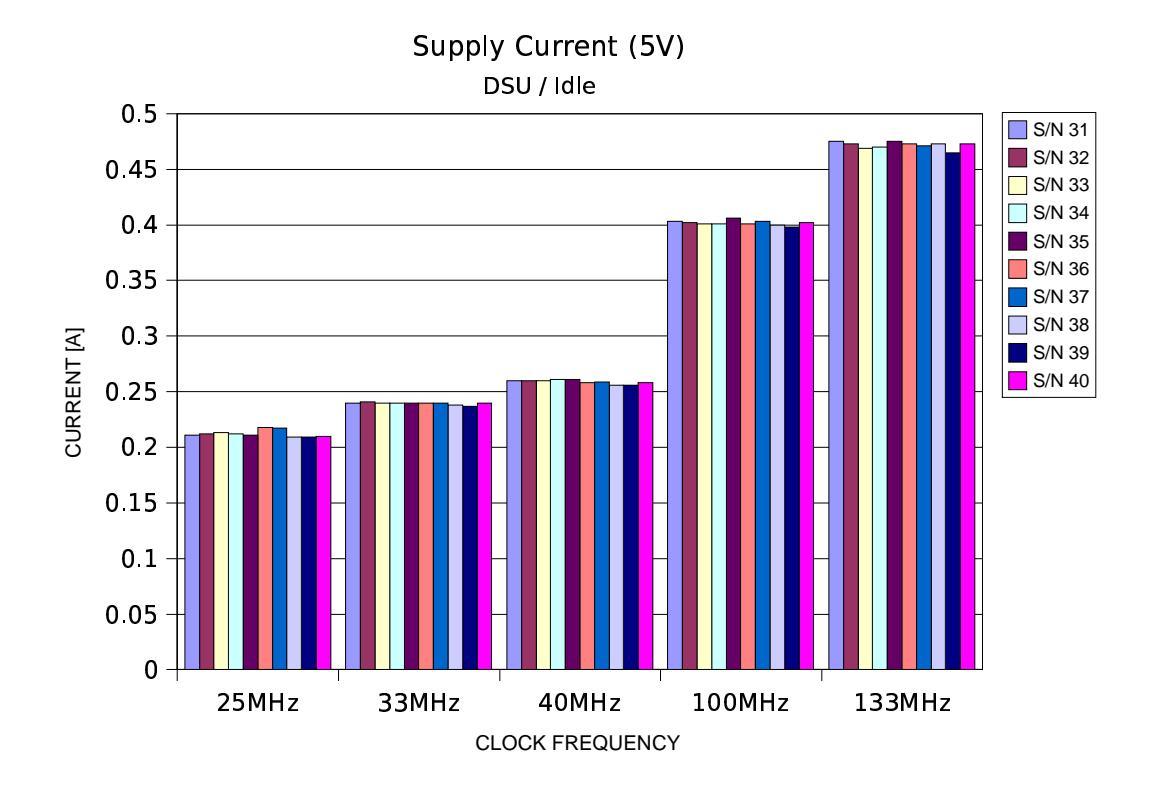
Figure 2-1: Board Supply Current Versus Frequency (processor halted)

Measurements of the operational current required by the board were made for all devices at several clock frequencies, as graphed in the following figure. This is the current measured at the input to the board, and includes both the quiescent and active current of the ASIC plus the current of the Memory/Peripherals.

Based on the above measurements, the calculated standby current of the board is estimated to be about 140 mA, while the current consumption of the Leon chip is about 2.5 mA/MHz. (equivalent to 4.5mW/MHz for 1.8V core voltage).

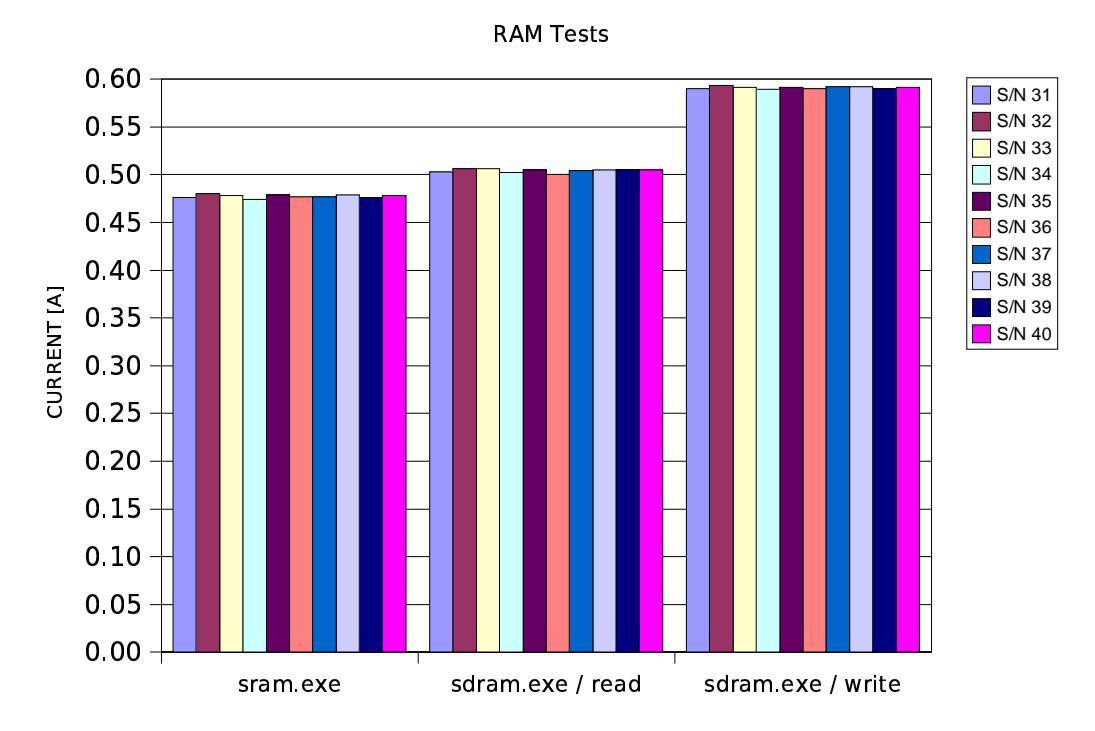
Figure 2-2: Board Supply Current versus Type of Memory access (100MHz)

The Leon chip has very little difference between power-down and full load. Most extra current when running programs comes from the memory - a program with

100% cache hit (and no memory writes) only consumes about 10% more current than the power-down mode (even with a high FPU load). As the power consumption of the memories, being the main contributor to the device's power consumption, seems to depend on the clock frequency and is mostly independent of read/write cycles being performed, some attention should to be paid to the design of memory power down modes for future designs.

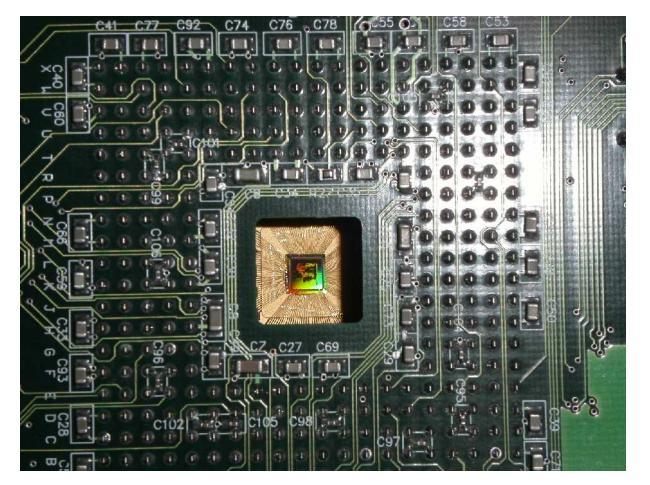
Figure 3-2: View of exposed die through PCB cutout

The UMC ASIC is packaged in a 299 pin Pin Grid Array, with the cavity on the bottom of the device. This requires that the design of the board incorporates an appropriate cut- out, and that the source irradiates from the 'bottom' of the PCB.

Additionally, as the chip is socketed, the resulting minimum distance to die is rather larger than would be preferred (at ca. 15mm). However satisfactory results were

obtained with this configuration.
