Customer Notification

EW78K

Embedded Workbench® for 78K

Operating Precautions

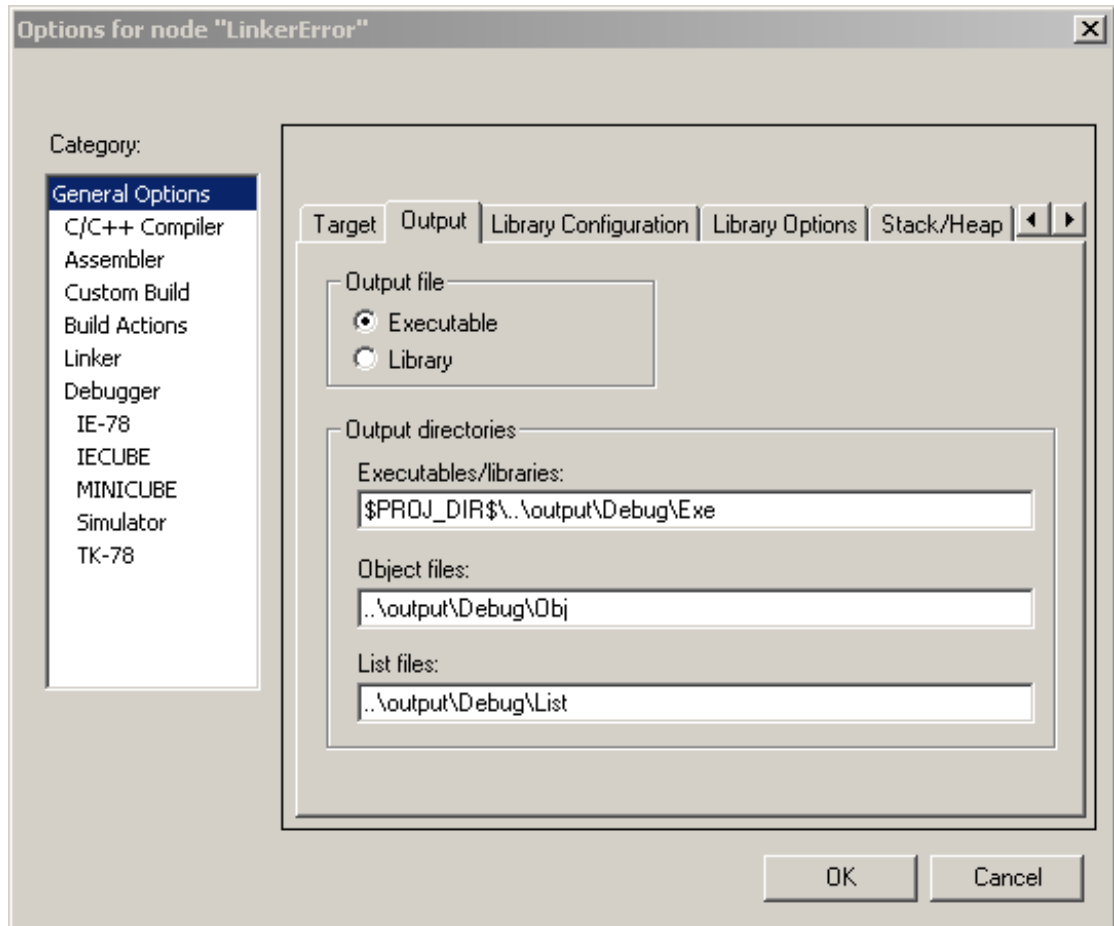
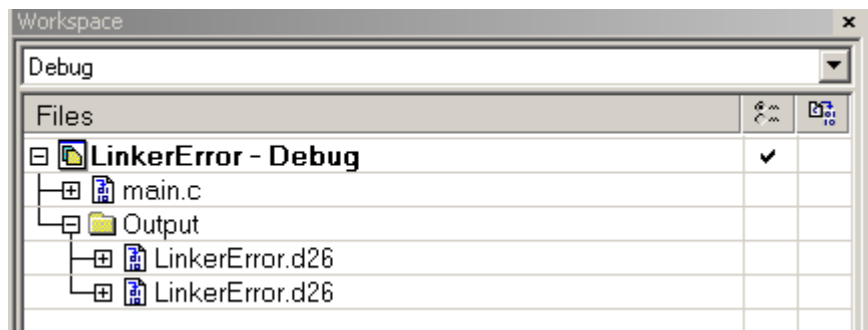
No. A10 Usage of Soft-Links in output path definition could cause the IDE to link two copies of the output files in the Workspace Windows

If the IAR System soft-links (e.g. \$PROJ_DIR\$) are used to define the output file path, the Embedded Workbench may link two copies of the generated output file in the Workspace Window.

Don't use soft-links in the output file path definition? The issue will be changed in next major update of EW78K.

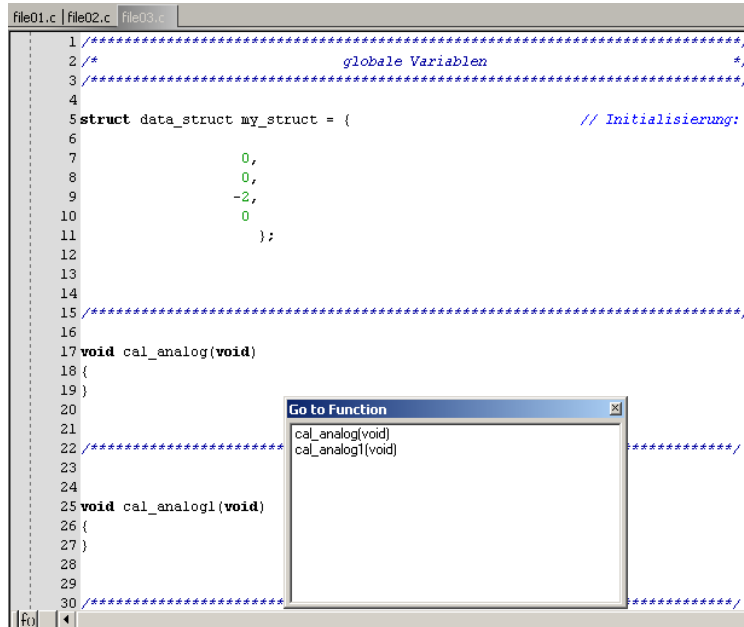
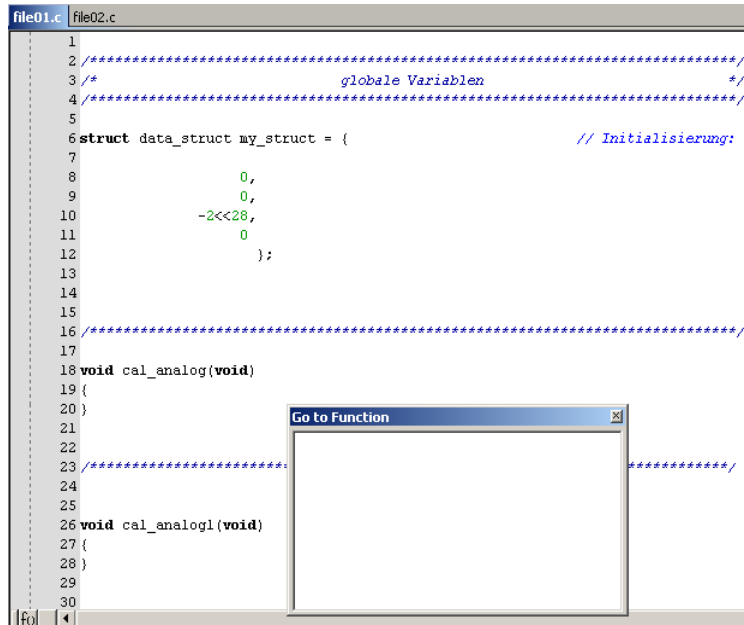
No. A14

Depending on some source code constructions (e.g. using shift operator to initialize a structure element) the Go to Function Window may be empty.
 Correct Go to Function Window:

Empty Go to Function Window although there are several functions defined in the active source file:

None. The problem will be fixed in the next EW78K platform update.

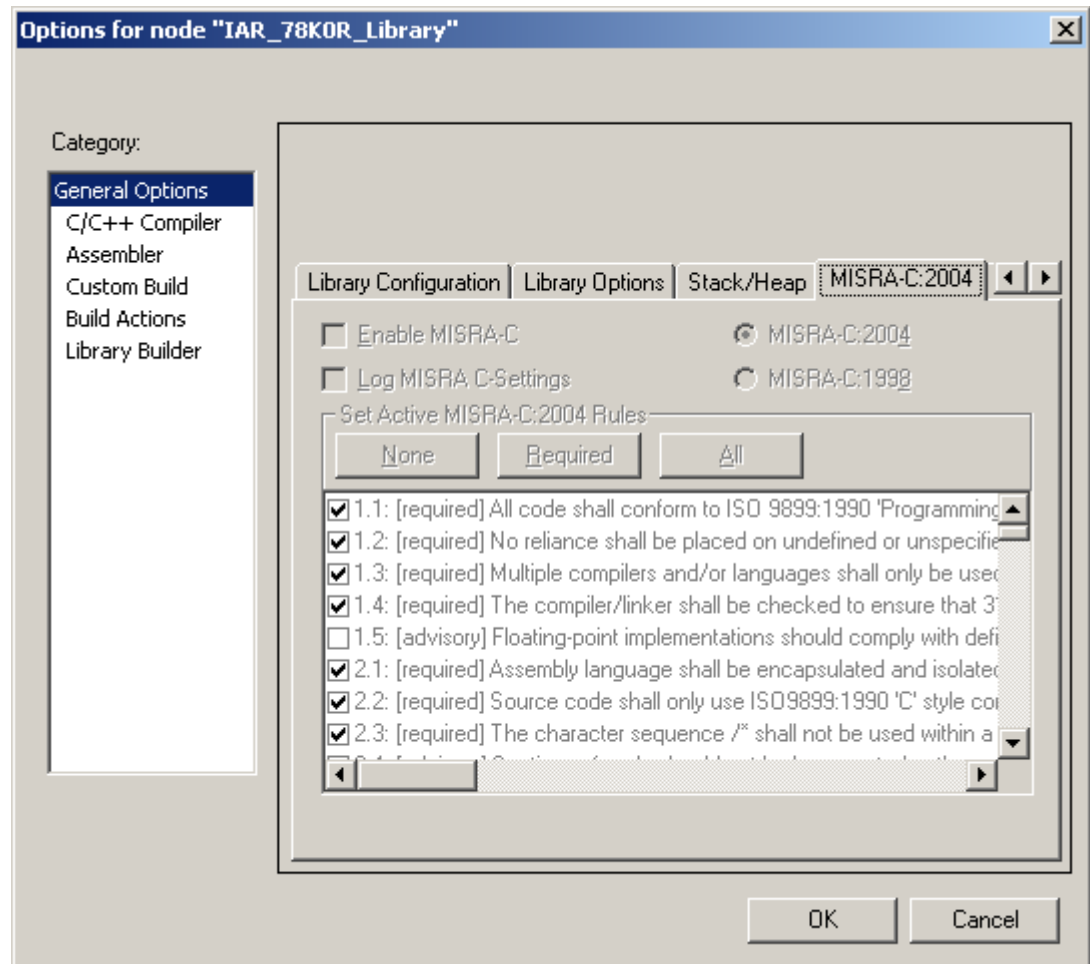
MISRA C checker can not be enabled in EW78K DialogueDetails

The MISRA C checker can not be enabled in the EW GUI:

An update patch can be downloaded from the IAR Systems MyPages area to fix this problem. Further details are described here:

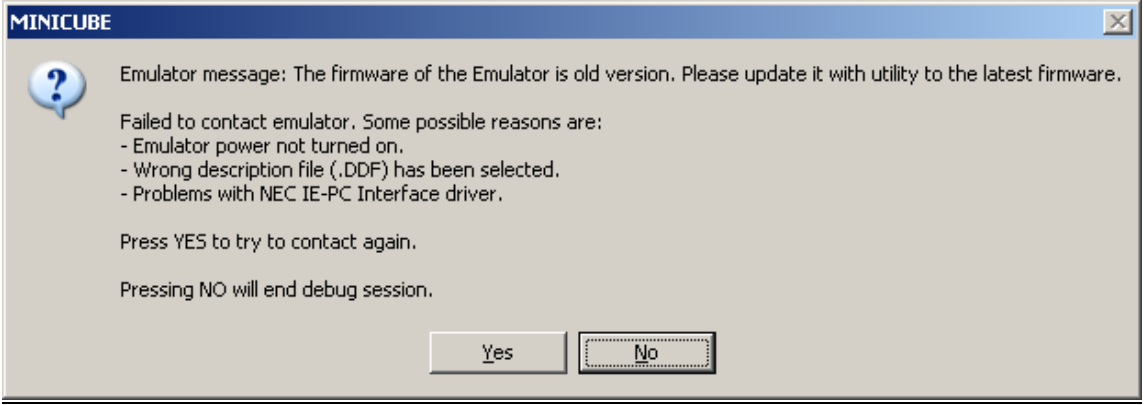
No. E44	<p>C-SPY 78K0 MINICUBE2 Driver: Error message about old firmware version</p>
	<p><u>Details</u></p> <p>After the installation of the update patch CS78KE_V460b the following error message will occur if the firmware-version of the MINICUBE2 is less than V4.06:</p>

<p><u>Workaround</u></p> <p>The MINICUBE2 firmware V4.06 will be available b/o October 2008. Until then please contact the Renesas software tool support team (software_support-eu@lm.renesas.com) to receive further information fixing the problem.</p>

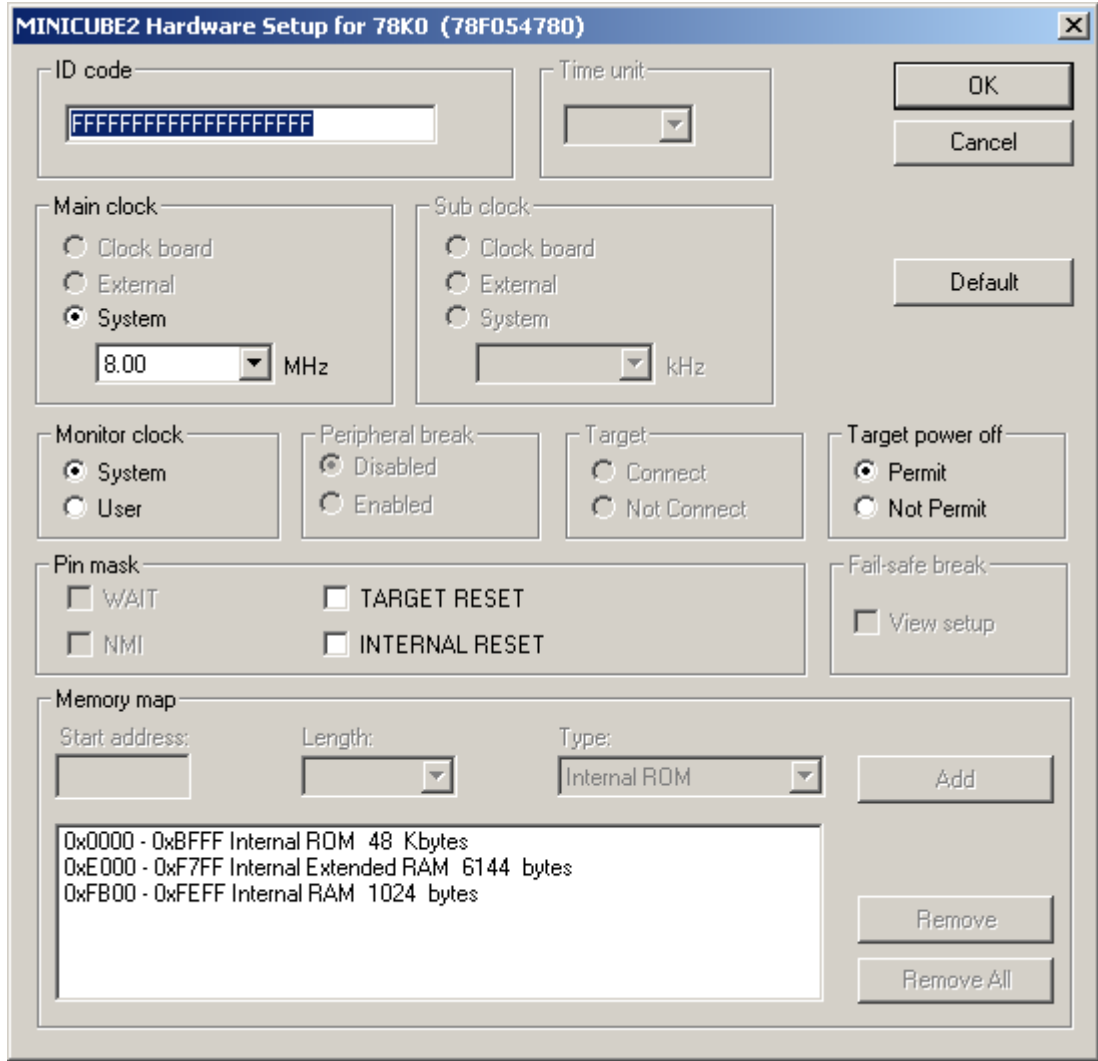
If no oscillator is mounted on the target hardware and no external oscillator is mounted on the 78K0 MINICUBE2 clock board, three different system clocks (4 MHz, 8 MHz, or 16 MHz) can be provided by MINICUBE2. The selection is done in the C-SPY Hardware Setup Dialogue:

Independent of the selection, the provided system clock is always 4 MHz.

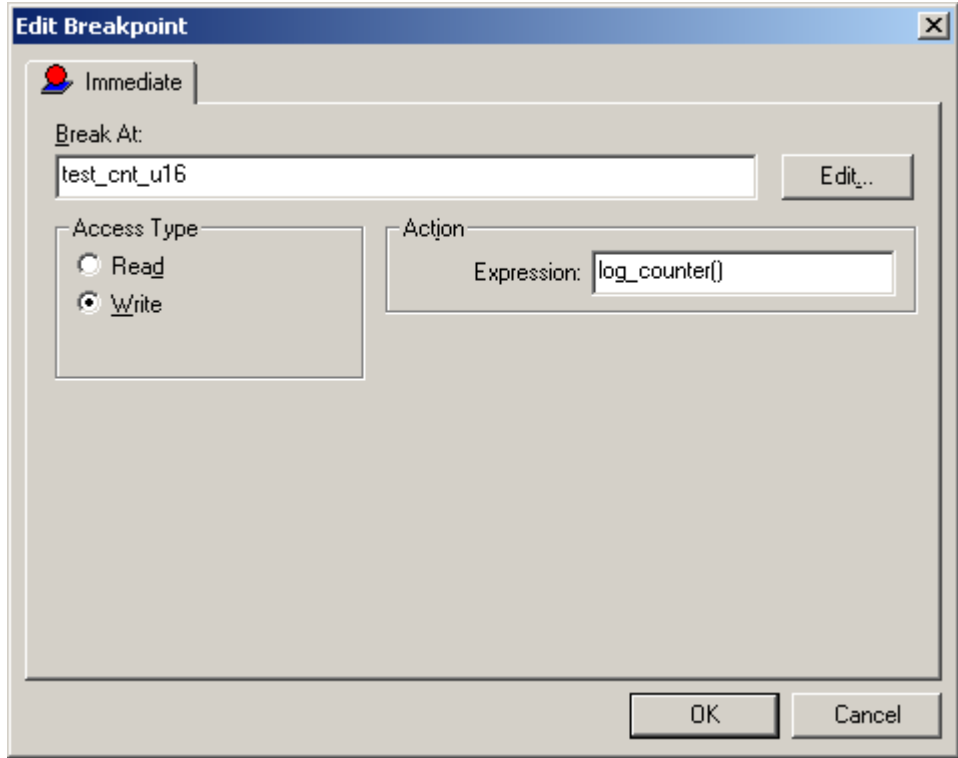
No. E51	<p data-bbox="322 262 1489 304">C-SPY 78K Simulator Driver: Wrong macro access to 16bit data</p> <p data-bbox="322 338 1489 371"><u>Details</u></p> <p data-bbox="322 398 1489 465">If a 16bit variable is accessed by a C-SPY macro triggered by an immediate breakpoint cause by an access to the same variable, the macro access may deliver a wrong result.</p> <pre data-bbox="322 521 906 696">unsigned short test_cnt_u16=0x1717; void test (void) { test_cnt_u16 ++; }</pre> <p data-bbox="322 730 501 763">C-SPY Macro:</p> <pre data-bbox="322 797 1066 913">log_counter() { __message "Testcounter : ", test_cnt_u16:%d; }</pre> <div data-bbox="322 943 1284 1697">

</div> <p data-bbox="322 1760 1489 1794"><u>Workaround</u></p> <p data-bbox="322 1821 1489 1888">Use a software breakpoint to trigger the C-SPY macro. The problem will be fixed in the next update.</p>
---------	--

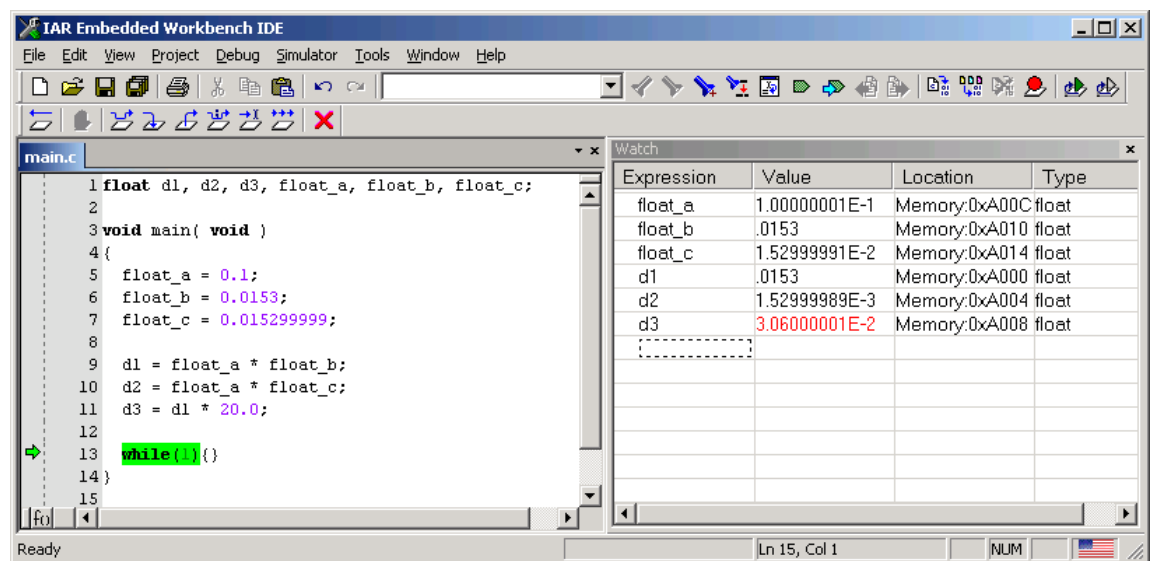
The displayed value of 'd1' is wrong, but the application uses the correct value. This can be seen in the calculated value of d3.

None. The problem will be fixed in the next update.

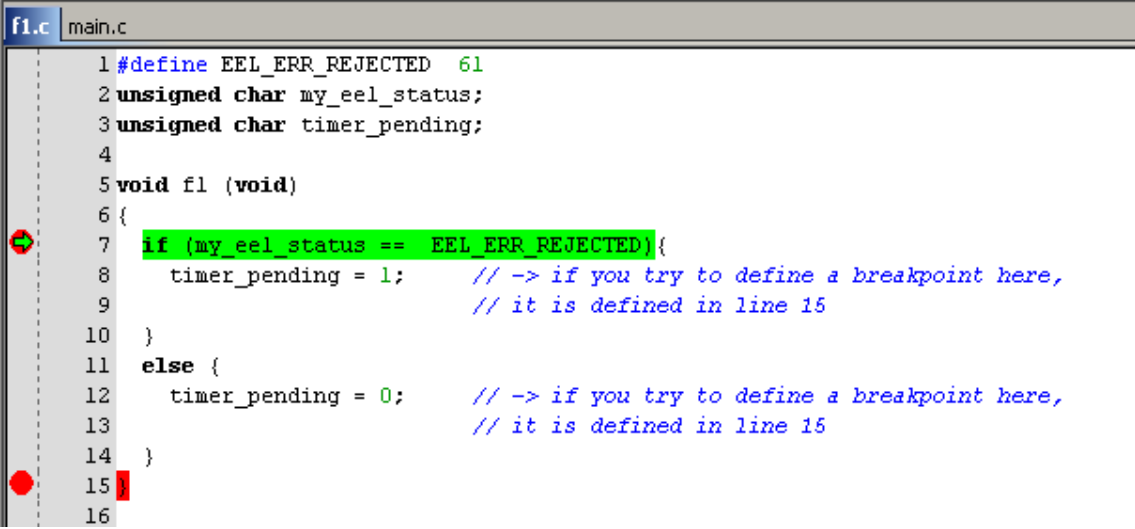
No. E54	C-SPY 78K: Breakpoint can not be defined at some source lines
<p><u>Details</u></p> <p>Due to missing statement information in the debug information generated by the compiler, breakpoints could in rare cases not be set on specific C source lines.</p>

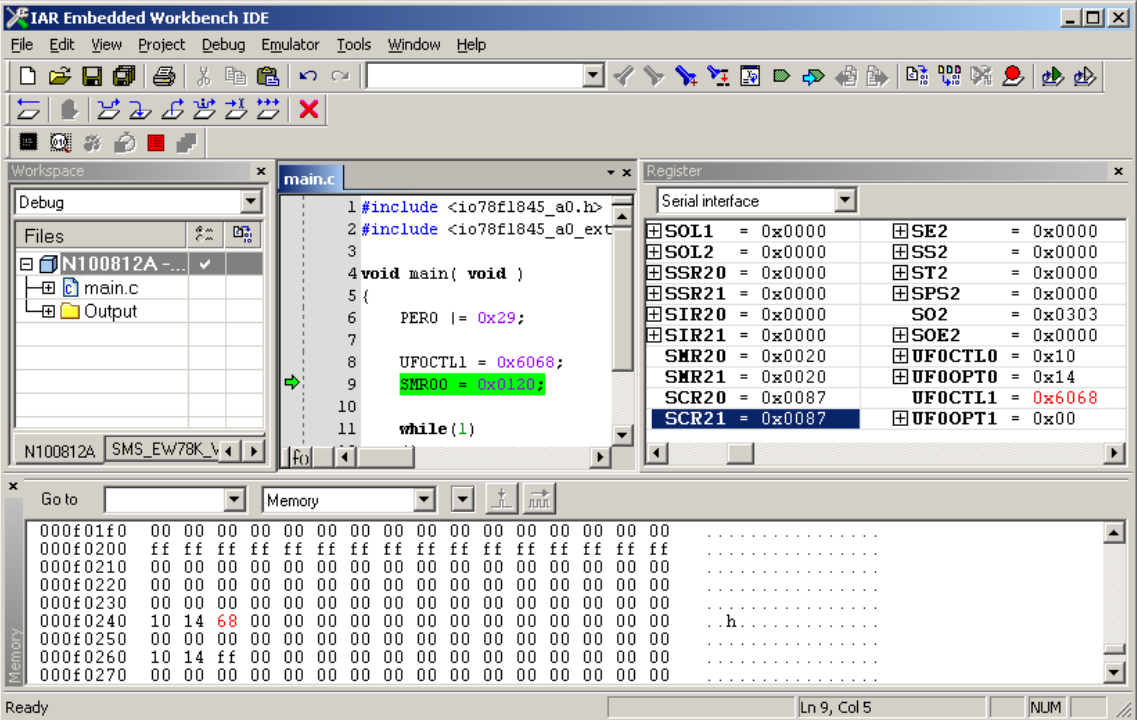
No. E55	<p>C-SPY 78K0R: Wrong Display of 16bit SFR in Memory Window</p>																																																																			
<p><u>Details</u></p> <p>The high byte of a 16bit special function register maybe displayed incorrectly in the Memory Window. The correct value is displayed in the Register Window</p>

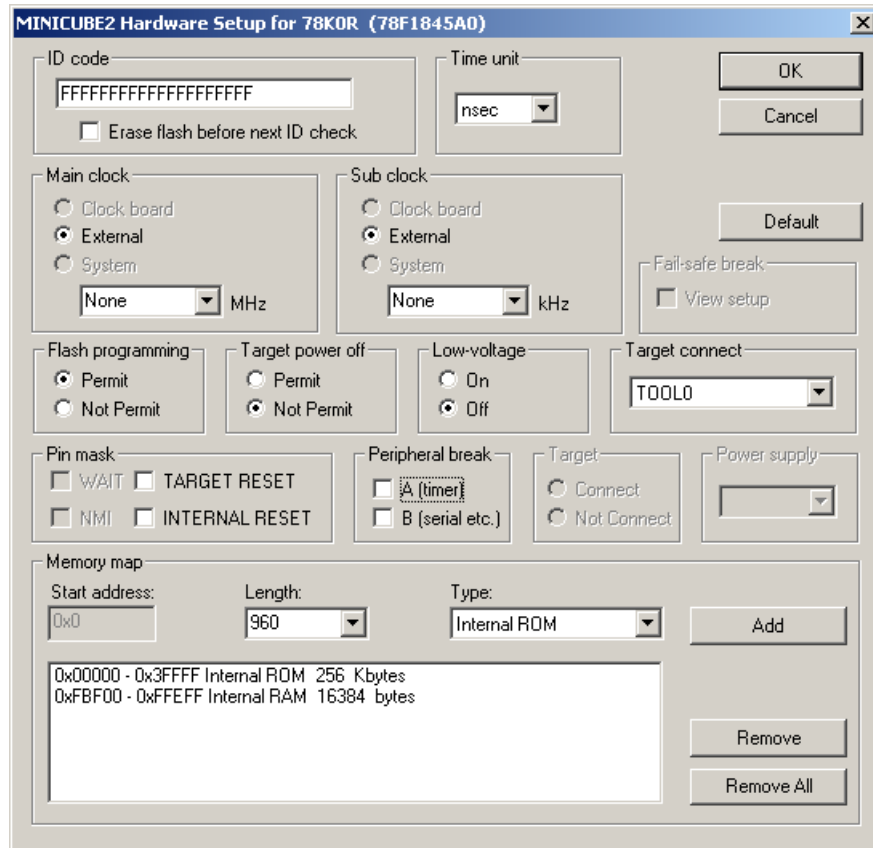
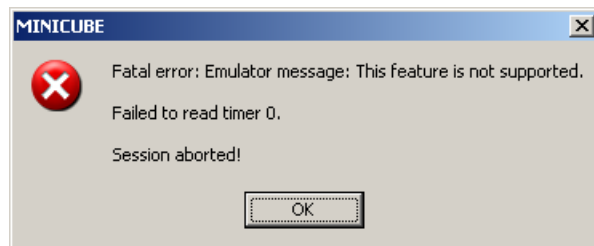
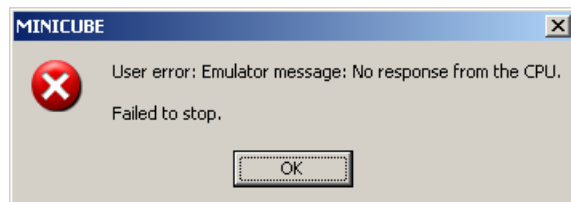
C-SPY 78K0R MINICUBE2 Driver: Broken Emulator Communication

After selecting the internal sub clock as CPU clock the communication between debugger and emulator will be broken at a manual stop, if single wire target connection (-> TOOL0) is used:

After a manual break while CPU is running at sub clock, the following error messages occur and the debugger session is closed:

Please use the two wire target selection (TOOL0 + TOOL1).

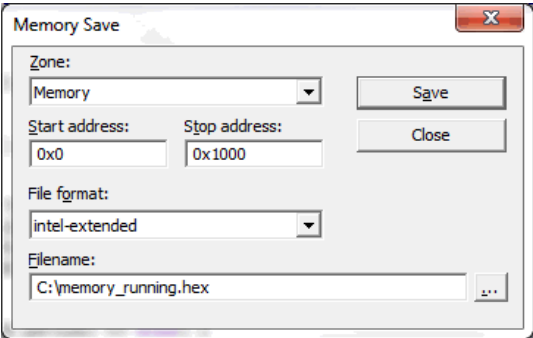
No. E60	All C-SPY Drivers: Incorrect Flash Memory Upload in Run-Mode
<p><u>Details</u></p> <p>When performing a memory upload (Debug --> Memory --> Save...) while the application is running the content of the output file is incorrect.</p>

<p><u>Workaround</u></p> <p>Stop application before memory update.</p>

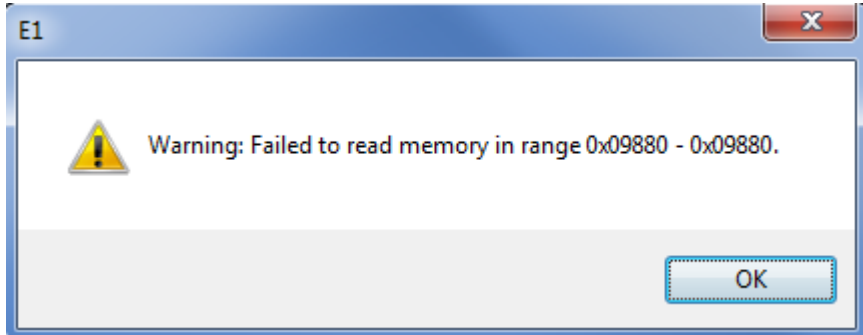
No. E63 **Reading Data-Flash-Memory causes an Error**

Reading Data-Flash-Memory while application is running may cause errors .
The following error will be shown during the debug session start, if the Data-Flash-Window is opened with more than 12 address lines:

If such a warning occurs, the Data-Flash-Window shows wrong values:
