**Orthopantomograph®
OP100 D**

**Orthoceph®
OC100 D**

Troubleshooting Manual

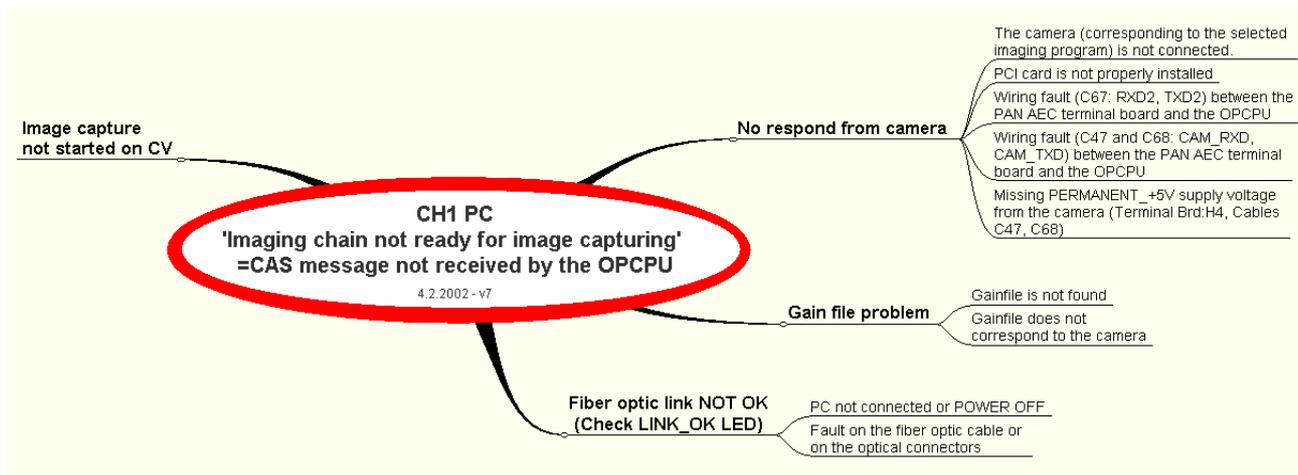
Fig 2.1. Ch 1 PC

Problem:	“ Ch 1 PC “ error message is displayed.
Why?	Detector not found.
How is it detected?	Error is generated when user has pressed OP100D or OC100D exposure button and CPU doesn't receive “PC ready” message

Possible causes:	Check or test:	Parts related:
1. No respond from camera because:		
a) The camera (corresponding to the selected imaging program) is not connected.	Check that the ccd-detector is connected to the PAN or CEPH head according to the imaging program selected from the OP100D / OC100D control panel.	Camera / Detector, OP100D / OC100D, control panel

d) Missing PERMANENT_+5 V supply voltage from the camera (Terminal Board:H4, Cables C47, C68)	Check that LED H4 on the PAN AEC Terminal is ON. LED tells you if Terminal senses camera connection or in case of fixed PAN head the jumper J1 is installed.	PAN AEC Terminal Board, PAN Connector Board, Camera Connector Board

Possible causes:	Check or test:	Parts related:
2. Image capture not started on CV	Check that you have initialized imaging sequence by pressing “start OPD/OCD image capturing session” button	Cliniview

4. Gain file problem		
a) Gainfile is not found	Check that your camera’s gainfile is saved under your Instrumentarium Imaging\Cliniview\Dicc\Ortho\Gainfiles\ folder. From Cliniview’s Help - system-info/Device verify that Cliniview has recognized the needed gainfile in panoramic or cephalometric imaging.	PC, installation media, gain file media

b) Gainfile does not correspond to the camera	Check that Gainfile number matches to camera / detector number	PC, installation media, gain file media

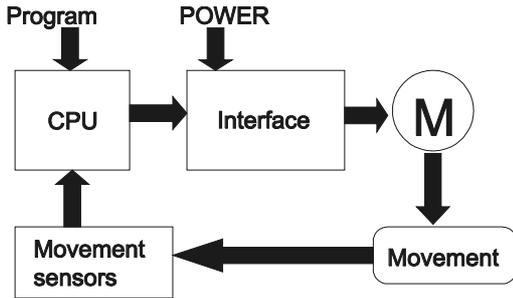
Fig 2.2. Movement control principle

Problem:	“ Sy 27 Por “ error message is displayed.
Why?	Position error: rotation movement failed.
How is it detected?	This error is generated during rotation if the CPU does not receive the correct sequence of ROTSW1 to ROTSW4 signals within a predefined time. CPU assumes that the rotating unit is not rotating and interrupts all movements and exposure.

Possible causes:	Check or test	Parts related
Unit rotates, but microswitches S 11 to S 14 may not operate properly. Signals ROT1SW to ROT4SW.	Use Sr 74 IOC. Test the signals, rotate by hand.	S11 - S14, C11, X9, CPU Board
Problem with motor control. Rotation stepping motor or motor driving circuitry in Interface Board may not operate properly.	Check the control from CPU to Interface Board. Check the motor control red LED's: all should lit when unit is rotating. Check X16 and X17 connections.	Interface Board, X16, CPU Board, X17, M3, X112

Possible causes:	Check or test	Parts related
Problem with motor power. Power Supply F2 blown.	Check F2 on Power Supply Board.	Power Supply Board, F2
Unit rotates, but not enough friction between the drive wheel and friction surface	Clean the friction surface with alcohol. Use Sr 80 ro-. Adjust the spring tension.

Problem with cephalostat lock under the rotating unit.	Check the cassette holder down position. There should be spacing between the cephalostat lock and lock wedge when rotating. If not adjust the cassette holder microswitches or check the cassette holder sliding rods.	Cassette holder microswitch & sliding rods, cephalostat lock
Problem with wiring.	Check the cables and their travel inside the rotating unit.	
TIMER ICD 27 (8254) in CPU Board may not operate	Replace CPU Board	CPU Board
Wrong CPU PAL version. Problem occurred with OT upgrade or during service.	If the motor movement is very fast or slow, the PAL version may be wrong. Interface Board & PAL 1.0.0 or 1.1.0 Interface Board OT & PAL 2.0.0 or 2.1.0	CPU PAL
Cassette holder top plastic plugs touching the main support.	Check the spacing, adjust cassette holder microswitches.	Cassette holder microswitch
S/N 70xxx: Rotation limiter bolts are touching the drive disk. Bolts are too long	Check the spacing between, add washers under the limiter bolts when needed. Bolts are M8x30.	Bolts

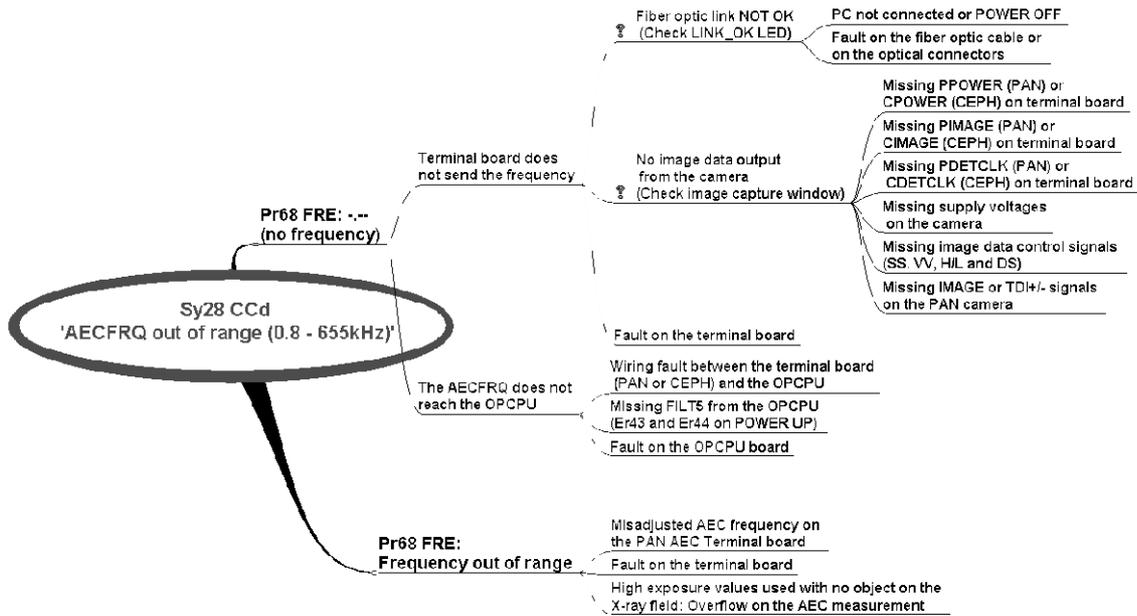
Fig 2.4. Sy 28 CCD

Possible causes:	Check or test	Parts related
1 Terminal Board does not send the frequency:	Check with Pr68 FRE	
1.1)Fiber optic link NOT OK because of:	Check LINK_OK LEDs on the Terminal Board and on the PCI Board	PAN AEC Terminal Board, CEPH Terminal Board, PCI Board.
1.1.1) PC not connected or POWER OFF	Check PC.	PC, PCI Board
1.1.2) Fault on the fiber optic cable or bad connection	Check that the fiber optic cable connectors are properly connected. Do the link test procedure to the fiber cables.	Fiber cables C41, C50 and C67.

Possible causes:	Check or test	Parts related
1.2) No or interfered image data from the camera caused by:	Monitor the image capture window whether the image appears there during exposure?

1.2.1) Missing PPOWER (PAN) or CPOWER (CEPH) on Terminal Board	Check that all the supply voltage LEDs are lit on the Camera Supply Board (PAN) or on the CEPH Head Board (CEPH) when the exposure button is pressed.	PAN AEC or CEPH Terminal Board, Camera Supply Board, CEPH Head Board, Cables C63, C67, C50, C52

1.2.2) Missing PIMAGE (PAN) or CIM-AGE (CEPH) on Terminal Board	Check that the PIMAGE LED or CIM-AGE LED is lit on the corresponding Terminal Board.	PAN AEC or CEPH Terminal Board, CEPH Head Board, Cables C67, C50, C52

1.2.3) Missing PDET-CLK (PAN) or CDET-CLK (CEPH) on Terminal Board	Measure the frequency between the Terminal Board test points TP5 and TP6 with a multimeter: If a frequency greater than 0 is found during the exposure, the line is working.	PAN AEC or CEPH Terminal Board

1.2.4) Missing supply voltage on the camera	Check A2a. Check cables C51, C63. Check cable C47 (PAN) or C68 (CEPH). Replace Terminal Board. Replace Camera.	Cables C47, C51, C63, C68. PAN AEC or CEPH Terminal Board

1.2.5) Missing image data control signals (SS, VV, H/L and DS)	Check A2d. Replace Terminal Board. Check cable C47 (PAN) or C68 (CEPH). Replace camera.	PAN AEC or CEPH Terminal Board, Camera Supply Board, CEPH Head Board, cable C47 (PAN) or C68 (CEPH). PAN or CEPH Camera.

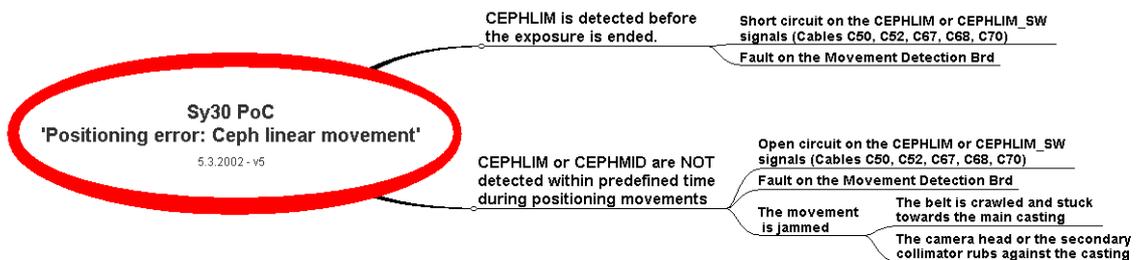
Fig 2.5. Figure 3. Sy 30 PoC

Problem:	“ Sy 30 PoC “ error message is displayed.
Why?	Ceph movement positioning error
How is it detected?	Appears if the CEPH linear movement (camera and secondary collimator) arrives to the end limit (CEPHLIM is activated) before the exposure is ended.

Possible causes:	Check or test:	Parts related:
Beam is not correctly aligned: The Beam Alignment Board forces the OPCPU to increase the scan speed for too long period.	Check beam alignment and beam detection functionality	Beam Alignment Board Head Board CPU Board Cabling
Short circuit in CEPHLIM signal (or between CEPHLIM and CEPHMID signals)	Check CEPHLIM and CEPHMID signaling from Movement Detection Board to CPU Board	Movement Detection Board Ceph Straight Conn Board Ceph Terminal Board Head Board CPU Board Cabling
CEPHLIM or CEPHMID are NOT detected within predefined time during positioning movements	Check the CEPHLIM or CEPHLIM signals Check the Movement Detection Board Make sure that the movement isn't jammed due to 1 belt crawling 2 camera head rubbing against the casting or 3 secondary collimator rubbing against the casting 4 the nut of the camera or the secondary collimator axle is jamming	Movement Detection Board Belt Camera head Secondary collimator Inspect the drive nut tightness

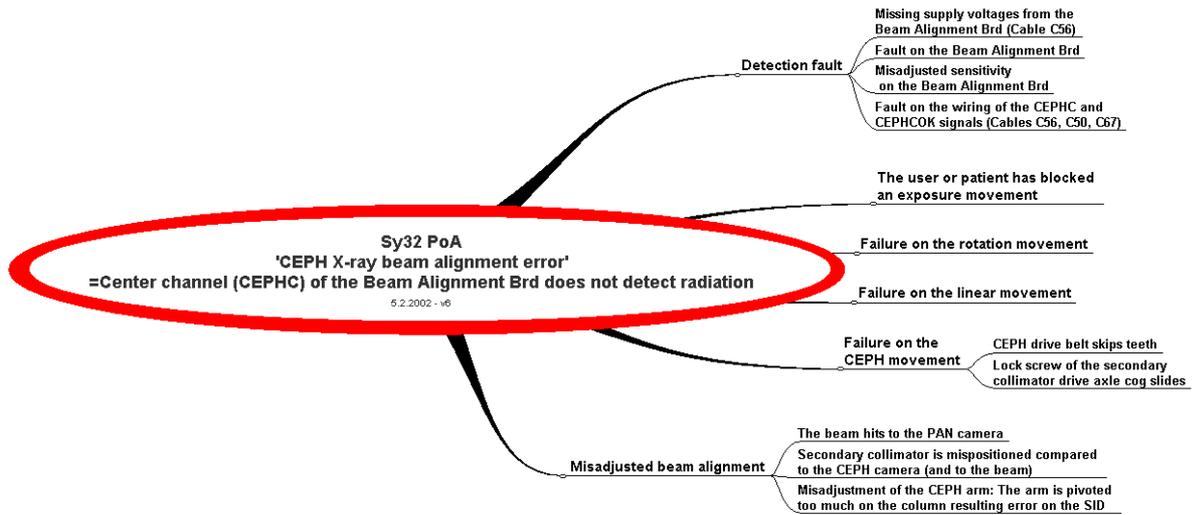
Fig 2.6. Sy 32 PoA

Possible cause:	Check or test:	Parts related:
Beam is not correctly aligned	Check beam position and adjust if necessary Check that the beam doesn't hit to the PAN camera Check positioning of the secondary collimator Check adjustment of the CEPH arm: The arm is pivot too much on the column resulting error on the SID	Beam Alignment Board Secondary collimator Pan camera
Beam detection fault	Check sensitivity adjustment of the Beam Alignment Board Check functionality of the Beam Alignment Board Check CEPHC and CEPHCOK (TP16) signals on Head Board Check cabling from Head to CPU and Beam Alignment Board	Beam Alignment Board Head Board Cables
Missing supply voltages from the Beam Alignment Board	Check cpower signal from Head Board (TP22) Verify that the supply voltages +5V (TP32) and -5V (TP29) are present on Beam Alignment Board (LED H4) Check cabling from Head to CPU and Beam Alignment Board	Head Board Beam Alignment Board Cables

Failure on the linear movement	Make linear movement (Sr 81 LI-) and CPU I/O (Sr 74 IOC) tests	Linear motor and microswitches
Failure on the rotation movement	Make rotation movement (Sr 80 ro-) and CPU I/O (Sr 74 IOC) tests	Rotation motor and microswitches
Failure on the CEPH movement	Check that CEPH drive belt doesn't skip teeth Check that lock screw of the secondary collimator drive axle cog doesn't slide Make CEPH movement (Sr 82 CE-) and CPU I/O (Sr 74 IOC) tests	Ceph scan motor and microswitches Secondary collimator drive axle
The user or patient has blocked an exposure movement	Check the patient positioning
