Errata and Added Information to
**MC68360 Quad Integrated Communication
Controller User's Manual Rev 1**

January 8, 1998

This document describes the latest information and changes to the first revision of the MC68360 user's manual.

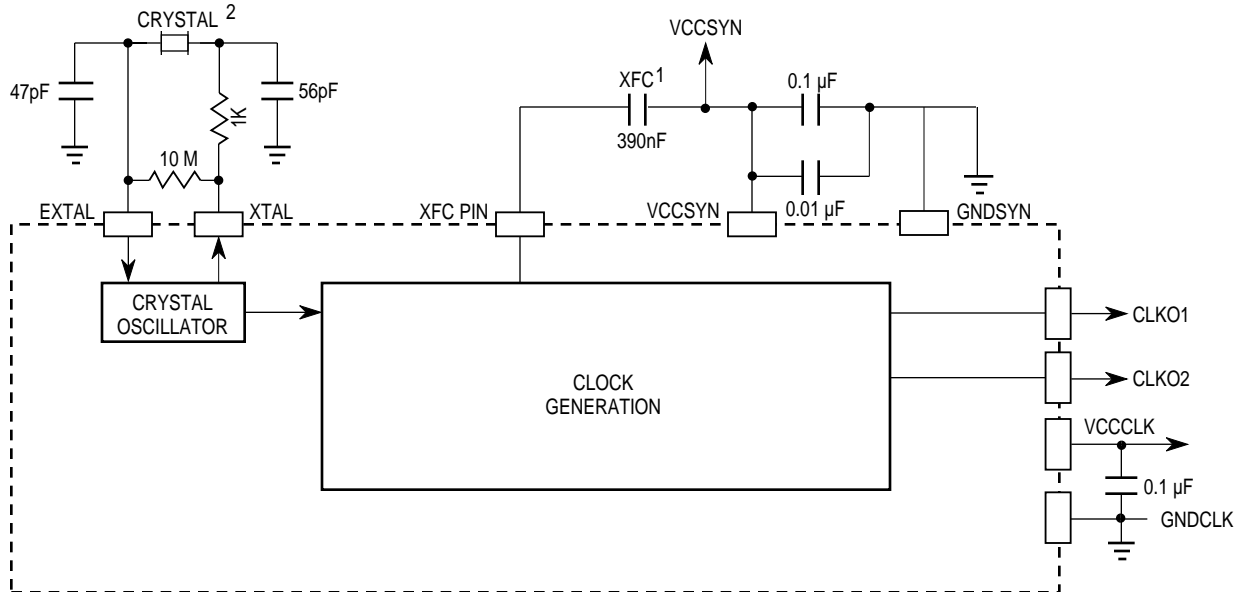
Figure 6-6A External Components for 4.192MHz

Also on page 6-14 the following figure should be added.

1. Must be low-leakage capacitor. See Section 10 Electrical Characteristics for recommended values.
2. Values are for 4.194MHz crystal and may vary due to capacitance on PCB.

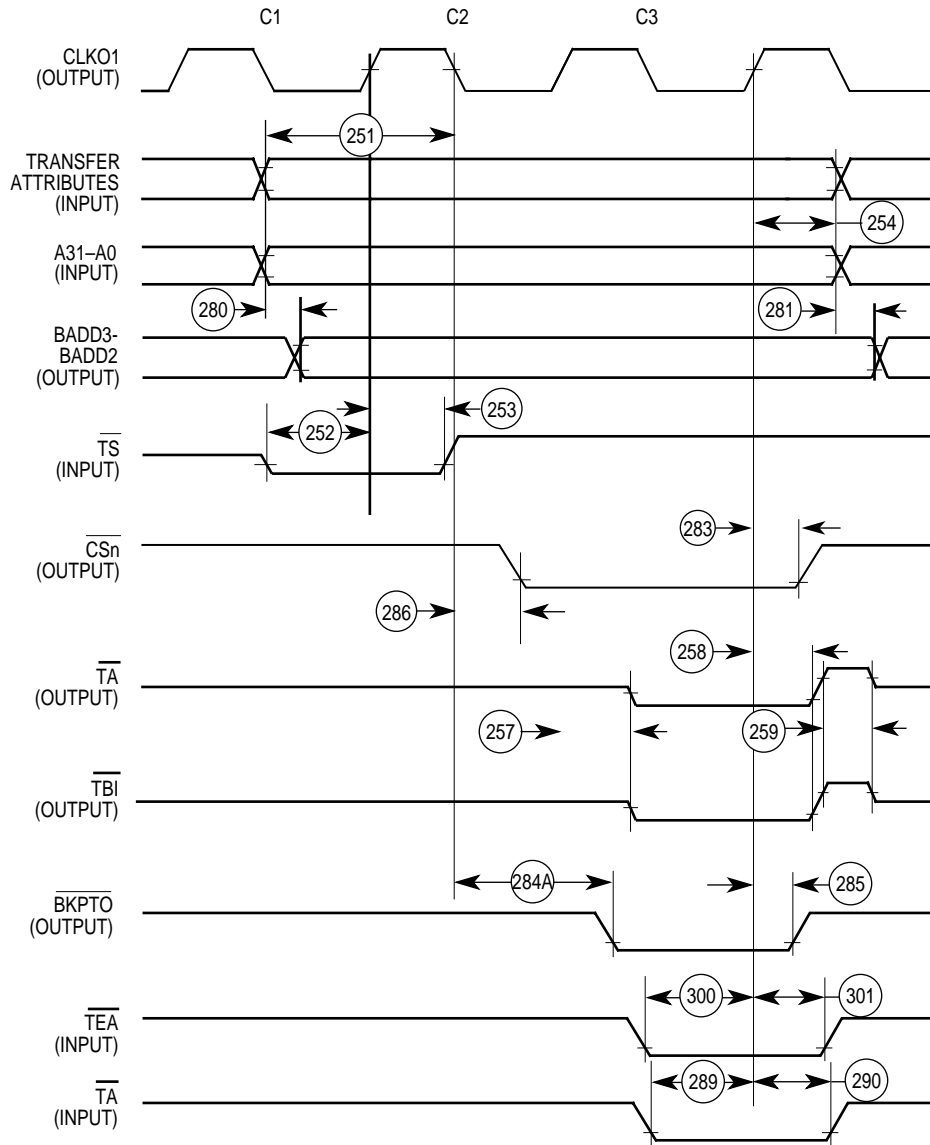
Figure 10-45(b) MC68040/EC040 SRAM Read Cycle (TSS40=1, CSNT40=1)

The following figure should be added below figure 10-45(a)

NOTE: MC68040 Transfer Attribute Signals = SIZx, TTx, TMx, R/W, LOCK
OE and WE are not supported when TSS40 is set to 1
