IMPORTANT PRODUCT INFORMATION

Product: IC693DSM302 Module (“DSM302”)
IC693DSM302AD
Firmware Version 1.30

Purpose of this Document

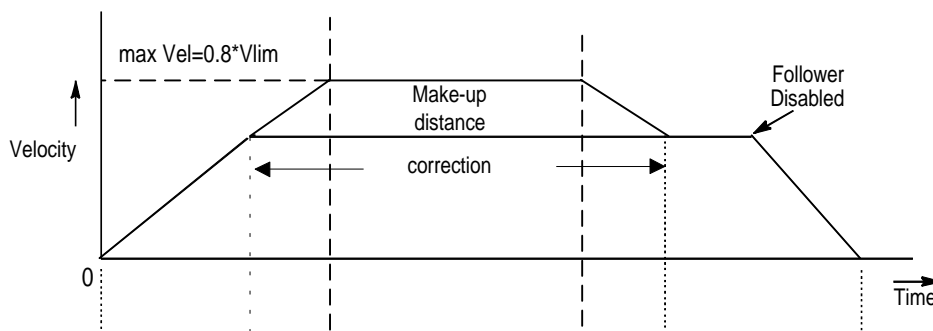
Enhanced Follower Axis Ramp Control

The Follower Axis Ramp Control Function is enhanced in DSM firmware release 1.30. The enhancement improves motion smoothness. Prior to this release, when the follower was active and the master in motion, the acceleration/deceleration control during the make-up correction phase was not controlled by a velocity profile. This could cause unwanted machine shock. The enhanced method uses a trapezoidal velocity profile to address this problem. During the entire make-up correction phase, the acceleration/deceleration is limited to the jog acceleration value. Also during the correction, the velocity is not allowed to exceed the maximum. Appropriate warning/error codes notify the user about abnormal operation (see error table below).

The figure below shows the velocity profile during the follower ramp cycle. *Note: The enhanced follower make-up may affect existing applications that use the old follower make-up feature.*
