ControlLogix Combination Controller and SERCOS Interface Card, Revision 16

Catalog Number 1756-L60M03SE

This revision of the firmware release notes, 1756-RN642E, provides updated information specific to firmware revision 16.22.

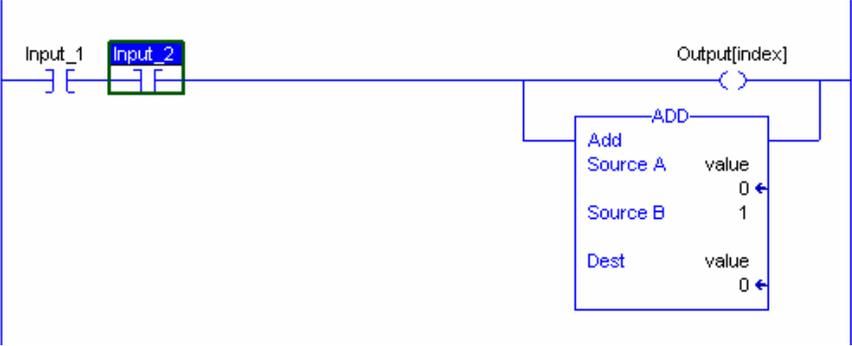
Firmware Revision	Description
16.22	<p>Fault handlers can be defined at the controller and program scope levels. These fault handlers are typically used to handle major recoverable faults that can occur during runtime execution of an application due to programming errors. A typical example of this would be handling indirect addressing that has gone out of range; MyTag[index], where index is larger than the size of the array.</p> <p>Faults can also be handled by the controller during pre-scan of the controller program on the transition to Run mode. Again, for example, the handling of indirect addressing that has gone out of range.</p> <p>There is an anomaly when these methods attempt to handle a fault.</p> <p>These are the possible ways the anomaly can manifest itself:</p> <ul style="list-style-type: none"> • The controller will experience a major non-recoverable fault. I/O goes to their configured safe state, and the user application is cleared from memory. At this point, a Code 1 Type 60 or 61 major recoverable fault will be logged in the controller. This requires you to redownload the application. • Tag data corruption. • Online saving or uploading failures. • Anomalous program execution. <p>For example, if a rung is being scanned false and there is an instruction that has false execution, the fault handler executes so the remainder of the rung will scan true. In the example below, the OTE instruction has an index out of range. After returning from the fault handler, the ADD instruction will execute, even though the rung input conditions are false.</p>

<p>Lgx00106481, Lgx00107423, Lgx00100766, Lgx00106478</p>
