IMPORTANT PRODUCT INFORMATION

Product:	Max-ON™ Hot-Backup Redundancy Software, Release 2.02	
IC641HBR300C	Max-ON Hot-Backup Software, Lite Edition	PLC Folder release 2.04 Max-ON Tools, build 2.02.014 Max-ON Helpfile, build 2.02.005
IC641HBR301C	Max-ON Hot-Backup Software, Standard Edition	PLC Folder release 2.04 Max-ON Tools, build 2.02.014 Max-ON Helpfile, build 2.02.005
IC641HBR302C	Max-ON Hot-Backup Software, Extended Edition	PLC Folder release 2.04 Max-ON Tools, build 2.02.014 Max-ON Helpfile, build 2.02.005
IC641HPD001C	Max-ON Hot-Backup Software, Distributor Demo, Single CD	
IC641HPD010C	Max-ON Hot-Backup Software, Distributor Demo, 10 CD Package

GFK-1877C

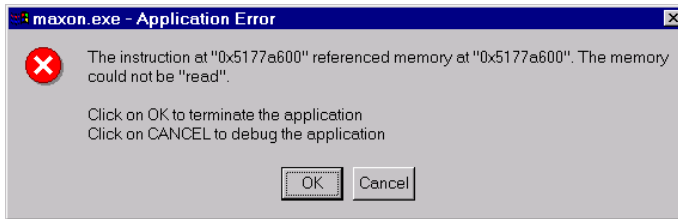
1. **When exiting Max-ON Tools software you may receive the following Windows error message.** This occurs perhaps one out of ten times.

Suggested Resolution: Click on *OK*. This problem appears to be cosmetic in nature only. There is no permanent effect on the operating system or other applications that are running at the time the message appears.
