Product: Genius Modular Redundancy Phase IV Software v2.00

Important Product Information: GMR Phase IV Software

GFK-1287F

February 2006

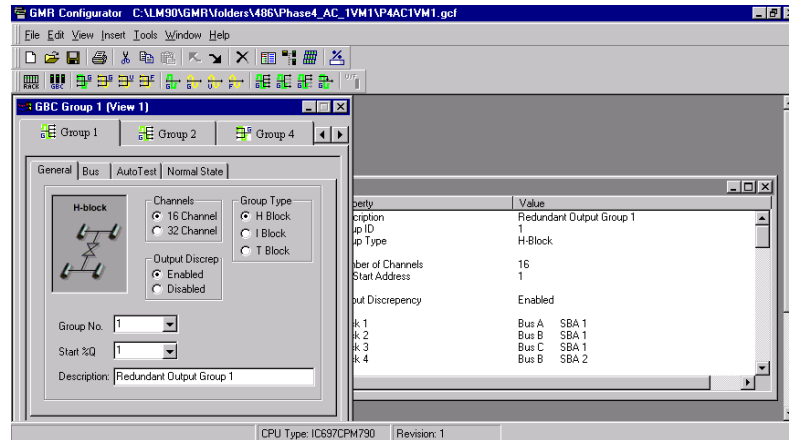
2. **Normal State Must be Configured Appropriately for Critical Outputs in Fire and Gas Application:** Critical outputs in a Fire and Gas application must be configured such that the ‘normal’ state is the opposite of the safe or demand state as appropriate, so that the GMR diagnostics will perform correctly. For example, normally energized (‘on’) outputs will be forced to the safe, or de-energized state, in the event of failure, whereas normally de-energized (‘off’) outputs will be forced to the energized state (as in a Fire and Gas application). To configure outputs in this manner, bring up the GMR Configuration Utility and select the output group as shown.

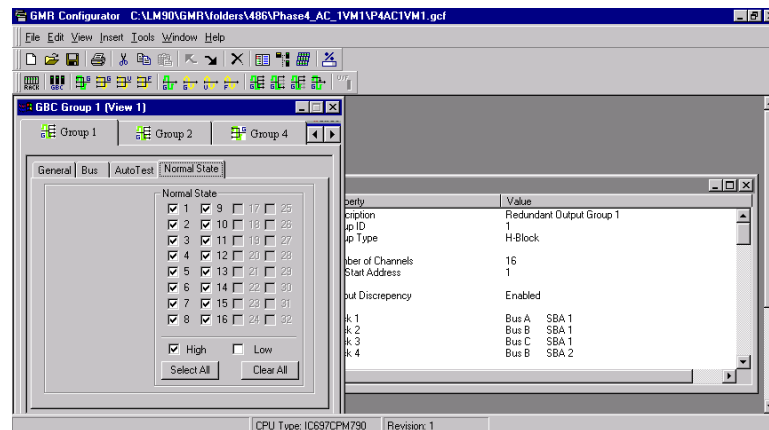
Select (mouse click) the Normal State tab for the associated output group, to display the following screen.

The normal state can be configured on a point by point basis or, with the Select All and Clear All buttons, can be configured uniformly for all points in that output group.

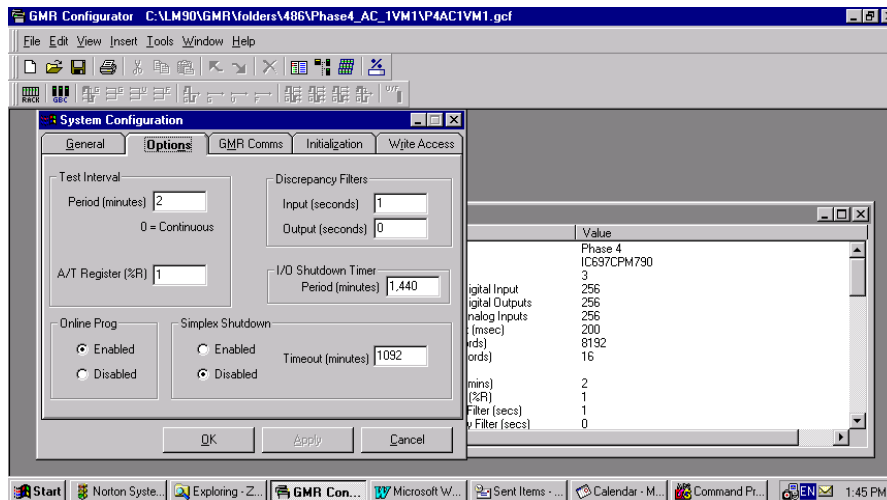
- Output Autotest Faults When Outputs are Rapidly Changing State:** In addition to the output discrepancy faults that can occur as a result of non-steady-state outputs in redundant output groups, it is also possible that Output Autotest faults could occur. This may happen under very narrow timing conditions when the output block's state has been overridden to the de-energized state (during the Autotest sequence) and the output value changes. This would cause the Autotest to fail, resulting in a Output Autotest fault message. A second side effect is that the output would remain overridden in the de-energized safe state, consistent with TUV requirements. Note that this TUV requirement applies only to outputs which are normally energized, as determined by the setting in the GMR Configuration Utility. Those outputs configured as normally de-energized will not see this particular fault under these conditions.

Because of the asynchronous operation of CPUs in a GMR system, it is possible that output blocks, while voting the output from three separate CPUs, could “see” a discrepancy when an output is simply changing states. Earlier versions of GMR dealt with this situation by filtering discrepancies that occurred during state changes. However, under some circumstances, this default filter may be inadequate. A field has been added to the GMR Configuration Utility (revision 7.00 and later) that allows the user to adjust the filter by adding a configurable number of seconds (between 0 and 65535). In effect, an output discrepancy would have to exist for the configured number of seconds before being reported as a fault. (For more information on GMR Output Discrepancy reporting, see the *GMR User's Manual*.)

To access the parameter in the GMR Configuration Utility, select ‘View’ from the menu bar, followed by ‘System Configuration...’ Then select the Options tab to reveal a screen similar to the one below:

In the Discrepancy Filter area, a value can be entered for Output. A value of ‘0’ will cause the system to act just as earlier versions of the GMR Software now operate, with the filtering algorithm described in the User’s Manual. This is the default value.
