ABI PRISM® 310 Genetic Analyzer

Errors Encountered on the ABI PRISM® 310 Genetic Analyzer

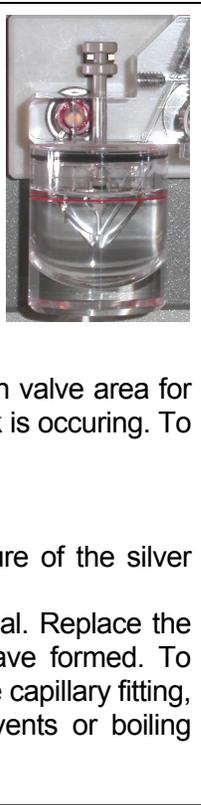
<p>3 Anode Buffer Jar / Pin Valve – Inspect the anode buffer jar and pin valve for leaks.</p> <ul style="list-style-type: none"> ▪ The pin valve/pump block must be properly attached to the instrument. The pin valve has an upper and a lower head. The silver toggle arm of the 310 Analyzer must sit between the upper and lower heads to function properly. ▪ Check that the volume of the buffer jar does not change. If the volume increases dramatically, polymer may be leaking into the jar. ▪ To perform a leak test, remove the buffer jar from the pump block. Dry the pin valve area with a laboratory wipe. Run a SeqFillCapillary module then inspect the pin valve area for signs of polymer leakage. If polymer is present then a leak is occurring. To remedy the leak, the following options may work: <ul style="list-style-type: none"> ▪ Soak and flush the block in warm water. ▪ Remove and replace the pin valve. ▪ It is possible that the solenoid controlling the pressure of the silver toggle arm needs calibration. ▪ Lastly, damage to the block can prevent a proper seal. Replace the pump block as microscopic fractures/cracks may have formed. To prevent damage to the block, avoid over-tightening the capillary fitting, and do not subject the pump block to organic solvents or boiling water.
