The following information relates to the construction / assembly of a HobbyKing AT-6 “Texan” – including what are considered (IMHO) to be reasonable and worthwhile modifications.

### **Build Record**

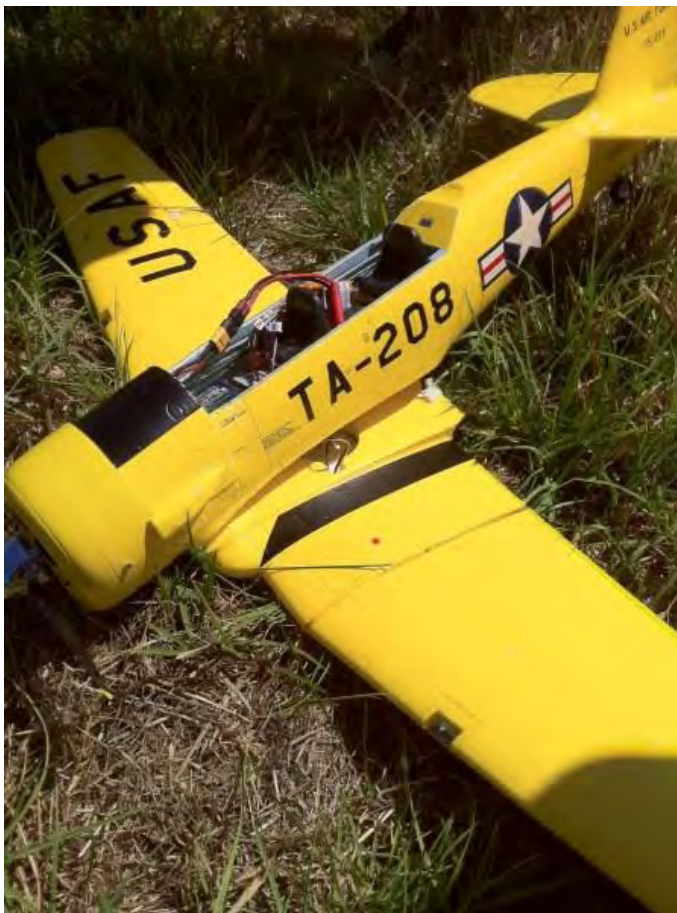
On the third flight a tip stall was experienced with the aircraft being damaged on impact.

The motor shaft was bent, various cracks in the foam were to be noted, the wing saddle was significantly moved with resultant damage / distortion.

Cowl was damaged and one propeller blade broken off.

Refer to the end of this build record for details / method of repairs.

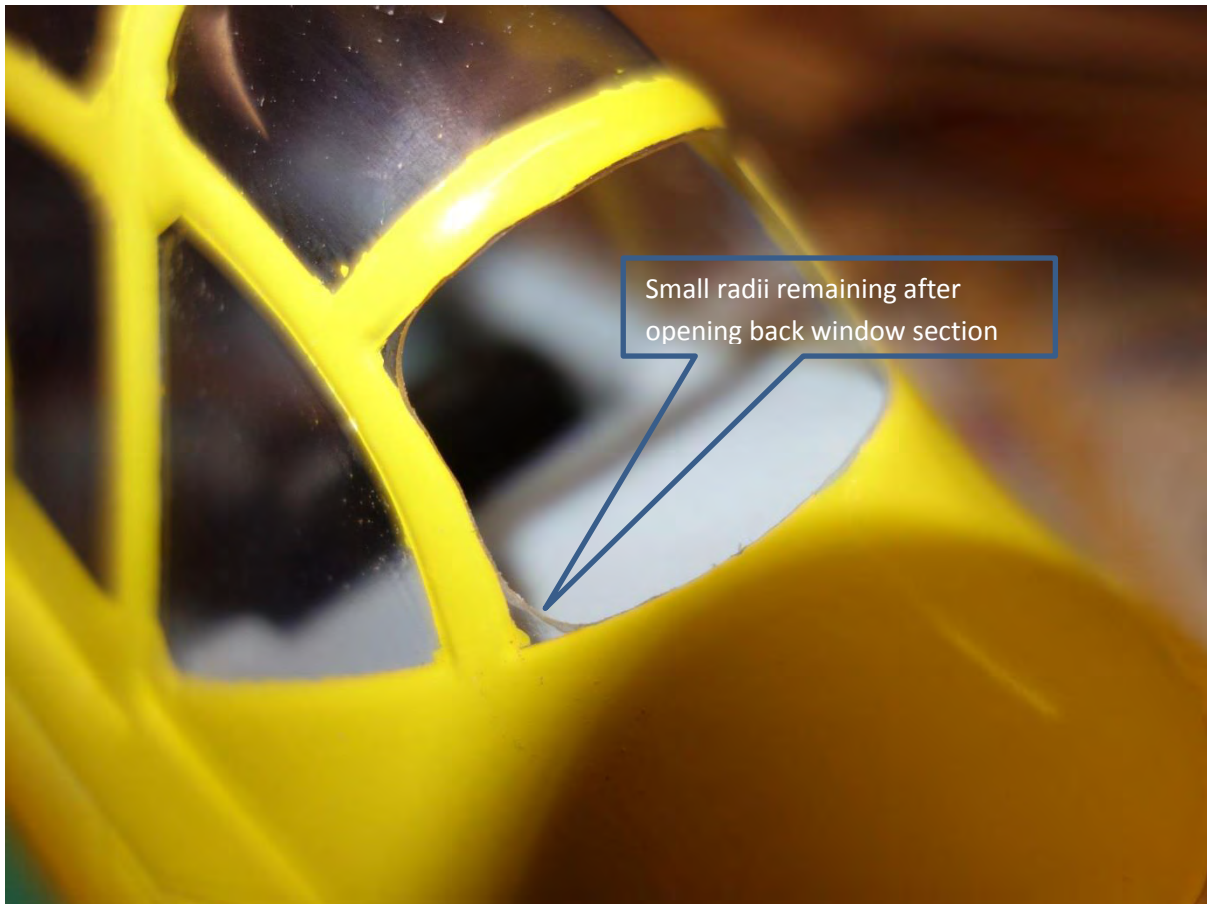
*Small radii in corners can be noted – from a distance the opening is hardly noticeable.*

The rear central window of the canopy was removed using a small Dremel grinding tip. This should assist in allowing additional heated air to be exhausted from the aircraft's internal spaces. It also allows air introduced by the propeller to be exhausted – without this the canopy will overcome the magnetic catch and lift – if not be lost.

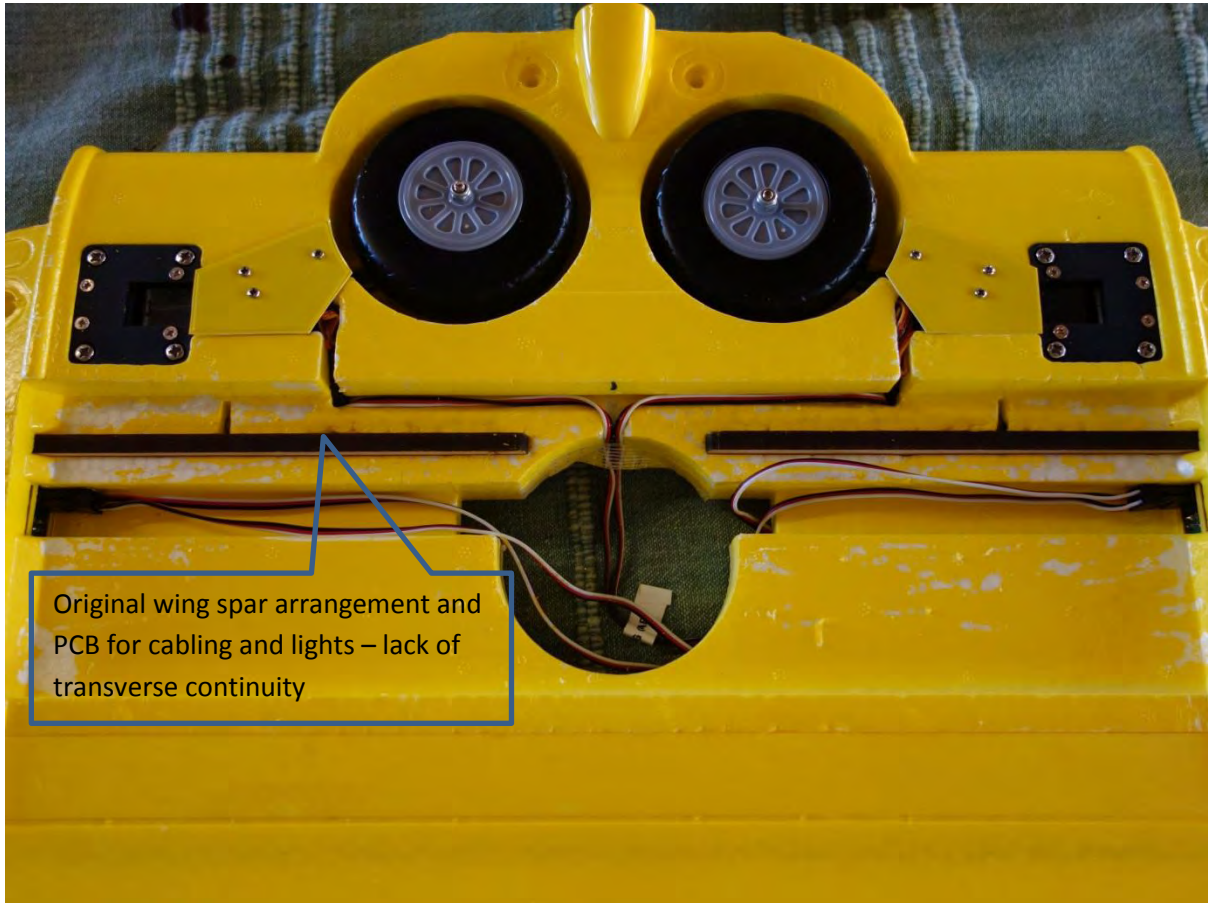
***This photograph indicates the original arrangement of the spars and the cabling exposed once the cover panel is removed.***

There is unacceptable bending of this section as the spars do not meet at the central point.

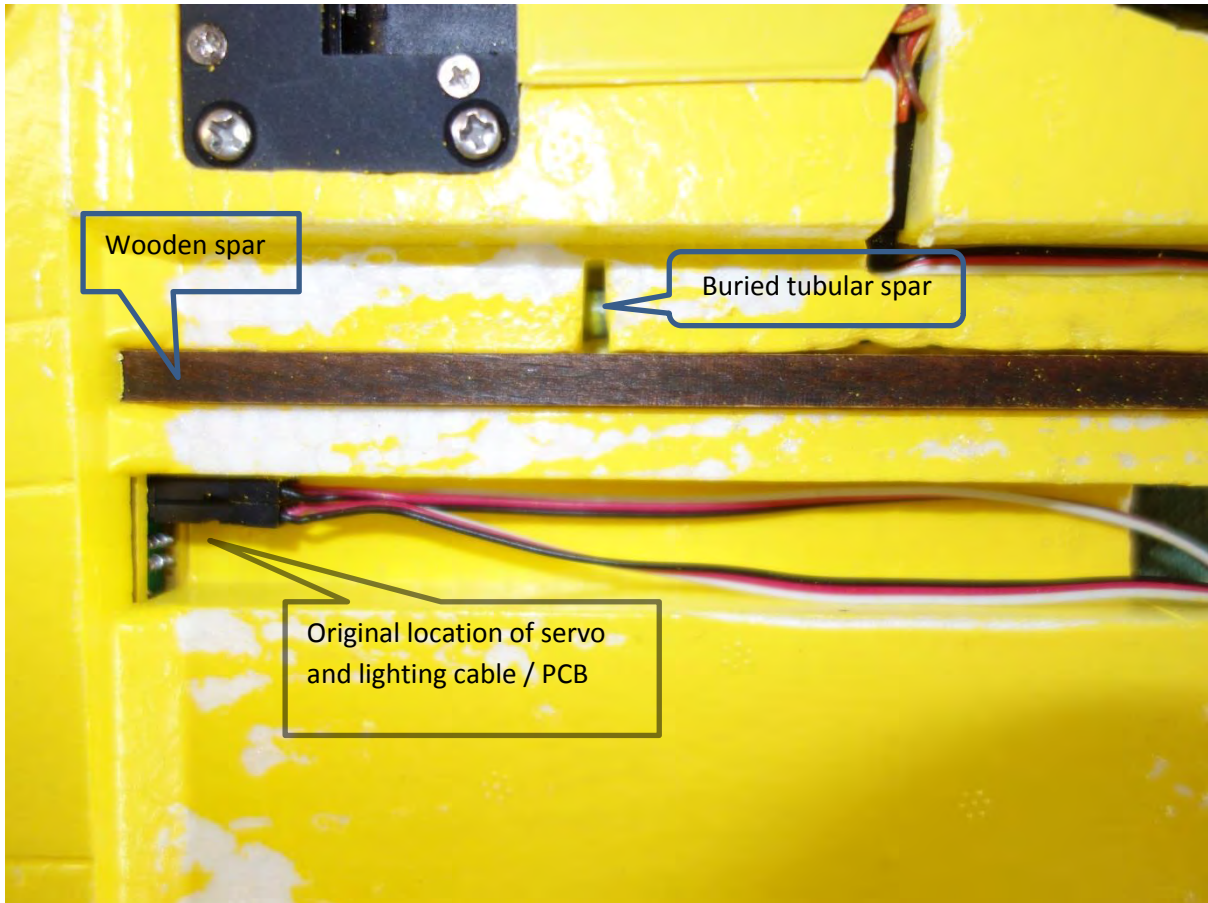
***The space between the buried auxiliary spar and the wooded spar – in the original arrangement can be easily seen in this photograph. It is the space between the wooden spar and the rod that is used to accommodate the CF reinforcement.***

Once the channel is cleaned out and uniform – not really a difficult task a section of carbon fibre is introduced into the opened channel.

The carbon fibre section used was 10mm x 2 mm thick the overall length being approximately 400mm in one continuous length.

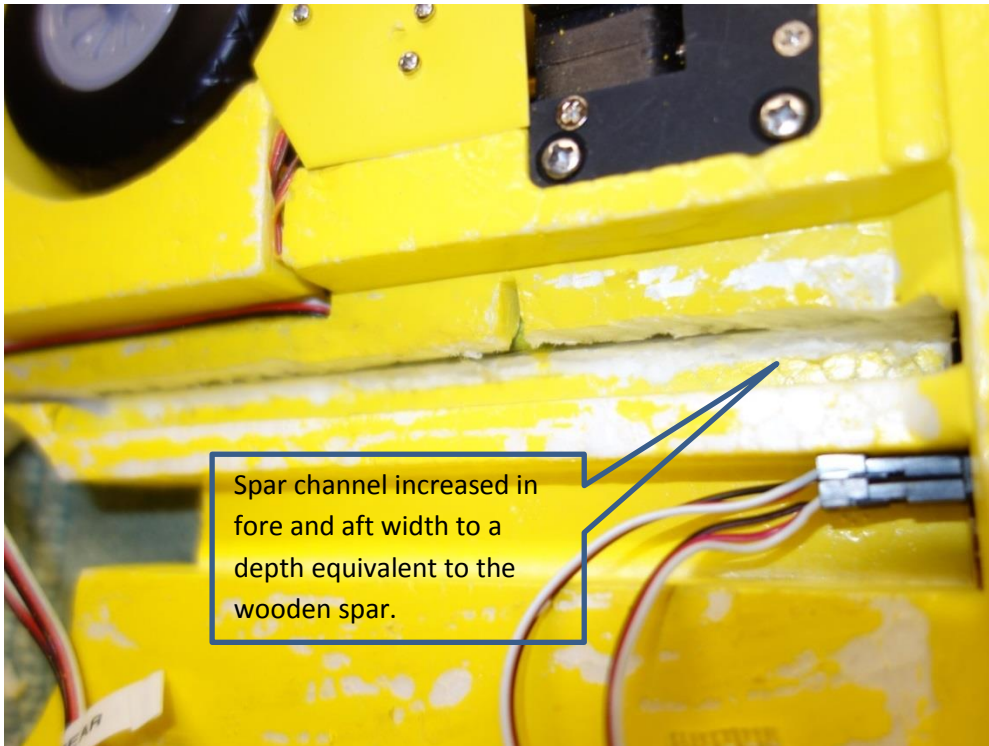
Spar channel increased in fore and aft width to a depth equivalent to the wooden spar.

*This photograph indicates the channel created to house the carbon fibre reinforcement*

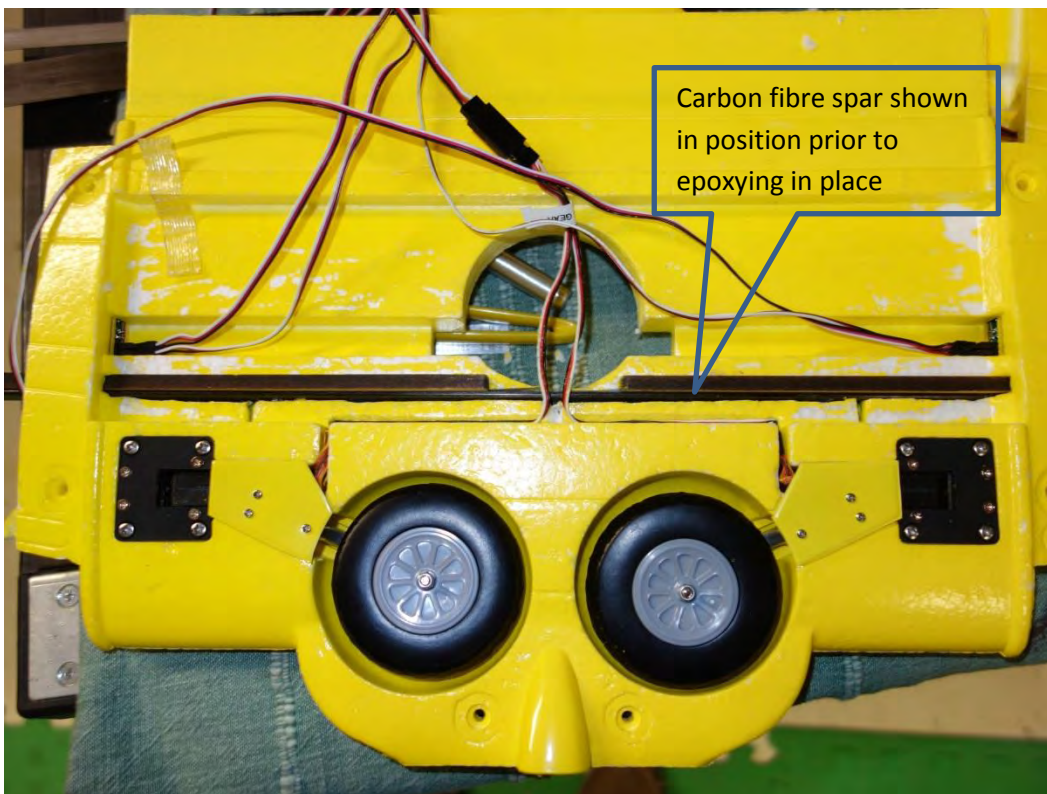
Carbon fibre spar shown in position prior to epoxying in place

*This photograph indicates the temporary fit up of the carbon fibre section in the channel area before epoxy gluing. The carbon fibre can be seen extending to the left of the central wing saddle.*

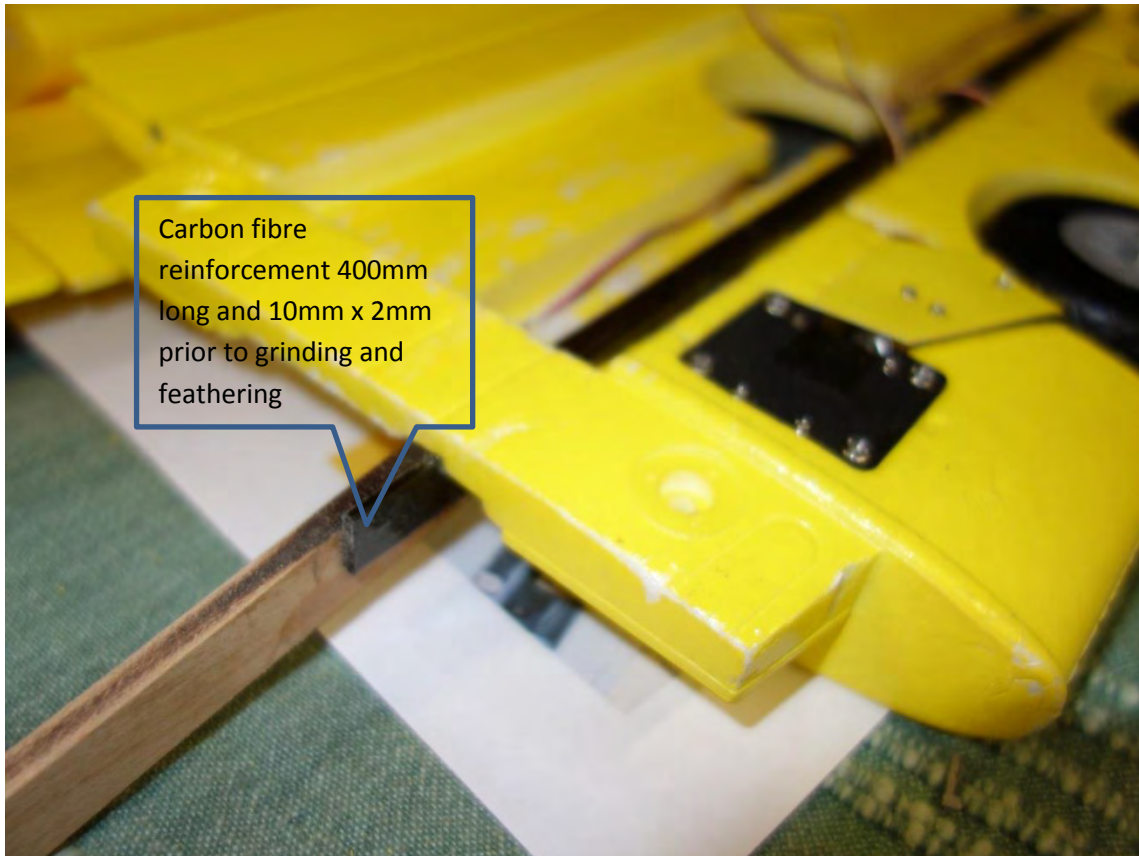
***This photograph is included to indicate the extent of the additional carbon fibre spar reinforcement outside the wing saddle.***

The part of the carbon fibre above the top edge of the wooden spar is carefully ground away and then the end of the reinforcement tapered by grinding to reduce any abrupt change in section..

The spar opening in each wing panel is then enlarged slightly to accommodate the thicker reinforced (now) composite spar.

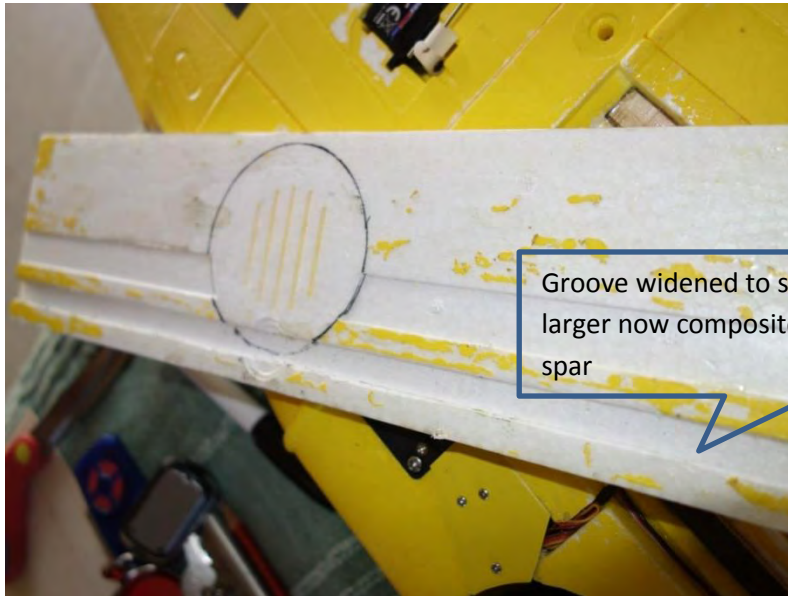
***The channel immediately above the original wooden spar is widened to accommodate the wooden spar plus the carbon fibre insert.***

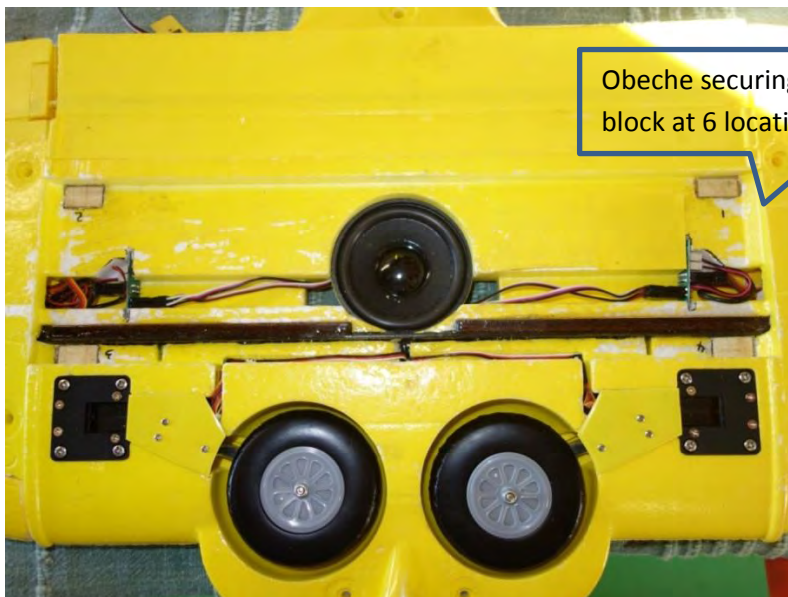
***Carbon fibre spar epoxied in place – note four obeche inserts for screwing cover in place – two additional inserts were fitted at mid width of the cover – above and below the speaker in the photograph***

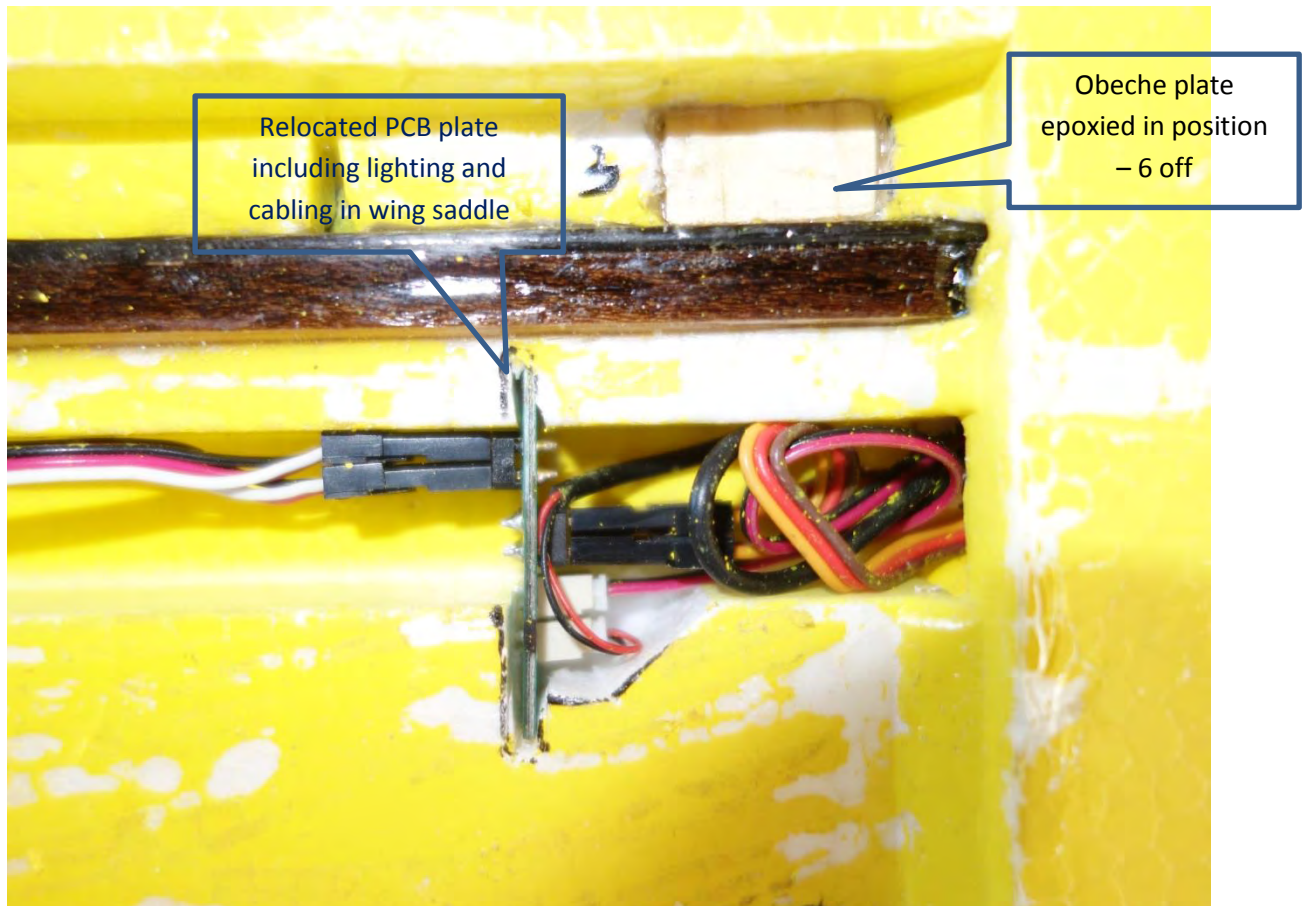
### ***New location of PCB plates in wing saddle and not on removable wing section***

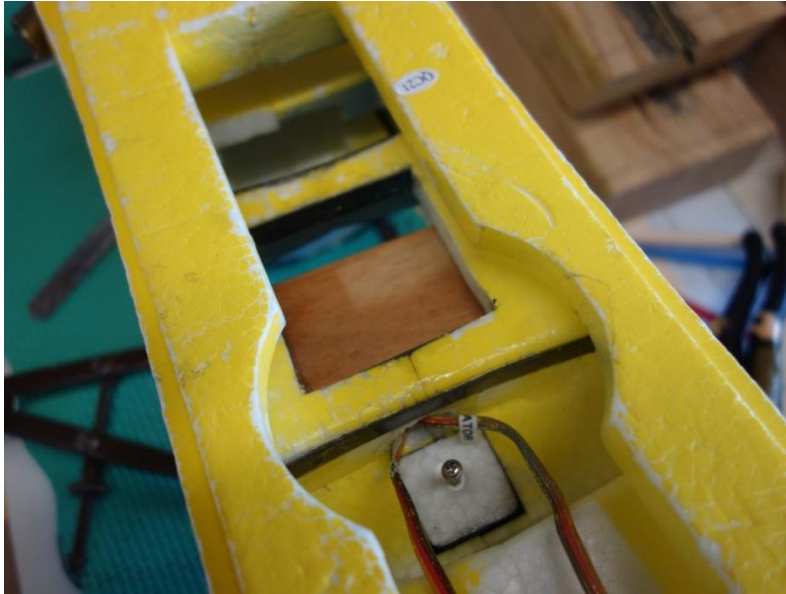
***Opening in fuselage to allow easier access of cabling and better ventilation / air flow***

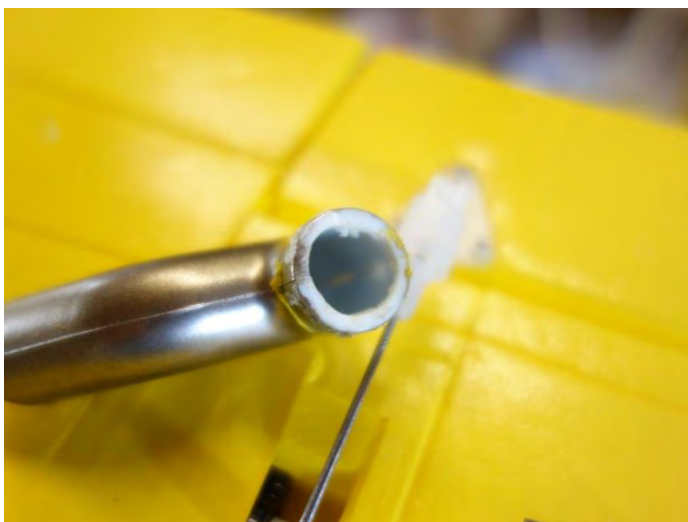
***Exhaust pipe cleared on foam***

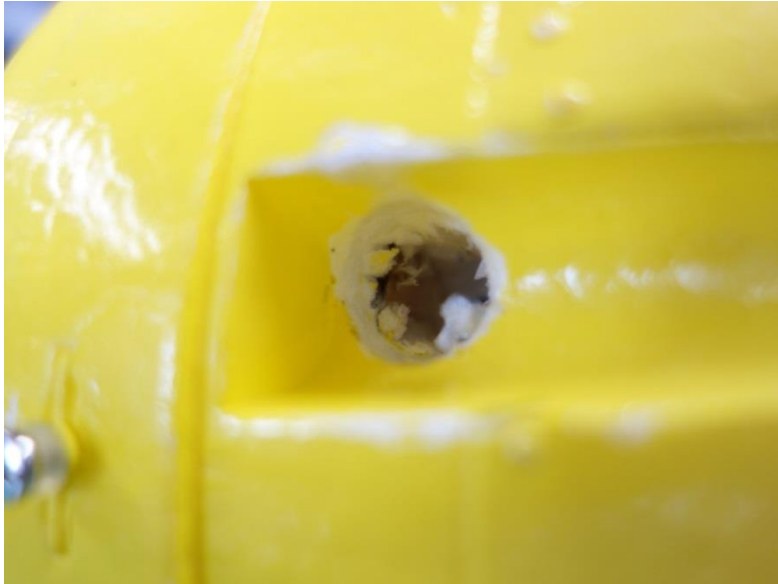
***Opening in fuselage continued internally as to allow air flow from internal annular space immediately behind propeller***

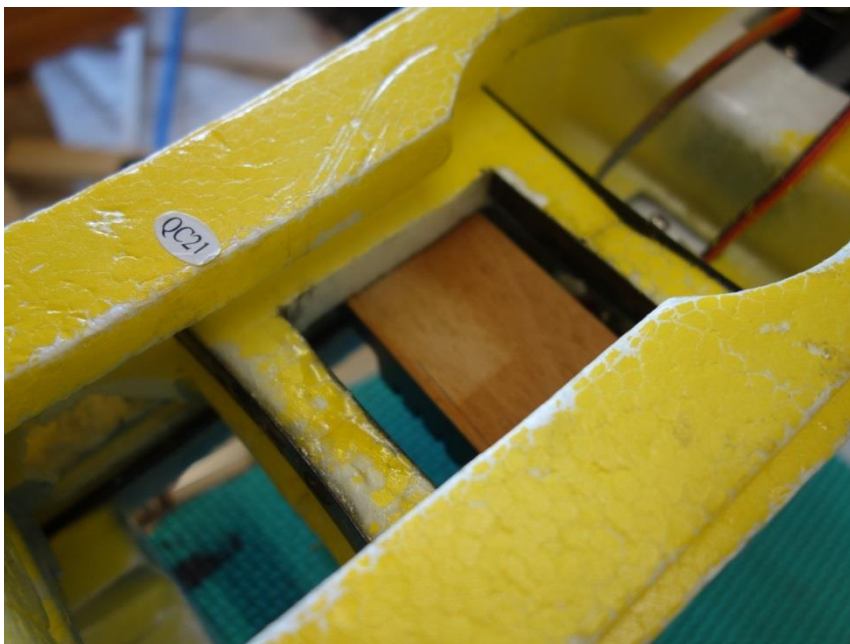
***View from underside indicating openings introduced and the underside of the sound module support ply plate***

Where these openings were made the transverse and longitudinal sides of the openings were strengthened with 10mm x 0.5 mm carbon fibre epoxied in place.

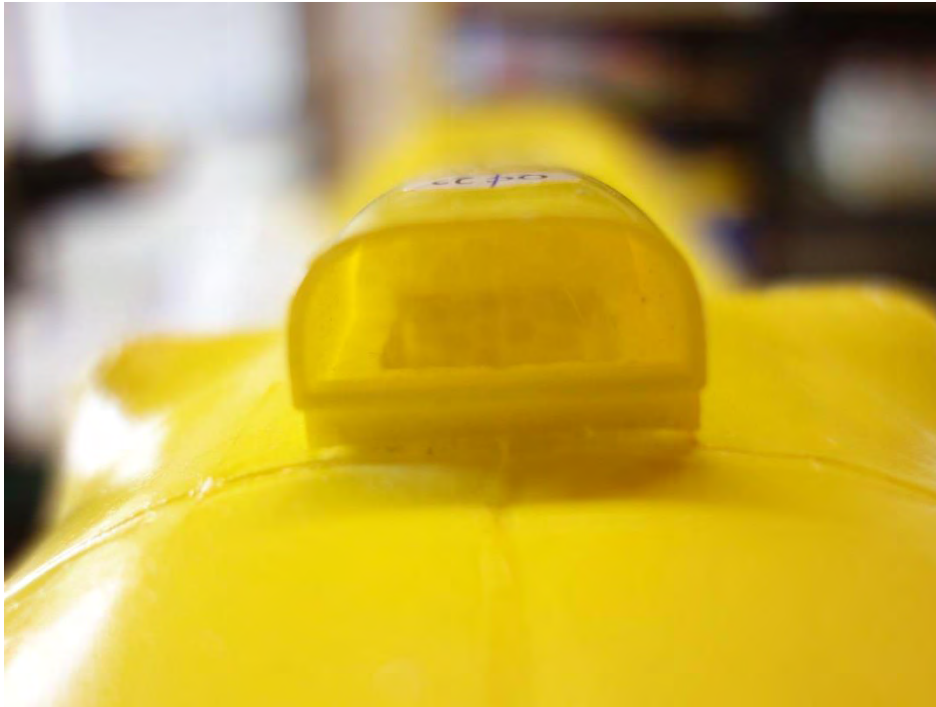
***Lower inlet scoop opened up***

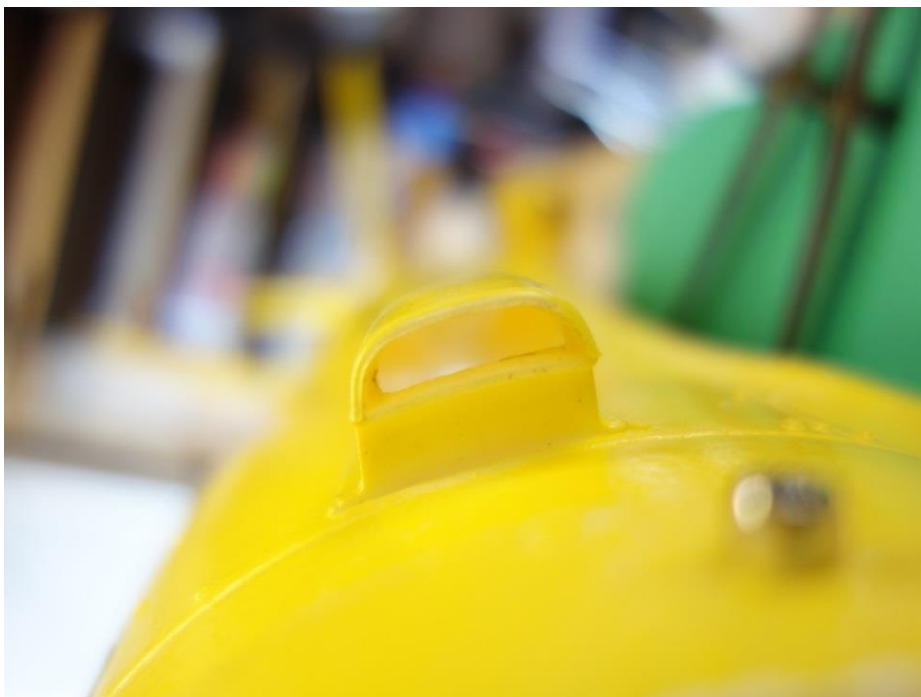
***Side inlet scoop opened up***

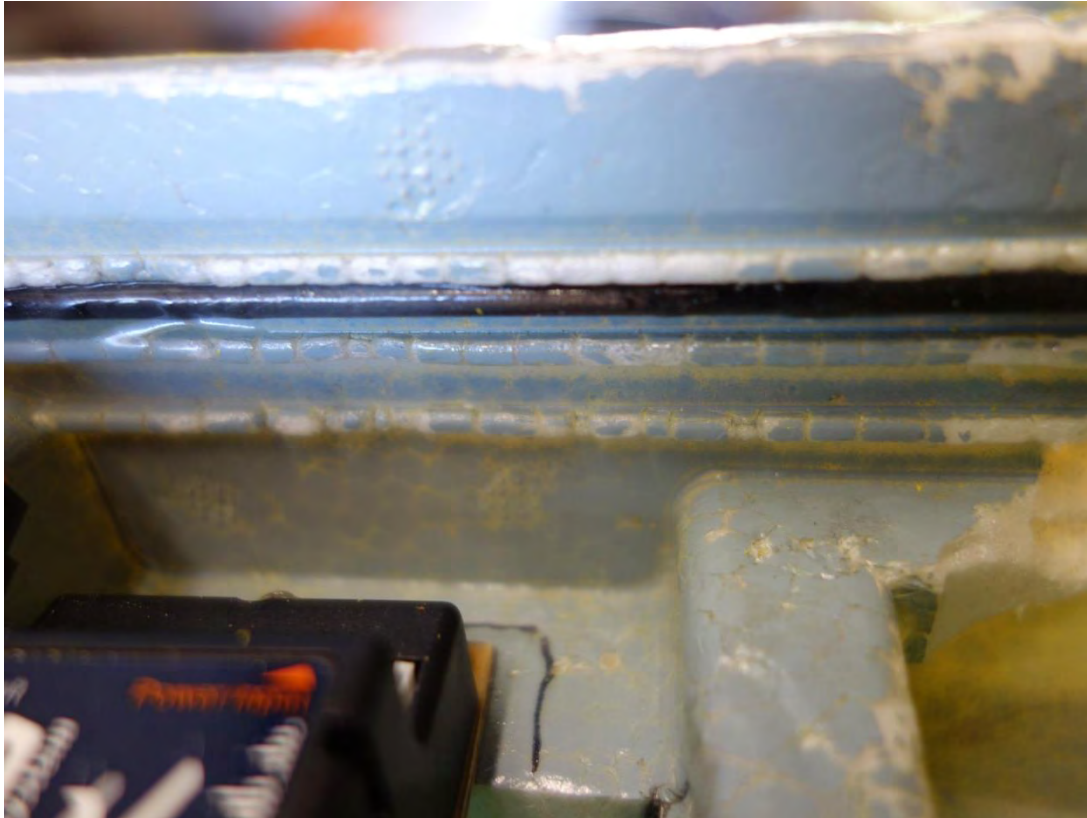
***Carbon fibre rods epoxied to sides of fuselage***

These rods were about 350 mm in length of 3 mm diameter and were epoxied in place into existing grooves as can be seen in the above photograph.

The carbon fibre stiffeners added to the sides of the fuselage within the cockpit became detached in the incident. These have been re epoxied in place – it is always somewhat difficult to properly secure CF onto the surfaces of foam.

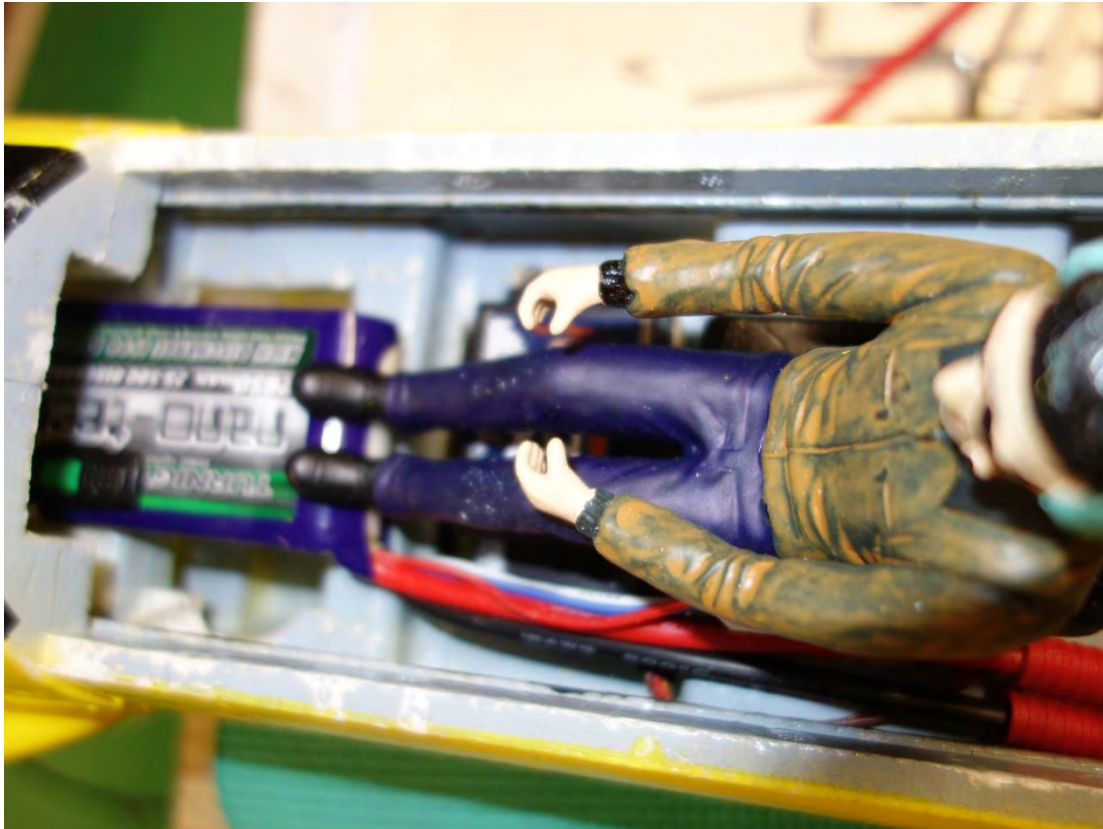
*The pilot's feet provide further assistance in that when the canopy is secured the pilot's feet securely hold the battery in location.*

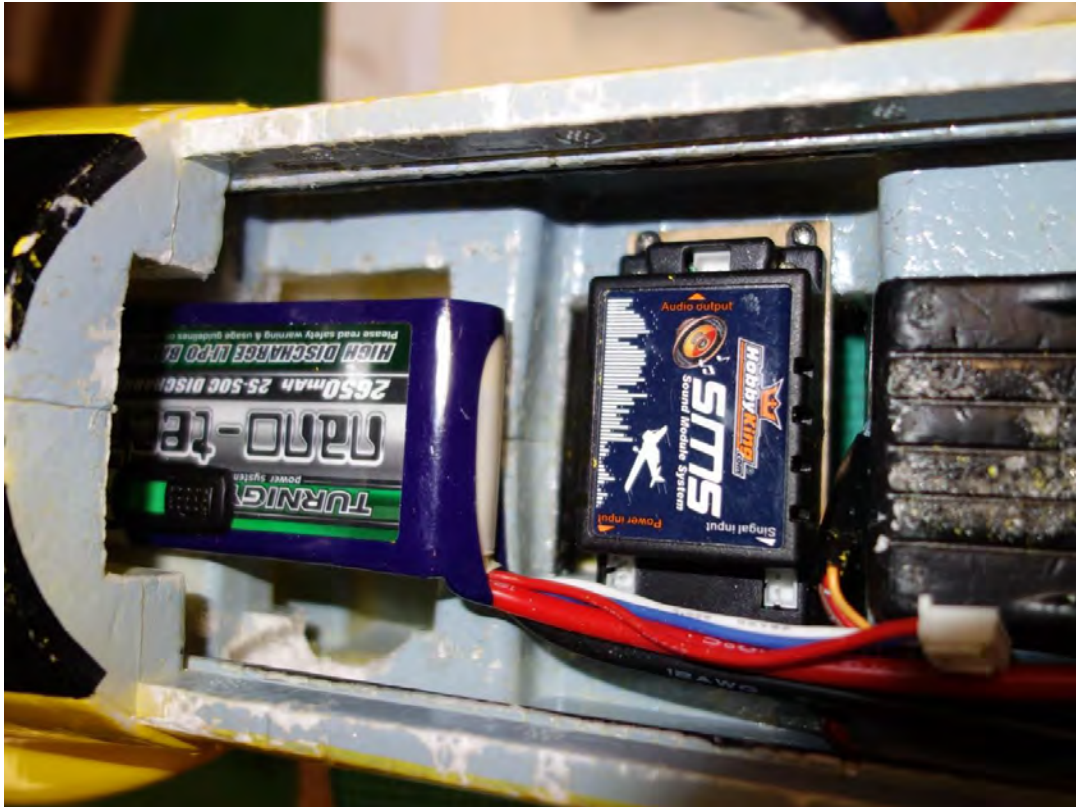
*The sound module cables and other cables are immediately below the module and connection is very straight forward given the easy access now afforded with the additional openings.*

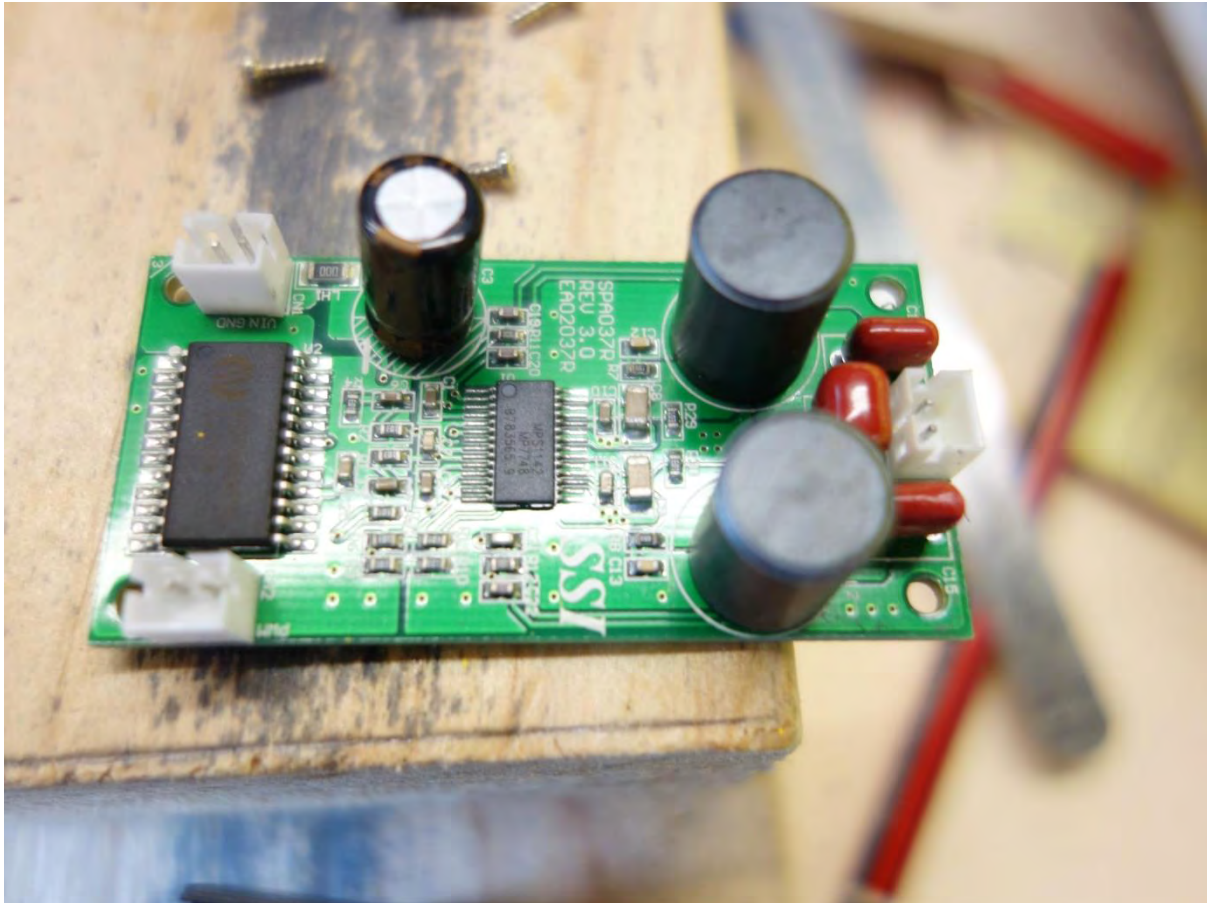
***Sound Module with cover removed***

There is no volume control that I recognise as such.

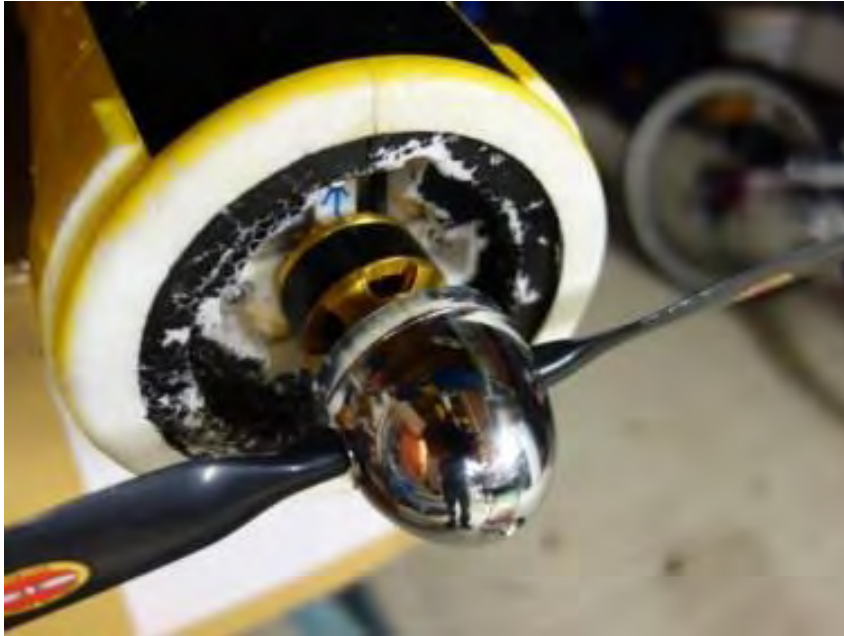
The motor shaft was bent in the incident.

*During the time that this searching was going on an alternative motor (in the spares box) has been fitted – a Scorpion 3008 – 1220kV.*

To allow installation a 3mm thick aluminium plate was been fitted to the ply bulkhead and the plastic offsetting motor mount reused as to maintain the thrust lines. The motor is directly attached to the aluminium plate.

A larger collet to suit the 5mm Scorpion shaft was fitted and the original propeller retained.
