Customer Notification

ZUD-F35-08-0004-01
Apr 10, 2008
Masaharu Ishikawa
Hirohiko Ono, Group Manager
Microcomputer Software Division
Microcomputer Operations Unit
NEC Electronics Corporation

V850E Server Operating Precautions

(For On-Chip Debug Emulator)

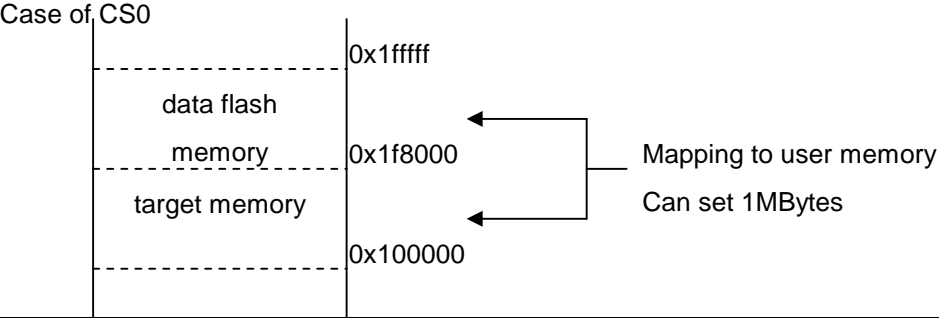
No	Description
1	When you access to the data flash memory area by way of the library, unexpected break may occur. To avoid this phenomenon, please disable the guard break function for internal RAM (set "ramgrd" option of "flsf" command) and disable the guard break function for SFR(set "sfrgrd","sfrwp","sfrp" option of "flsf" command)
2	<p>When you set the user memory from 0xX00000 to 0xXf7fff, the data flash memory area which is from 0xX80000 to 0xXffff is considered as the user memory too. It is because the Exec allocates the user memory by the unit of 1MBytes. In this case, the fail-safe-break doesn't happen even if a program writes to the data flash memory area.</p>

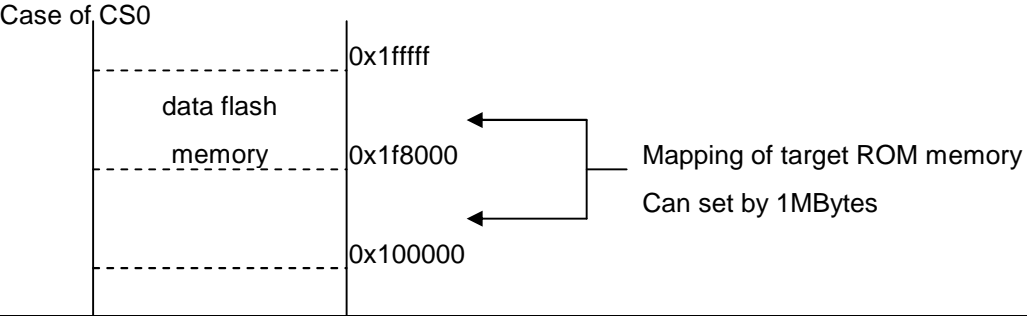
3	<p>When you set the data flash memory area by "dfmap" command, the area from 0xX00000 to 0xX7ffff becomes accessible even if you don't set anything to the area. It is because the Exec handles the data flash memory area by the unit of 1MBytes. In this case, the fail-safe break doesn't happen even if a program reads the area from 0xX00000 to 0xX7ffff.</p>
