# 1769 CompactLogix Controllers, Revision 20

Catalog Numbers 1769-L31, 1769-L32C, 1769-L32E, 1769-L35CR, 1769-L35E

Publication 1769-RN021C-EN-P - November 2012

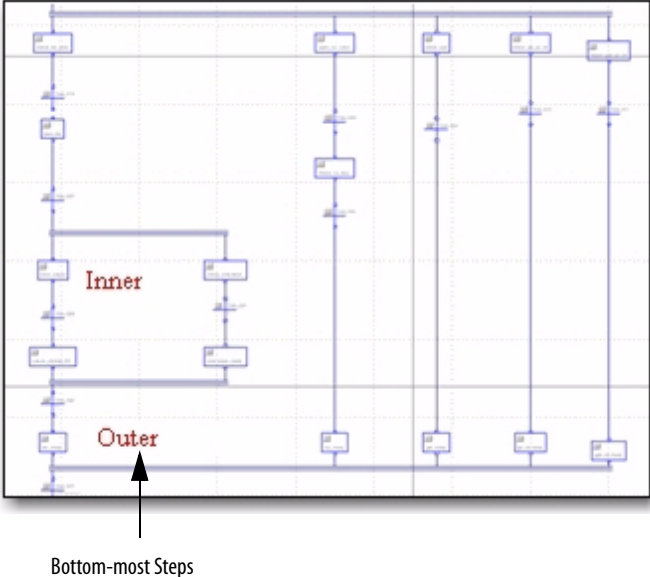
Cat. No.	Description
1769-L31 1769-L32C 1769-L32E 1769-L35CR 1769-L35E	<p><b>CORRECTED:</b> An anomaly can occur when you nest simultaneous branches in a Sequential Function Chart (SFC) routine as shown below.</p>

<p>During normal operations, the logic does not step out of a simultaneous branch until all of the incoming legs have reached their bottom-most step. In the example shown, the logic does not step out of the Outer simultaneous branch until the leftmost leg has stepped out of the Inner simultaneous branch. The first time through the SFC routine, the application works as expected. On subsequent scans, however, the chart steps out of the Outer simultaneous branch even though the left leg has not reached the Inner simultaneous branch yet.</p> <p>This behavior occurs because the information in the bottom step, that is, the step next to the step when it actually is not. This stale information incorrectly causes the transition to move on as if the left leg is at the bottom step when it actually is not.</p> <p>To work around this anomaly, confirm all of the incoming legs have reached their bottom steps in the transition. You can check the .x bits to make sure the bottom-most step of each converging leg is active before allowing the chart to advance. This check can be added to the transition logic already present.</p> <p>For example, the steps in the following expression are the bottom steps (see graphic above) of the incoming legs. Each step has a timer. The transition does not move on until all of the step timers have reached their preset value.</p> <p>The expression can be modified to be sure those steps are truly active. This is the <b>original expression</b>:</p> <pre>// Unit is ready to Transition Step1_ready.dn and Step2_ready.dn and Step3_ready.dn and Step4_ready.dn and Step5_ready.dn</pre> <p>This is the <b>modified expression</b> to work around this anomaly.</p> <pre>// Unit is ready to Transition Step1_ready.x and Step2_ready.x and Step3_ready.x and Step4_ready.x and Step5_ready.x and Step1_ready.dn and Step2_ready.dn and Step3_ready.dn and Step4_ready.dn and Step5_ready.dn</pre> <p><b>IMPORTANT:</b> The .x bit is cleared when the chart transitions out of a step.</p> <p>Adding this check to the condition forces the engine to wait until all of those steps are genuinely active before advancing out of the simultaneous branch.</p> <p style="text-align: right;">Lgx00118188, Lgx00116506</p> <p><b>CORRECTED:</b> Applications that have a large quantity of HMI tags on scan in the controller can experience a non-recoverable major fault when doing online edits.</p> <p style="text-align: right;">Lgx00118192, Lgx00115817</p> <p><b>CORRECTED:</b> Even though the message path is incorrect, messages to the CompactBus will complete.</p> <p>For example, a path of 1,3,10,3 would go to the Compact I/O™ module in slot 3 when it should error. The path should have been 1,3,1,3.</p> <p style="text-align: right;">Lgx00122439, Lgx00120959</p>

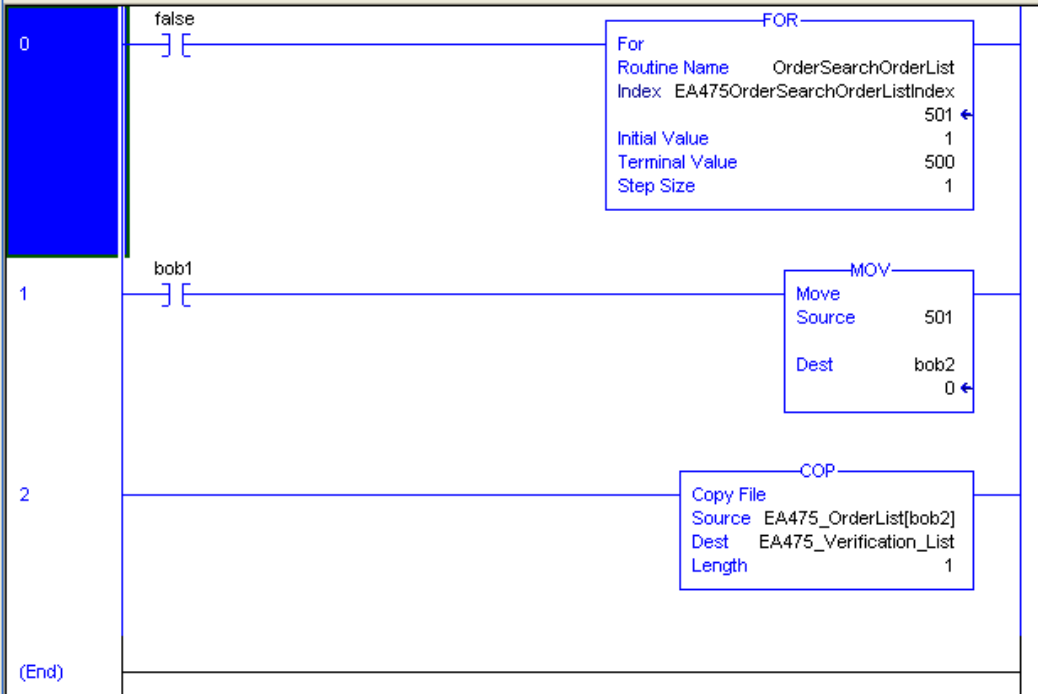
Cat. No.	Description																														
1769-L31 1769-L32C 1769-L32E 1769-L35CR 1769-L35E	<p><b>CORRECTED:</b> If a FOR instruction is scanned true and an instruction has an index out of range that references a UDT or multi-dimensional array, the controller will fault. Clearing the fault and returning to run mode will cause a nonrecoverable major fault.</p>
