Errata to MPC603e & EC603e Microprocessor User's Manual, rev. 1

This errata describes corrections to the MPC603e & EC603e RISC Microprocessor User's Manual. For convenience, the section number and page number of the errata item in the user's manual are provided.

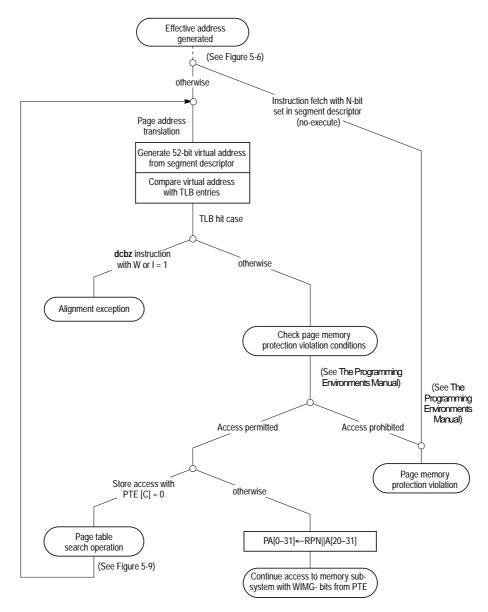
Figure 5-8. Page Address Translation Flow—TLB Hit

- 5.4.3.1, 5-27
- The phrase, "the valid entries are loaded and" should be deleted from the second sentence in the last paragraph of section 5.4.3.1.
- 5.4.4, 5-29
- Figure 5-8 in the published manual incorrectly shows the loopback arrow on the left side pointing to the node above the word 'otherwise'. Replace Figure 5-8 with the following:
