SoftLogix 5800 Controller, Version 17

Catalog Numbers 1789-L10, 1789-L30, 1789-L60

This publication describes enhancements, anomalies (known and corrected), and restrictions for SoftLogix 5800 controller, versions 17.01 and 17.00.

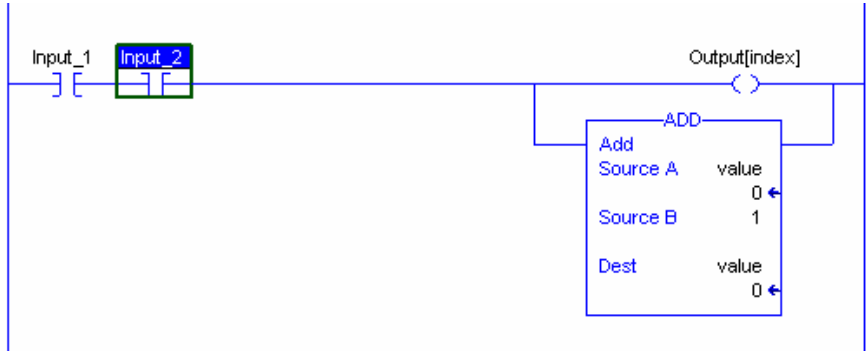
Firmware Revision	Description
17.01	<p>Fault handlers can be defined at the controller and program scope levels. These fault handlers are typically used to handle major recoverable faults that can occur during runtime execution of an application due to programming errors. A typical example of this would be handling indirect addressing that has gone out of range; <code>MyTag[index]</code>, where <code>index</code> is larger than the size of the array.</p> <p>Faults can also be handled by the controller during pre-scan of the controller program on the transition to Run mode. Again, for example, the handling of indirect addressing that has gone out of range.</p> <p>There is an anomaly when these methods attempt to handle a fault.</p> <p>These are the possible ways the anomaly can manifest itself:</p> <ul style="list-style-type: none"> • The controller will experience a major non-recoverable fault. I/O goes to their configured safe state, and the user application is cleared from memory. At this point, a Code 1 Type 60 or 61 major recoverable fault will be logged in the controller. This requires you to redownload the application. • Tag data corruption. • Online saving or uploading failures. • Anomalous program execution. <p>For example, if a rung is being scanned false and there is an instruction that has false execution, the fault handler executes so the remainder of the rung will scan true. In the example below, the OTE instruction has an index out of range. After returning from the fault handler, the ADD instruction will execute, even though the rung input conditions are false.</p>
