# **UR Universal Relay series**

## **Revision 4.20 release note**

**GE Publication Number: GER-4029**

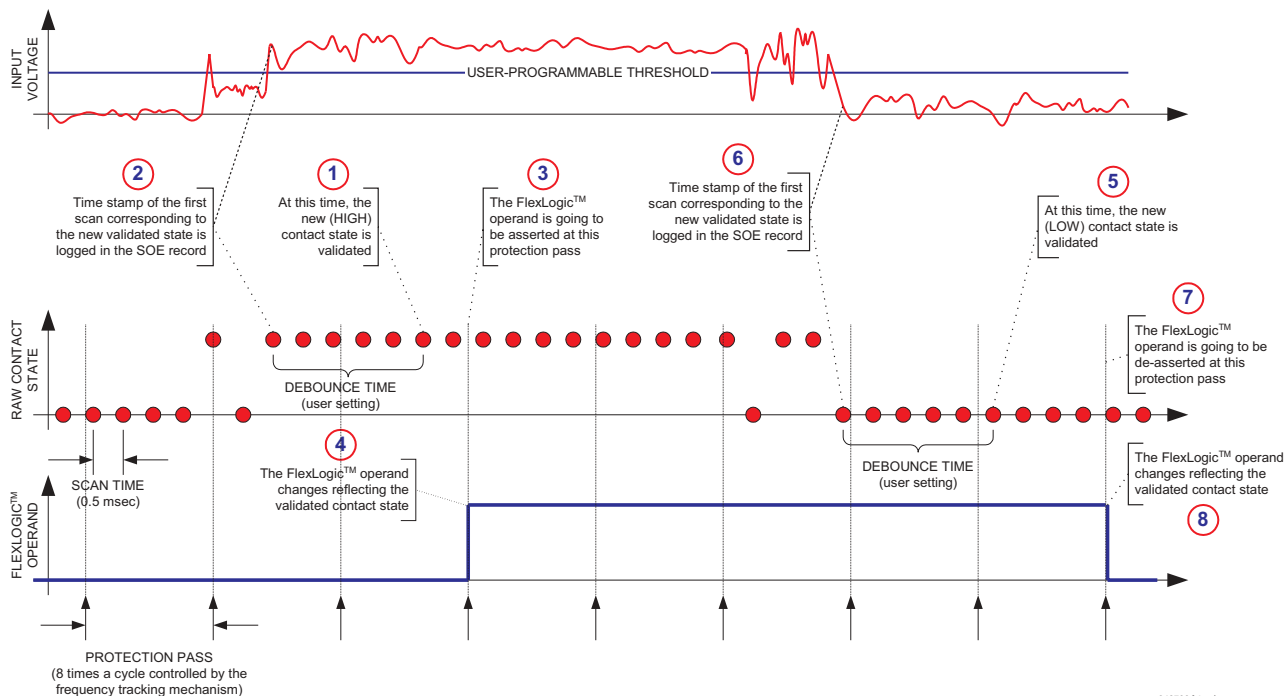
### R Communications: DNP Binary Inputs Change timestamps for Contact Inputs 8739

A firmware update has been made to the assignment of timestamps for contact input state changes when reported as DNP Binary Input Change events. The firmware now provides the same timestamp for DNP Binary Input Change events as recorded in the UR event record. The UR event record was not changed. The timestamps reported via DNP Binary Input Change events now match the event record.

Previously the timestamp reported via DNP Binary Input Change events for contact inputs was delayed by the contact input debounce time plus up to 1/8 cycle.

The timestamp algorithm is shown below for reference.
