New MyLink Apps in Radio Software Update

TECHLINE news

TECHLINK

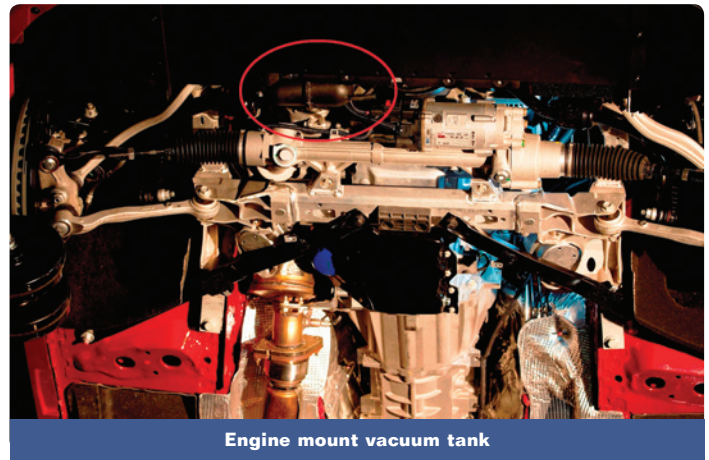
Engine mount vacuum tank

TIP: The vacuum system might not function properly if glycol gets inside the vacuum lines, vacuum tank, or solenoids. This will only happen if the engine mount is defective and glycol leaks out of the idle or bounce port and into the vacuum lines. If this fluid is noticed inside the vacuum tank or vacuum lines, the engine mount(s) that is leaking and the complete vacuum system must be replaced. If the engine mount is leaking, the quantity of glycol will be noticeable. Refer to the Powertrain Mount Service Procedure in the Service Information.

TIP: Perform testing with vacuum only. Under no circumstances should the engine mount system be tested using a pressure source. The tank was designed to seal vacuum pressure because that represents the in-vehicle application. It is possible that smoke from a pressure tester can exit the tank when tested under positive pressure, but measure zero leakage when tested under vacuum.

Vacuum leaks may be found using the J-23738-A Mityvac. Refer to the vacuum chart in the appropriate Service Information and apply vacuum to each component of the engine mount vacuum system. When performing the vacuum leak check procedures, be sure the electrical connections to both vacuum valve assemblies remain intact. It will be necessary to use the Tech 2 or GDS 2/MDI to command the valve assemblies on to complete the test of the entire system and valve (solenoid) assemblies.

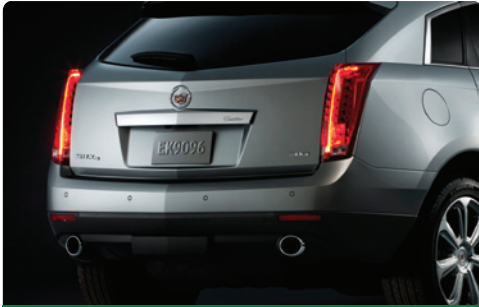
Keep the rear sensors clean for proper operation.

Unwanted rear Parking Assist alerts and/or unwanted Automatic Braking while backing up may occur if the rear sensors are dirty.

If the customer feels the brakes apply or experiences unwanted parking assist alerts while backing up, the rear bumper should be cleaned as soon as possible. If the rear bumper cannot be cleaned immediately, the Parking Assist and Automatic Braking features can be turned off by pressing the Parking Assist button on the center console next to the shift lever each ignition cycle to disable the system until the rear bumper can be cleaned.

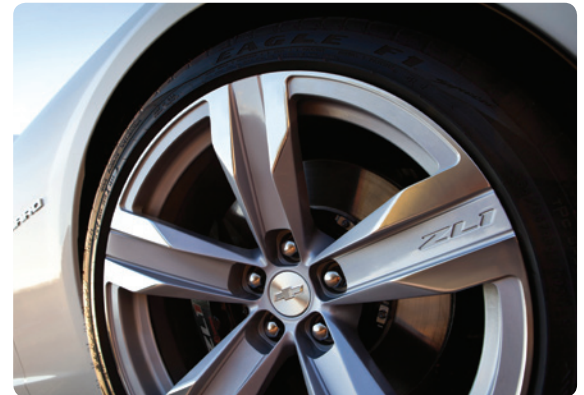
Tire Pop Noise in Cold Temperatures

The 2012-2013 Camaro ZL1 and 2013 Camaro SS with RPO 1LE feature high performance tires that may exhibit a single audible "pop" or "snap" noise immediately after the vehicle is put into motion. This noise is typically noticed first thing in the morning after the vehicle has been stationary overnight or for an extended period of time and is more pronounced in lower ambient temperatures. The noise sounds similar to a brake pad that has temporarily stuck to a rotor due to vehicle inactivity. After the initial vehicle movement, the noise can no longer be duplicated until the car remains stationary again for an extended period of time.

This condition is a characteristic of the vehicle's high performance tires. Due to the tires' soft rubber compound, they have a natural tendency to stick to the pavement. When the vehicle is moved, this pop noise is the sound of the tire releasing from the pavement. Do not make any repairs. This is a normal characteristic of the high performance tires.
