Repairhints

Communicator 9110/9110i RAE 2

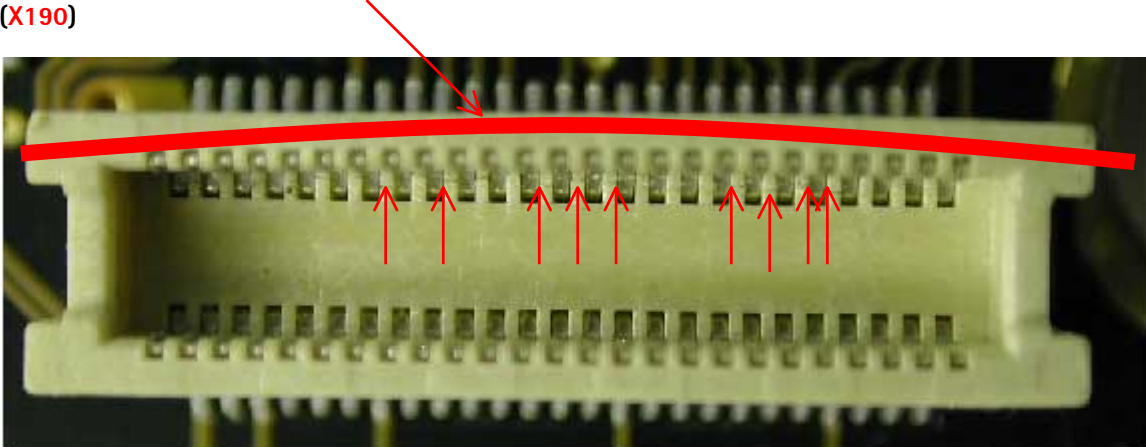
(X190)

- If the current consupion does not change, check **X190**, **C106** and **X160** for mechanical damage. (see pictures)
- If these are damaged, change if necessary.

Note! The edge is curved when the connector is broken, check also for short circuits under connector.

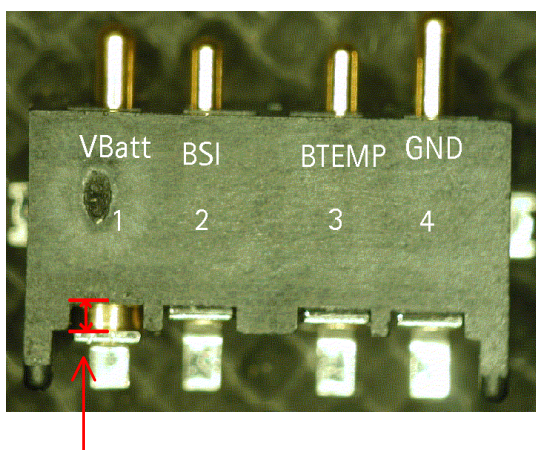
(X160) Battery connector

Mechanical damage from VBatt–Pin1 of X160

The VBatt pin is not as long as the GND pin. The phone may shut down or "Insert SIMcard" appears on CMT–Display if battery is not fixed correct in chassis. In this case the BSI pin (Battery Size Indicator) is loosing connection to battery, Change X160 (**See also SB–29**)

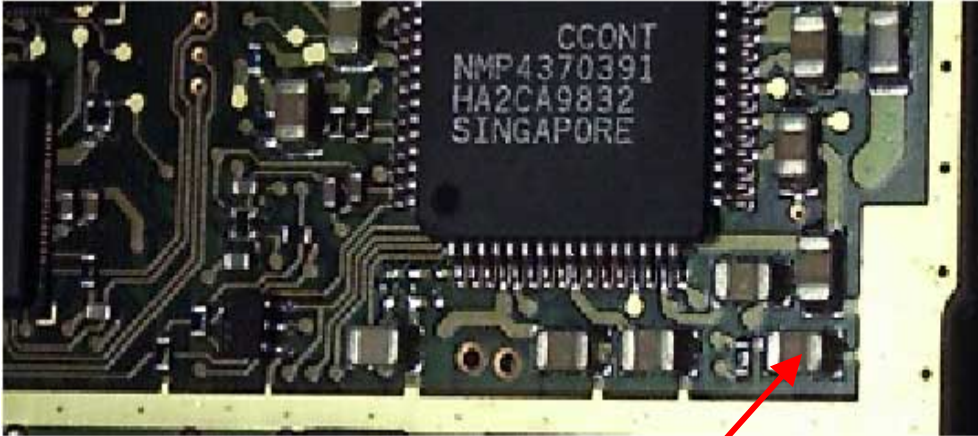
(C106)

- Check **C106** for cold or broken soldering by pressing the component slightly from the side with tweezers.

Broken or cold joint

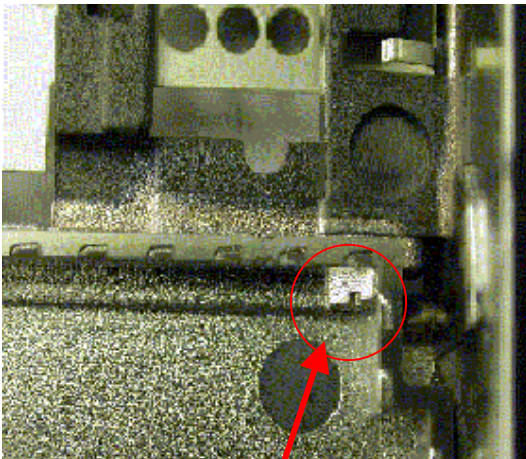
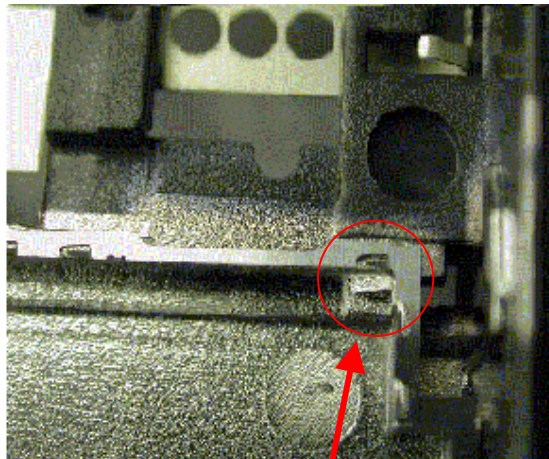
C106 is broken from old B-cover (see Pictures below)

Old B-cover

New B-cover

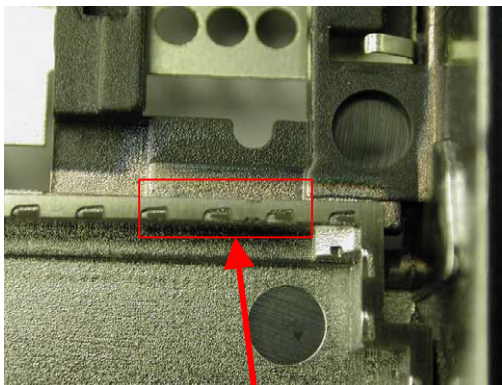
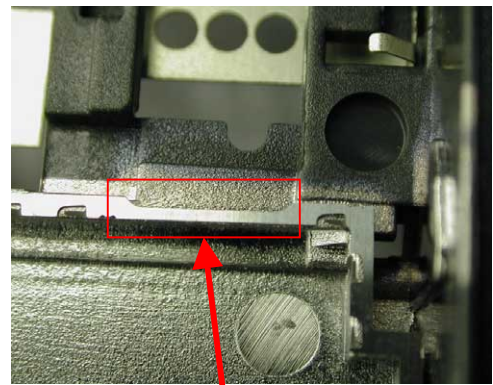
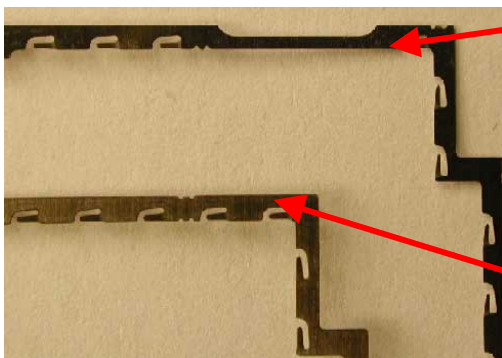
Metal gasket short circuits

- If "Insert SIMcard" appears on CMT-Display, check first which gasket is assembled.
- If the old one is installed, short circuits on SIM-contact Pin's 1-3 is possible, shown in the picture below. Change metal gasket in this case. Otherwise change Back cover to the new Version, because the new metal gasket is implemented.
- If there is the same fault, then refer to **SIMcard faults**

Old metal gasket

New metal gasket

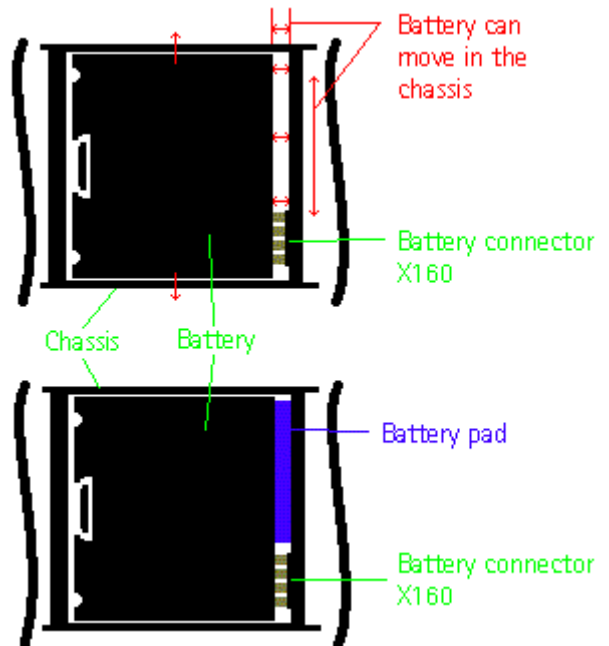
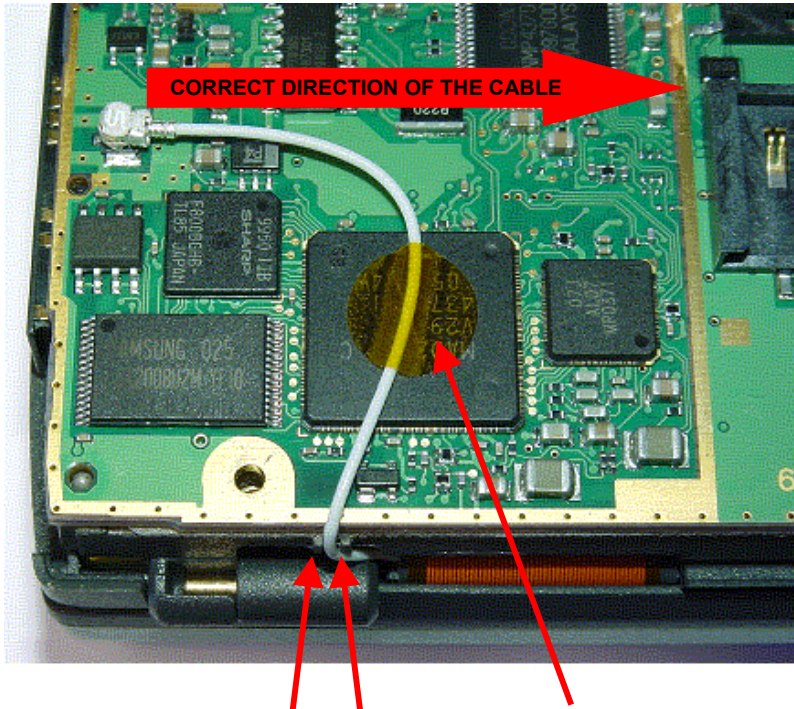
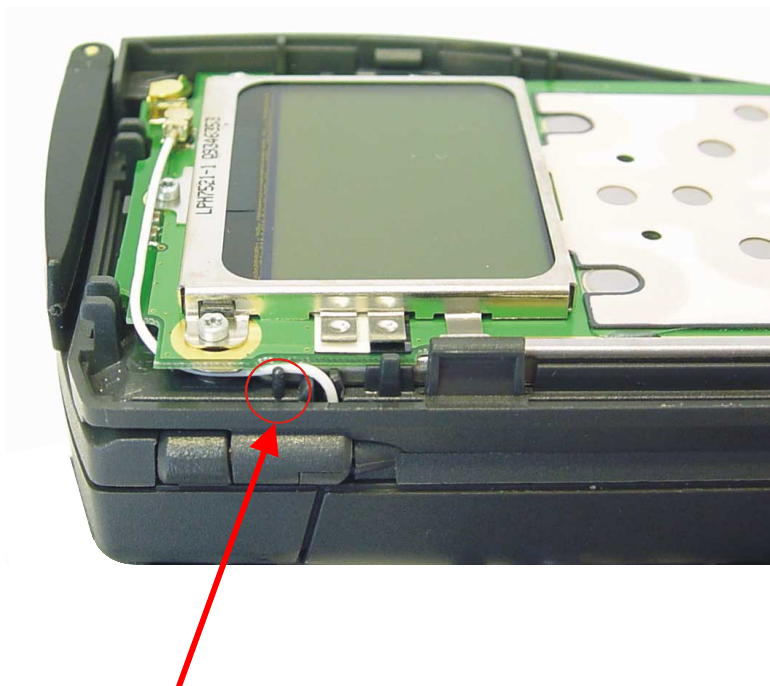
Field strength is poor or dropping calls when lid is opened

- If field strength indicator is poor or dropping calls when lid opened, the coaxial cable is broken. Change it by using the new more resistable coaxial cable (code 9780269).
- Use always the new route shown in the following picture below, because of audio problems at MIC-Line.

Cable routed between guidance

for better fixing use masking tape (code 7310079)

Cable routed behind the guidance rib

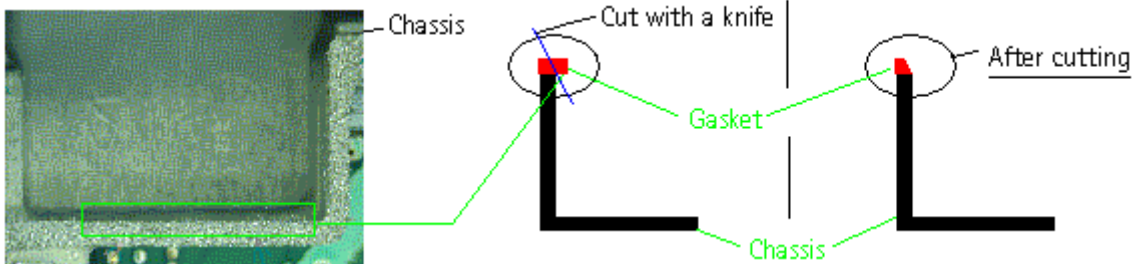
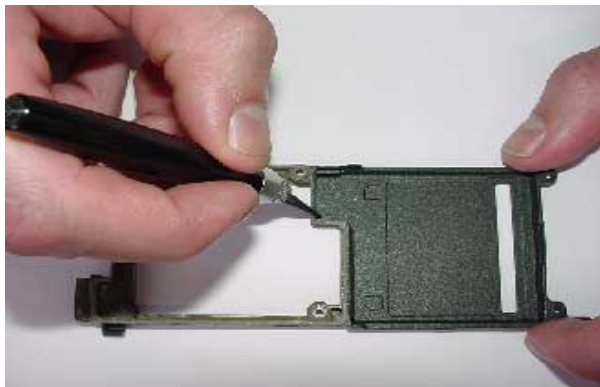
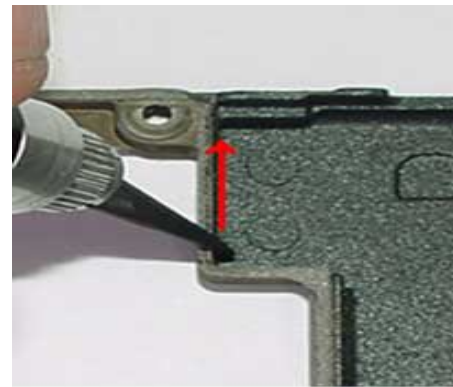
Poor operating time

If there are one of these symptoms, the chassis gasket short-circuits the battery connector pins.
Cut the gasket at battery pins area with a knife.

Note! Do not scratch the chassis (beware of corrosion)

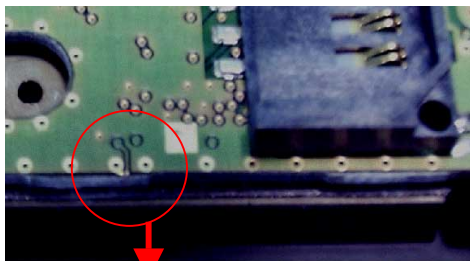
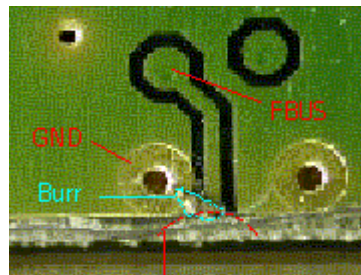
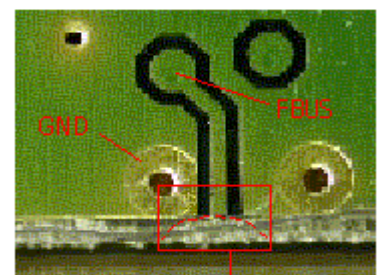
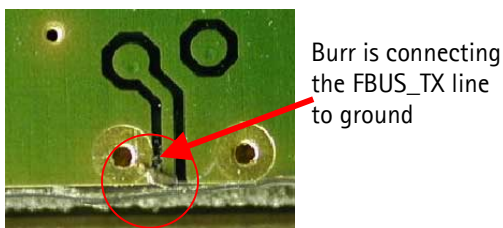
Burr in FBUS line

- **CMT flashing fails**, cause of wake up during flashing. The Burr is connecting the FBUS_TX line to ground.
- Check FBUS line on CMT (see picture), because the cutter at the production line sometimes cuts the FBUS line from CMT board badly

Cut with a sharp knife

After cutting

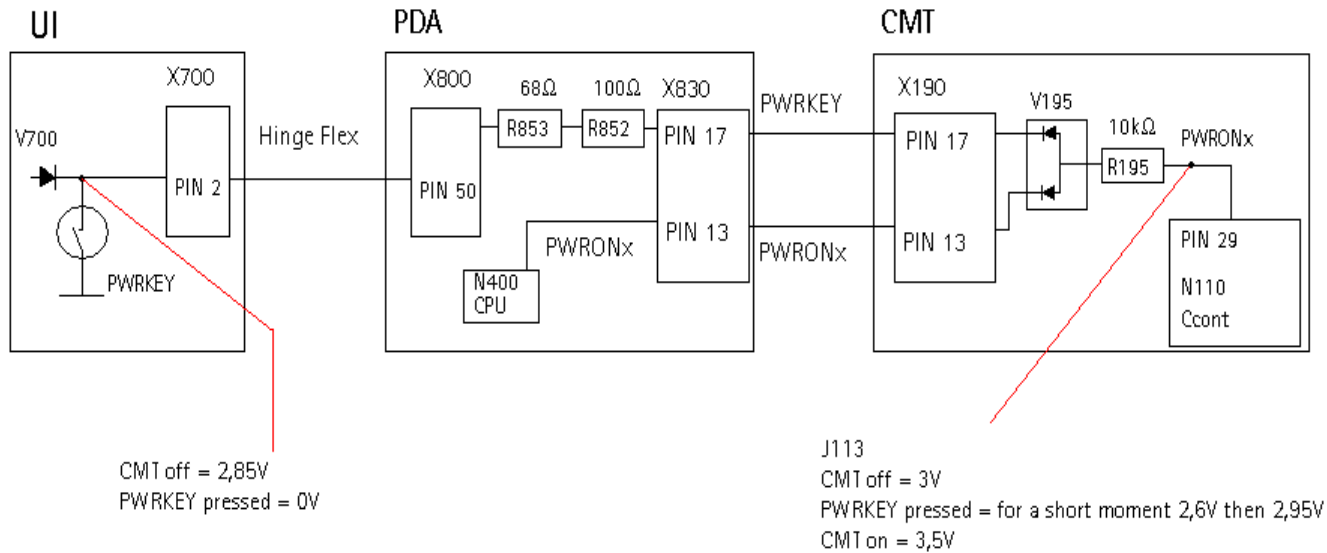
CMT PWRONx VBat = 3,6V

- Check voltage and all connections for broken soldering or short circuits (see picture)

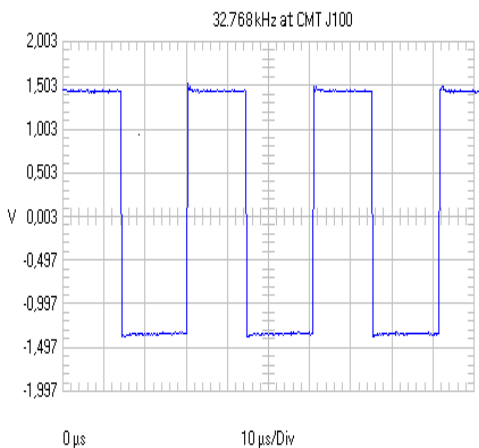
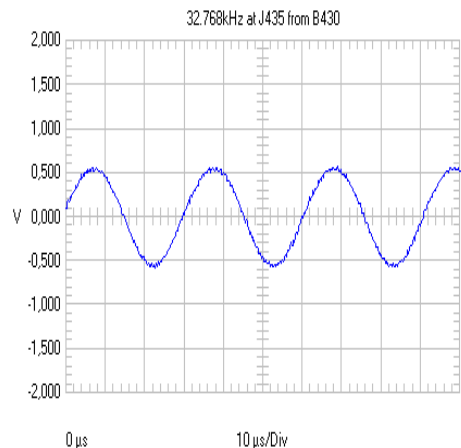
32.768 kHz B430 faulty

- If battery is connected, check 32.768kHz squarewave (Vpp=2.82V) at J100 (See picture below). If no signal, check sleepclock line for broken and/or short circuits from connectors X190, X830
- Check 32.768kHz sinewave (Vpp=1.20V) from B430 at J435 on PDA (See picture below)

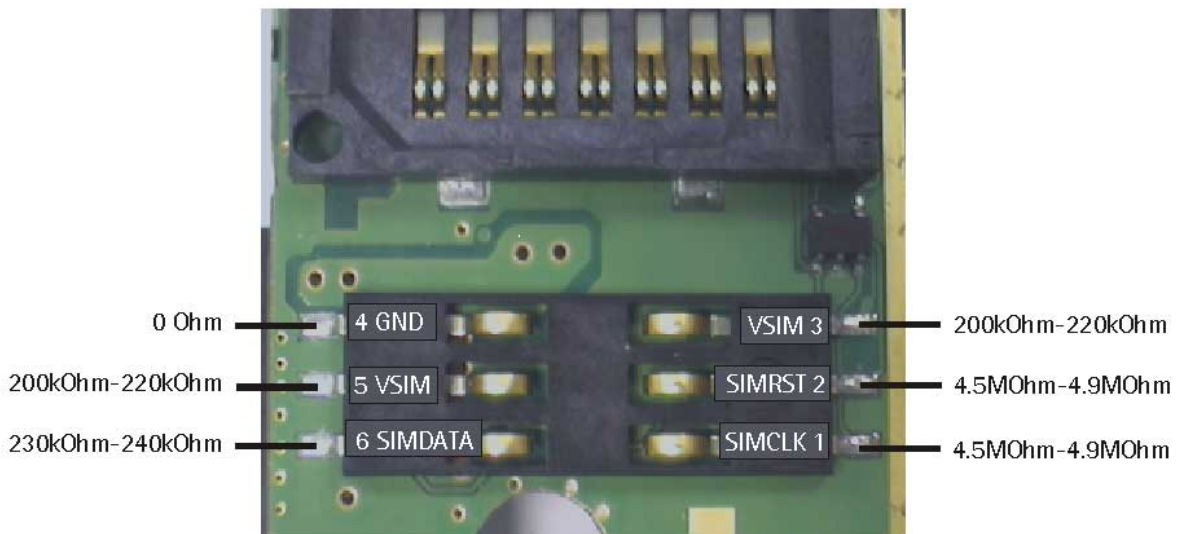
- Check if connector pins of SIM card reader X150 are bent or soiled, change X150 if necessary.
- Check resistance at Pin 1-6 (Look picture below).
- **Note!** Short-circuit the X160 (battery connector) between Pin 1 and 4, to unload the capacities for a short moment. Now check the resistance between GND (Pin 4) and the other five Pin's with a multimeter.
- If broken connection or grounded Pin's, check V104, R124, R125, R128, C127, C128 and N110 for cold or broken solderings or change faulty component if necessary.

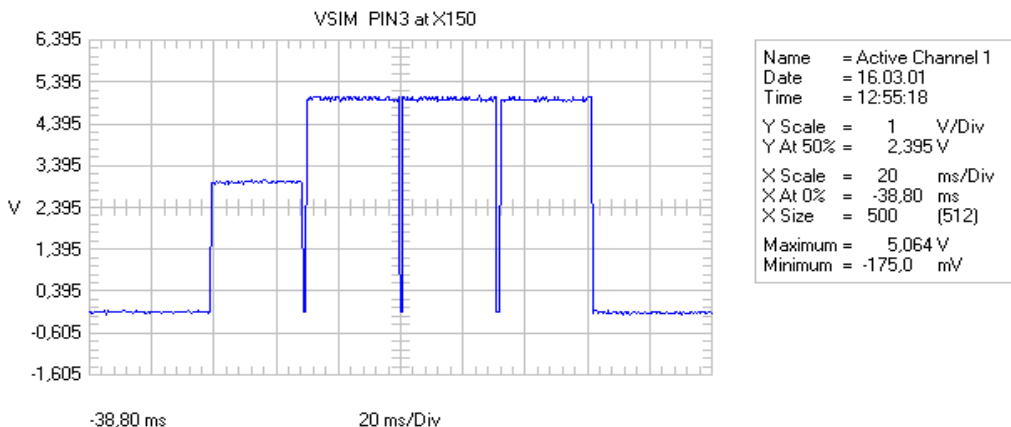
- Check VSIM=3/5V (depend on used SIMCard) at X150 Pin 3/5. If no signal, probably the CCONT N110 is faulty

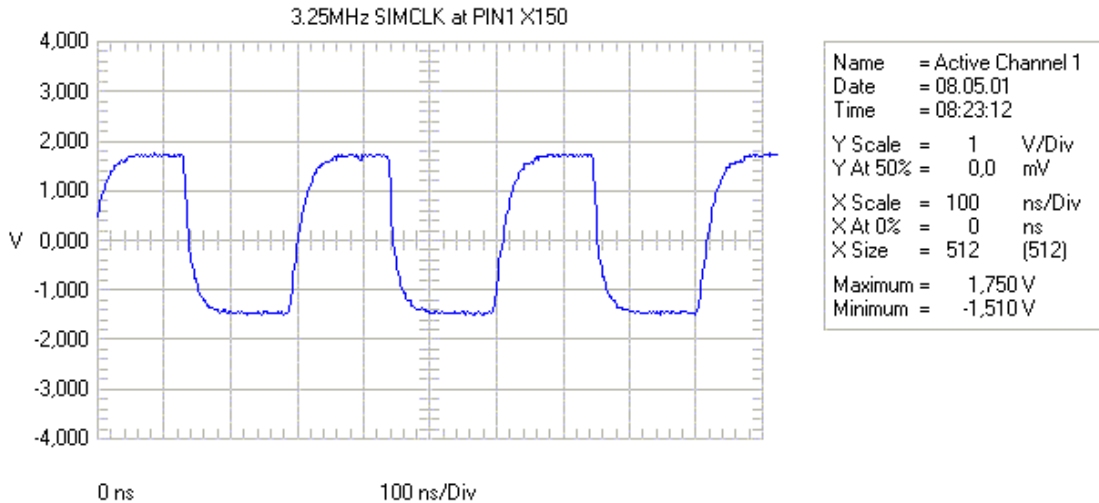
- Check SIMCLK=3.25MHz (Vpp=3.26V) at Pin 1 of X150 when phone powers on (with inserted SIMcard)
- If no signal, check SIMCLK at CCONT N110 Pin 41. If ok, change CCONT. If not ok, change MAD.

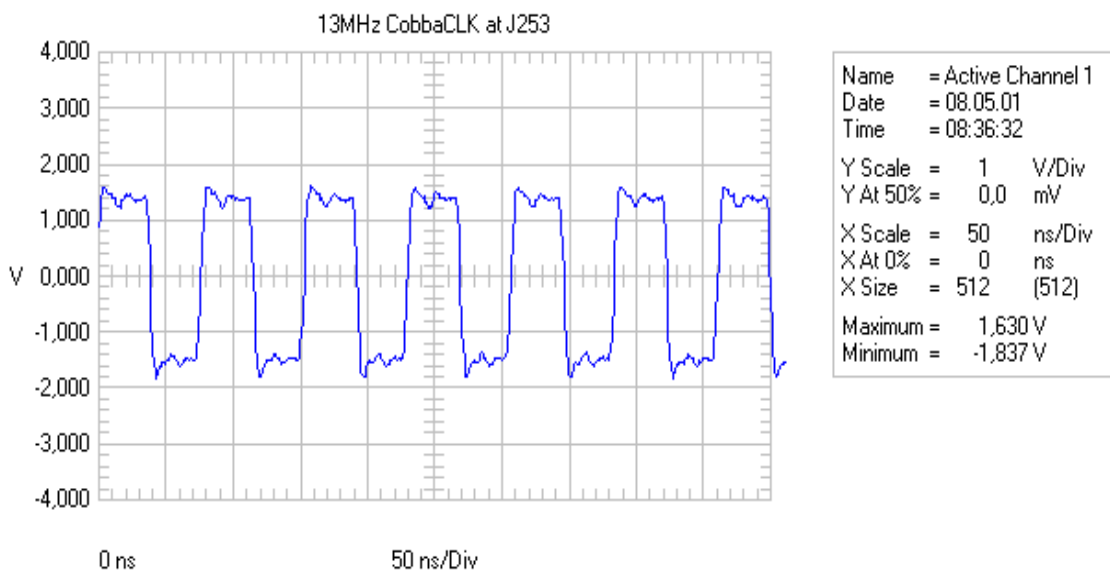
- If all SIMlocks closed, try to reprogram the SIMlock setting with NOKIA SECURITY PASSWORD or send phone to the next authorized regional service center.
- If the fault persists, check VCOBBA=2.8V at J110, if not ok refer **CMT electrical faults/CCONT**
- Check COBBACLK=13MHz (Vpp=3.47V) at J253 (see picture below), if not ok refer **CMT electrical faults/MAD**

- If SIMlock data's and SIMcard signals from CCONT are ok, change N250 COBBA

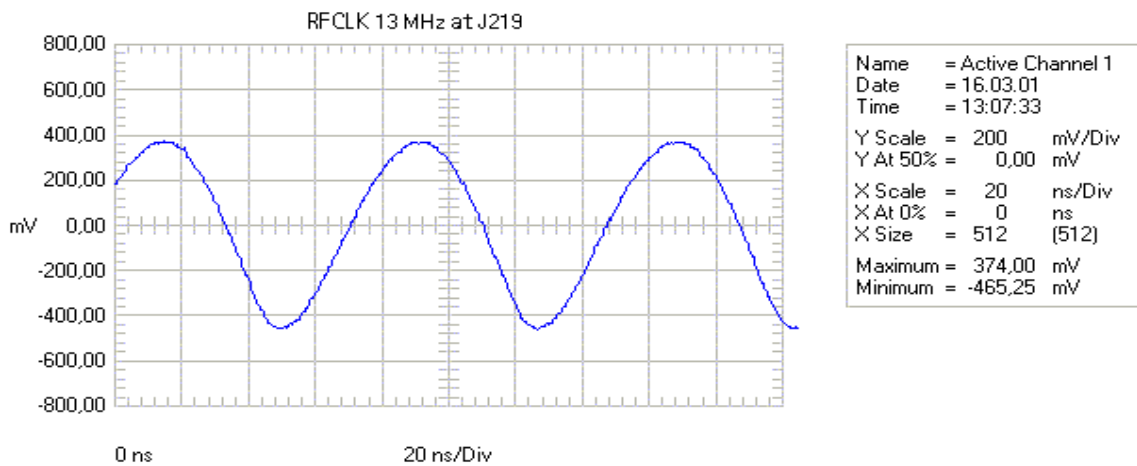
- Check RFCLK=13MHz (Vpp=830mV) sinewave at SUMMA N690 PIN15 for the right frequency 13MHz ±50Hz

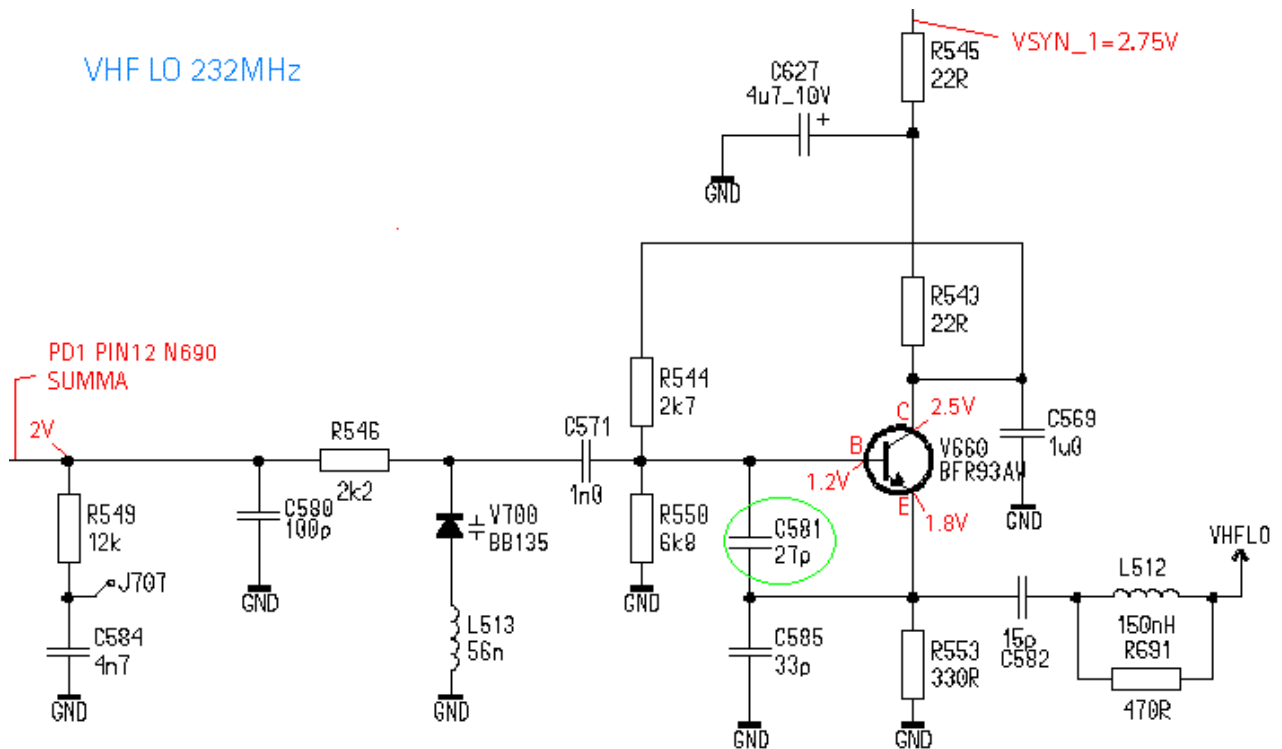
- Check 232MHz at N690 SUMMA Pin 8. If no signal, check **C581** for cold or broken soldering
- Check VSYN_1=2.75V. When 0V, check line to CCONT for shorts or breaks. If ok, change CCONT N110
- Check V660: Emitter=1.8V/Collector=2.5V/Base=1.2V. If the values are not ok, check the discrete components (see picture below)

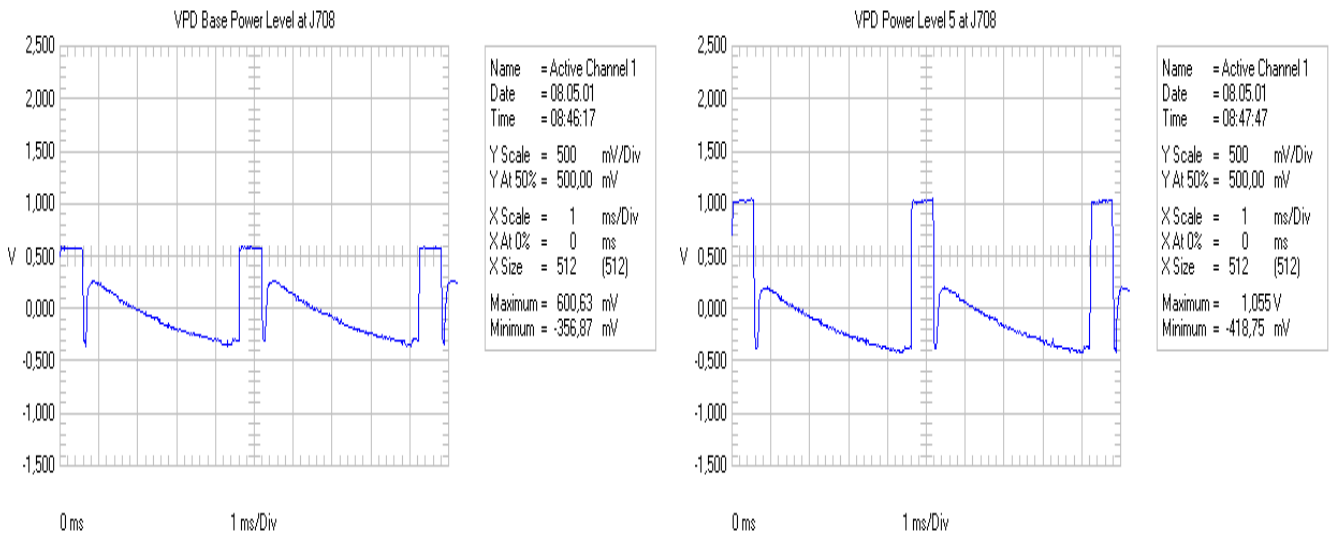
- Check Vbatt =3.6V at Pin 1, 2, 4 and 6
- Check 902MHz at Pin 8
- Check also 902MHz at Pin 13 and put the power level from Base up to 5. The signal must be getting stronger. When you see no difference between base level and power level 5, check with oscilloscope VPD on J708 (see picture base and power level 5 below) when turning power level up.

- If the values do not change at J708, check C618, R622 and SUMMA N690 Pin 31, change faulty component if necessary.
- If the values change but the signal is not getting stronger, tip very carefully with a non metallic item on top of N500.
- If the Signal gets stronger cause of cold ground soldering under component, change N500.
- Check VTX at Pin 16 (refer NO TX, VTX picture)

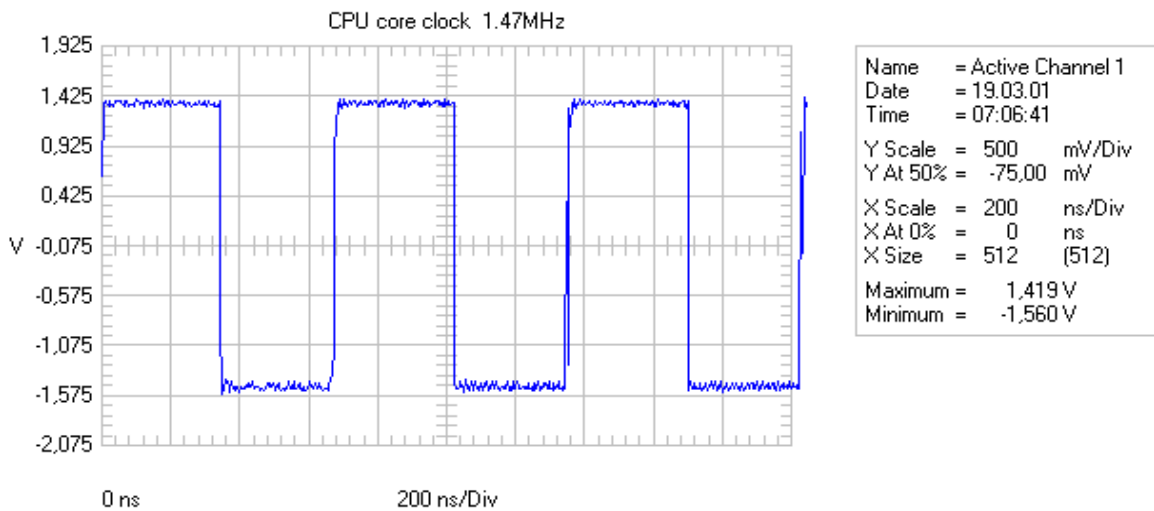
- Connect service battery to communicator and listen to the HF speaker if you hear some **POST BEEP Codes (Power on selftest)**
- **3Beep=Memory failure in 1st 64kB of memory** (connection between N400 and D441 faulty, in most cases change N400 cause of broken soldering. Otherwise the D441 XIP flash has to be changed..But if you do not have the possibility to JTAG, change the PDA module and send the faulty one to next authorized regional service.
- **Note!** For more information about POST BEEP Codes see in Service Manuel Chapter 7 Troubleshooting, POST BEEP Codes
- Check current consumption when connecting service battery (see flowchart)
- Check 32.768kHz (Vpp=1.20V) sinewave at J435 of B430
- Check CPU core clock 1.47MHz (Vpp=1.5V) squarewave at J400

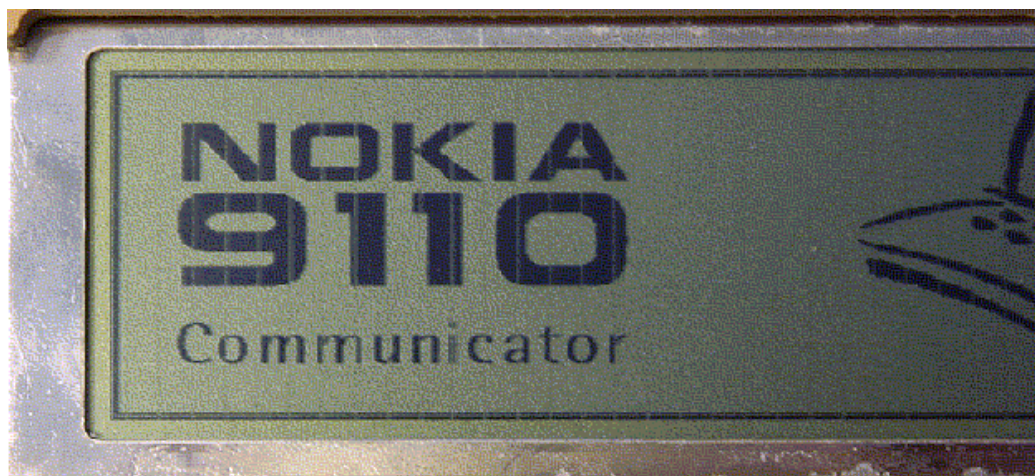
PDA-Display vertical stripes

- If you see vertical stripes on the PDA-Display and/or the PDA freezes after pressing buttons around the S-key
- Change N400

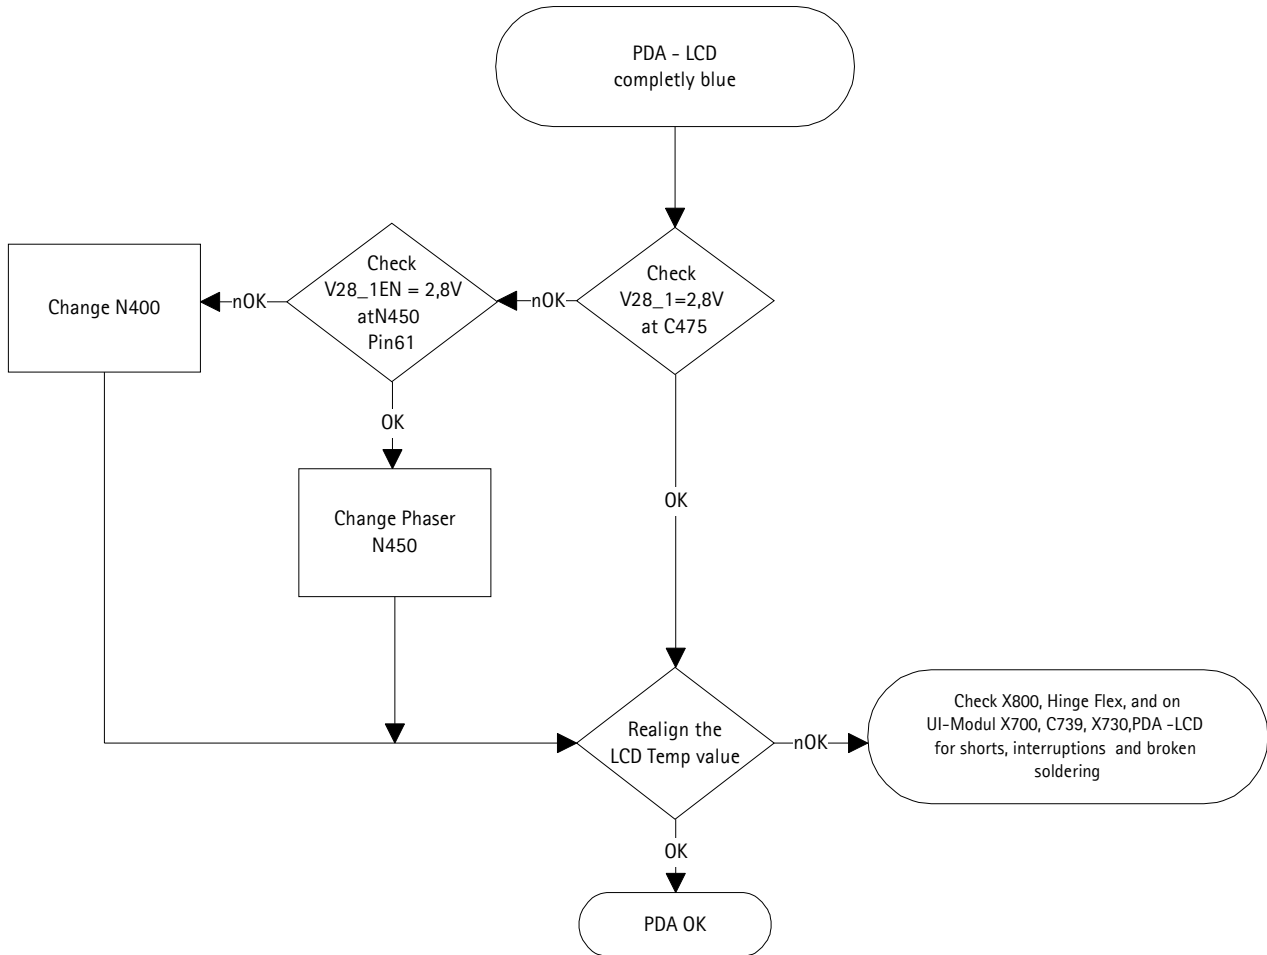
PDA-Display completely blue

After inserting the battery, the PDA-Display appears completely blue.

- After changing components you always have to realign LCD TEMP value. Follow the steps 1-9
 - Use WinTesla SW RAE2PD to tune the PDA - Display and follow the next steps
 - 1. Start the RAE2PD SW
 - 2. Speed : 115200; Com1 (or Com2 depending on your PC setup)
 - 3. Choose RS protocol and press OK
 - 4. Switch service battery in test mode (located at the right side of service battery) and connect it with PKD-4F dongle
 - 5. Connect the phone to serial port com1 (or Com2 port depending of your PC setup) using DLR-2 cable
 - 6. Connect service battery with 9110
 - 7. Disconnect and then connect service battery with Fla-7 (When the lid is open, a small point appears in the upper left edge.
(If the startup logo appears start again with step 7)
 - 8. If the message "Target responding in testmode" appears on PC, press "OK".
Otherwise press "cancel" and start again with step 7

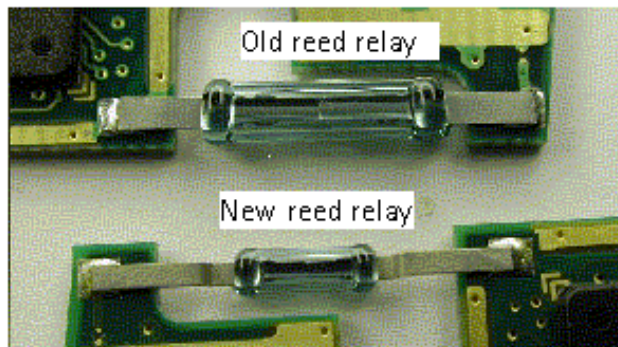
- When the power on button is pressed, the CMT-Display shows slight contrast but does not start, open the lid, use a magnet and put them in the lower left corner of keyboard area and check if the PDA-Display turn off
- If not, change S390 on PDA module

NOTE! Use always the new reed relay S390 (new code 5209005, old code 5309001)

See **SB-035**

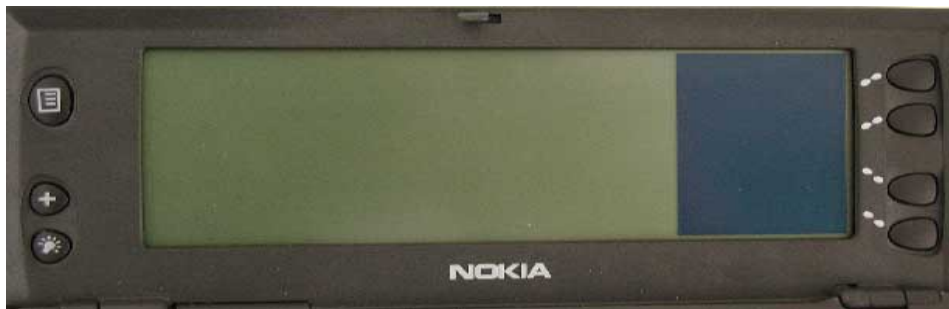
Blue areas in PDA-Display

- The PDA-Display has a broken corner under metal frame, change PDA-Display

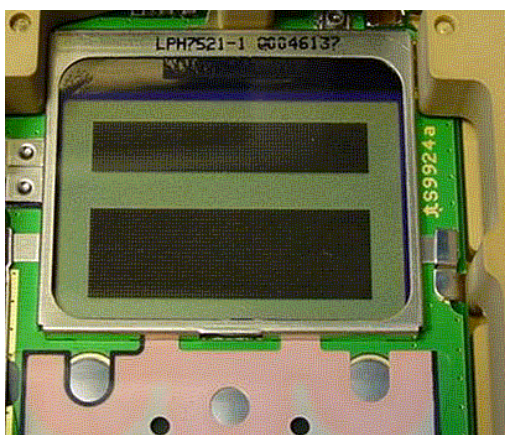
CMT-Display broken

- Lines missing in CMT-Display, because of broken corner under metal frame, change CMT-Display
