# OREGON FUEL INJECTION, INC.

## 6.5L DS Pump Diagnostics

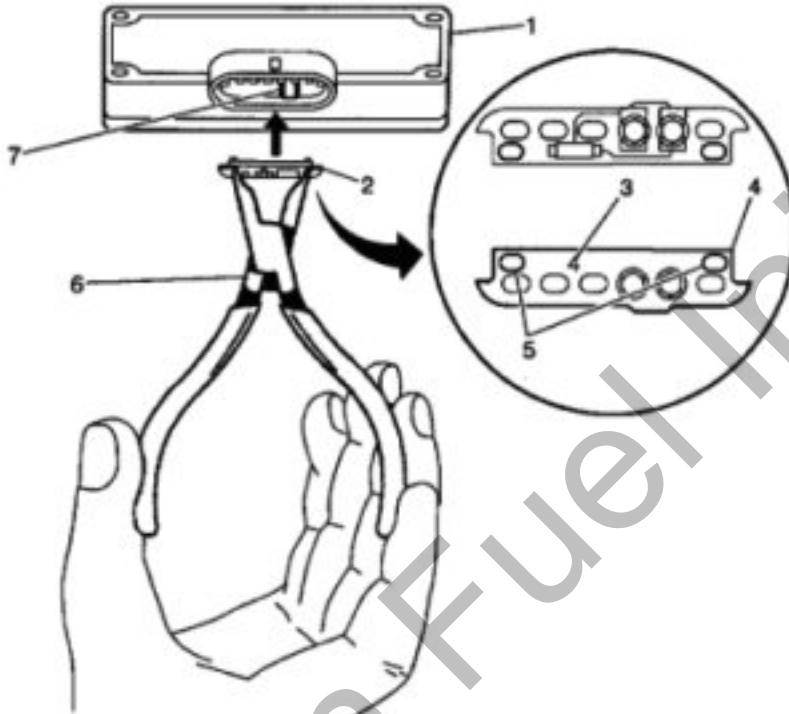
1. Fuel Solenoid Driver
2. Fuel Solenoid Driver Calibrating Resistor
3. Fuel Solenoid Driver Calibrating Resistor Identification Number
4. Fuel Solenoid Driver Calibrating Resistor Index Notch
5. Fuel Solenoid Driver Calibrating Resistor Removal Holes
6. Needle Nose Pliers
7. Fuel Solenoid Driver Index Notch for Calibrating Resistor

If the calibration resistor is damaged, there is an identification number on it (1 through 9) and we have them available.

**IMPORTANT: IF THE FUEL SOLENOID DRIVER CALIBRATING RESISTOR IS MISSING, DTC 56 (1994 1995) OR P1218 (1996-1998) WILL SET.**

Removing the PMD requires a T15 TORX bit. Replace the heat transfer pad and use snap ring pliers to remove the calibration resistor. Install the calibration resistor into the new PMD.

**INSTALL FUEL SOLENOID DRIVER:** Align the mounting screws on the PMD with the holes on the injection pump (or on the remote mount PMD heat sink) Torque the mounting screws to 23 LB-IN.

**IMPORTANT: DO NOT INSTALL THE FUEL SOLENOID DRIVER WITHOUT A NEW HEAT TRANSFER PAD. DO NOT REUSE A HEAT TRANSFER PAD. USE A NEW HEAT TRANSFER PAD ONLY. THE HEAT TRANSFER PAD IS REQUIRED TO PREVENT RAPID FAILURE OF THE FUEL SOLENOID DRIVER FROM OVERHEATING.**
