SPARC Enterprise T5140 and T5240 Servers Product Notes

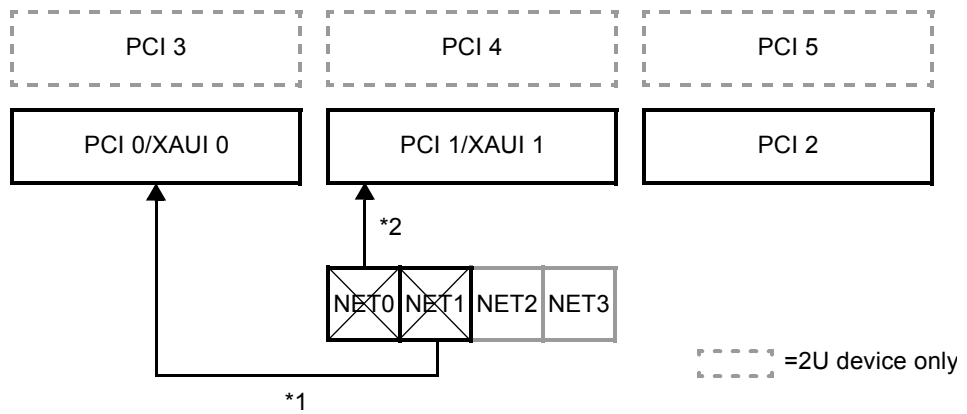
FIGURE 3-1 XAUI cards and on-board network ports

Installing a 10GbE XFP XAUI Adapter Card (XAUI card) in slot 0 disables on-board network port 1 (NET1)(*1). Installing the XAUI card in slot 1 disables on-board network port 0 (NET0)(*2).

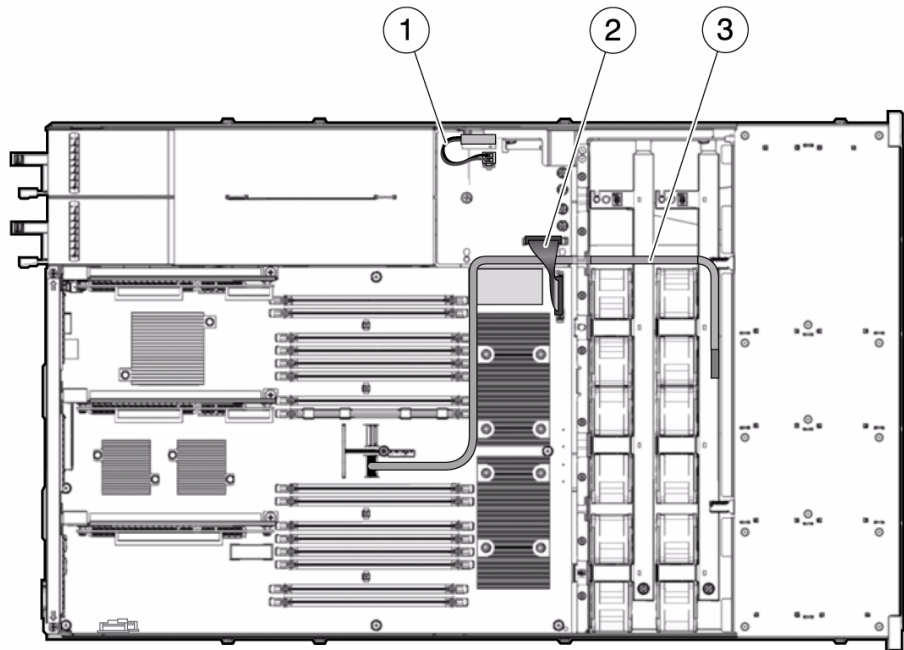
FIGURE 4-1 Internal Cables for the Onboard SAS Controller Card (Four-Disk Capable SPARC Enterprise T5140 Servers)

The data cable routing diagram for 4-disk capable backplanes is wrong. It shows the cable connected to SAS1. It should be connected to SAS0. This is the correct diagram:

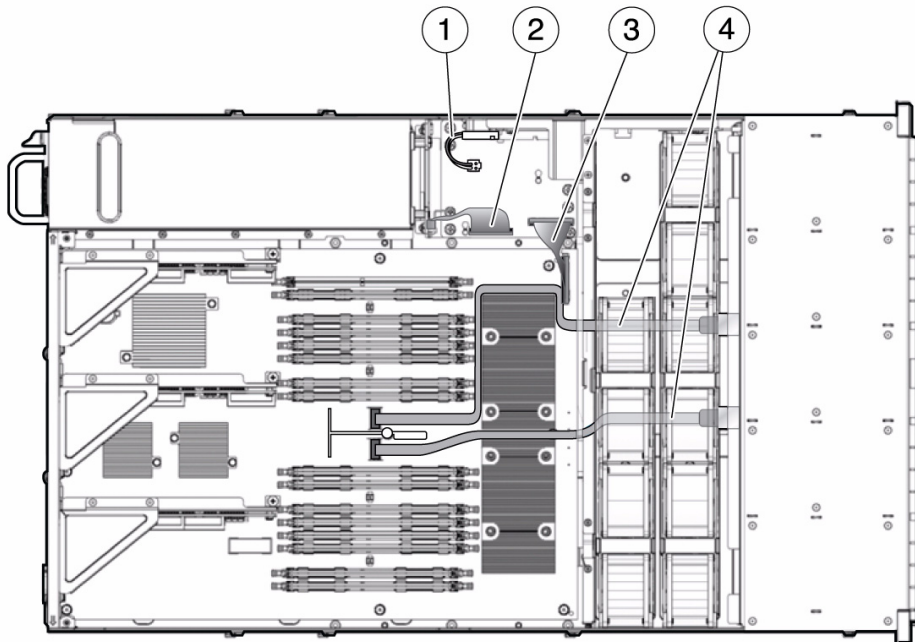
FIGURE 4-2 Internal Cables for Onboard SAS Controller Cards (Eight-Disk Capable SPARC Enterprise T5240 Servers)

The data cable routing diagram for 8-disk capable backplanes in T5240 servers is wrong. It shows a single data cable. There should be two. This is the correct diagram:

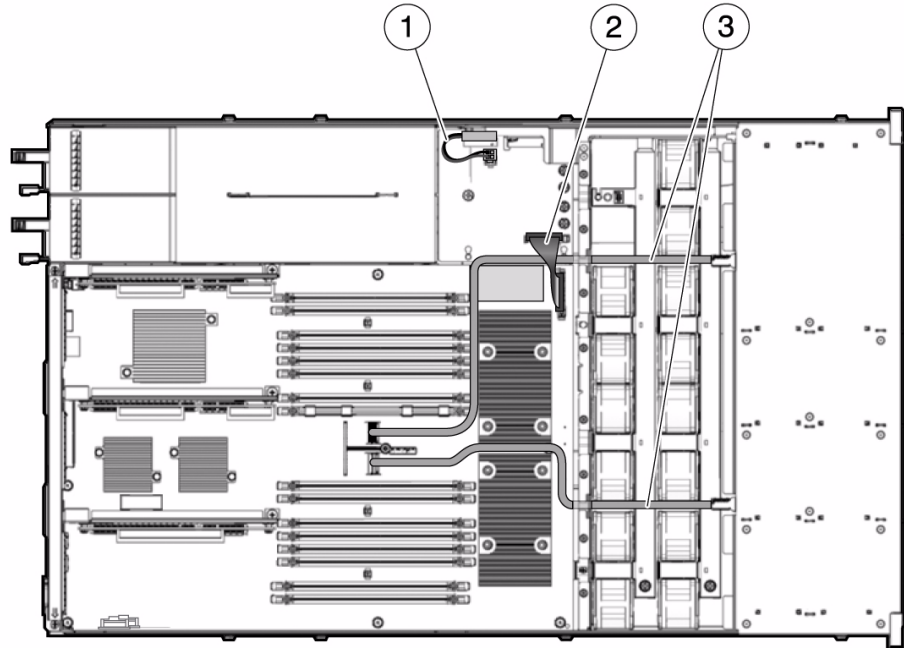
FIGURE 4-3 Internal Cables for the Onboard SAS Controller Card (Eight-Disk Capable SPARC Enterprise T5140 Servers)

The cable routing diagram for 8-disk capable backplanes in T5140 systems is missing a fan module in the upper right corner. This is the correct diagram:
