FUJIFILM ENGINEERING CHANGE NOTICE (FIELD CHANGE NOTICE)

SUBJECT: Releasing the information of DR-ID300CL Application Software V8.1
 (for Software licence unsupported version)

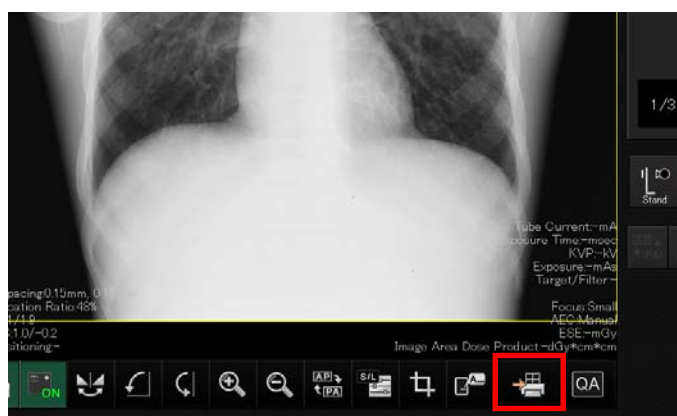
Free layout print function itself does not change.

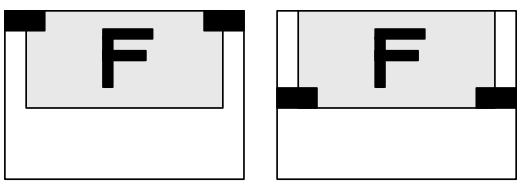
<ul style="list-style-type: none"> Expansion format output to 10"x14" film is enabled Single format output
8"x10"
