Implementation of the K6XX QSK Waveform Mod in the TS-950SD

KB2LJJ Radio Mods Database and Manuals

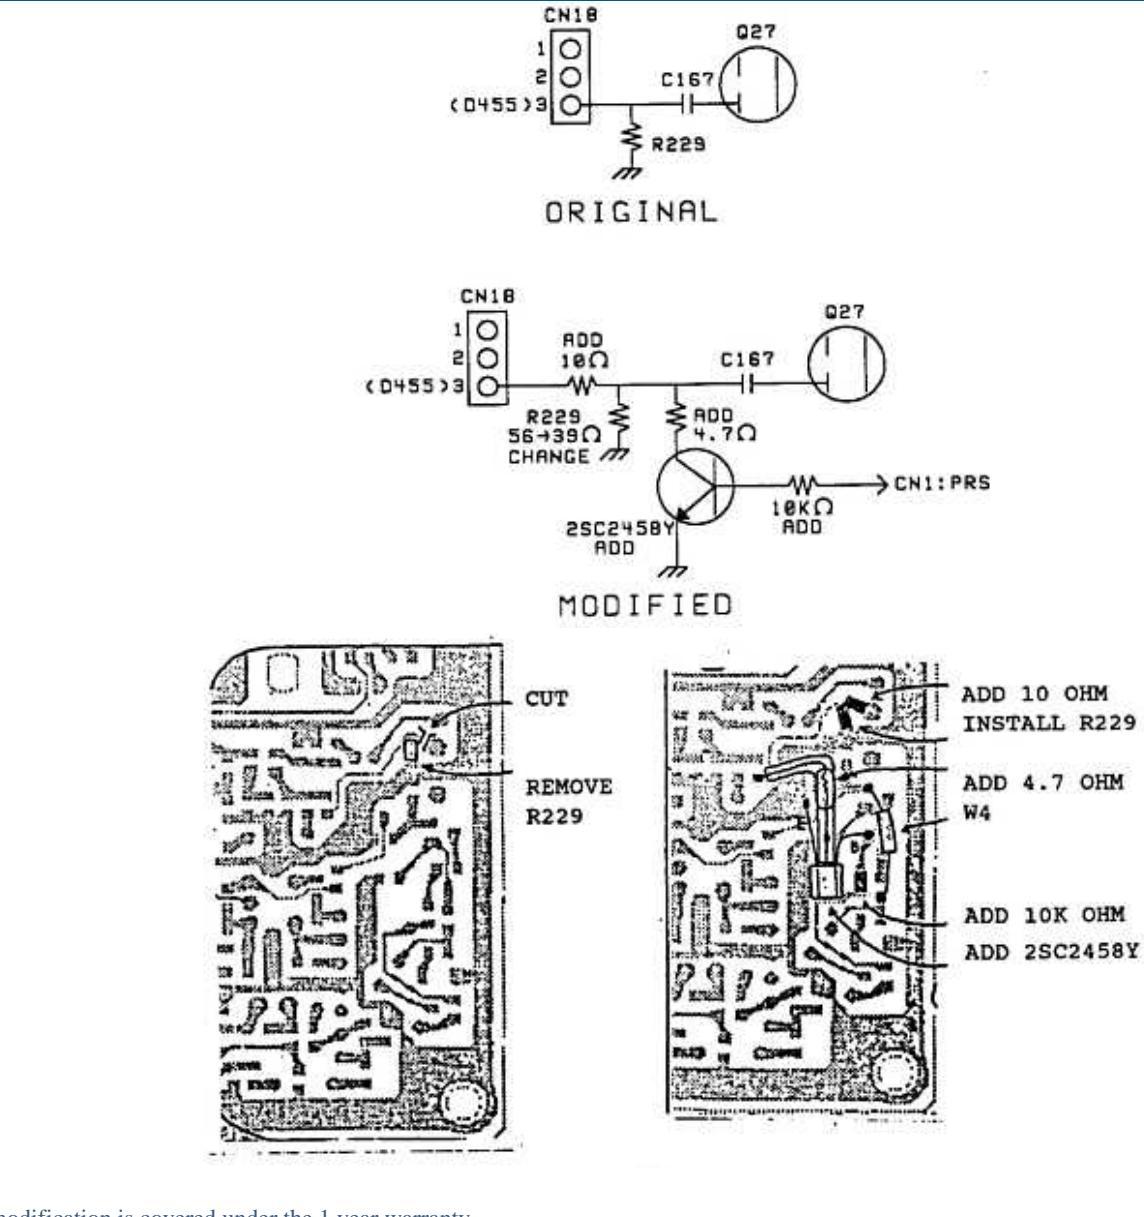
When the Processor-In control is set to some level below 10 dB of compression, a crackling noise can be induced on the transmit signal. The following modification will reduce the noise. After the modification has been performed, the noise can only be heard when the Processor-In control is set too low to be functional.

Solder the base and emitter leads as shown in the accompanying diagram.

Solder a 10 Kohm resistor to the circuit as shown.

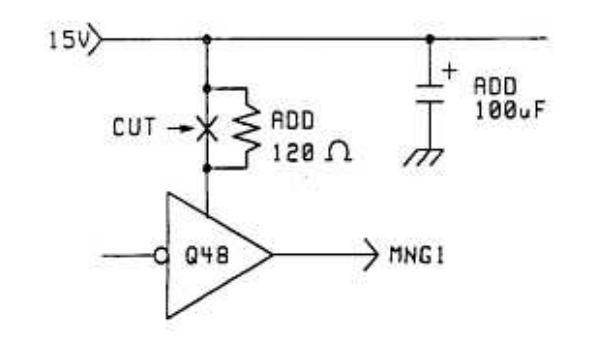
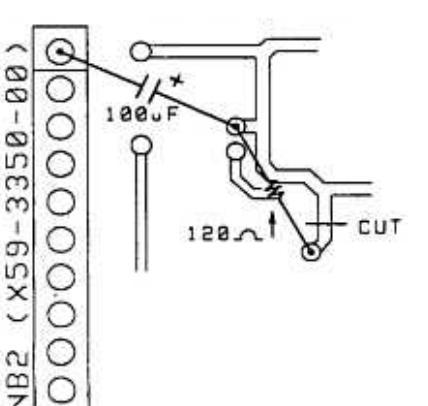
Switching noise from the main band noise blanker circuit may be induced on the 15V line and pass through the AF amplifier to the speaker. The following modification will correct this condition.

Cut the foil shown in the accompanying diagrams.

Add a 120 ohm resistor between the emitter of Q48 and the 15 V line.

Add a 100 $\mu F,$ 16 V capacitor between the 15 V line and ground.

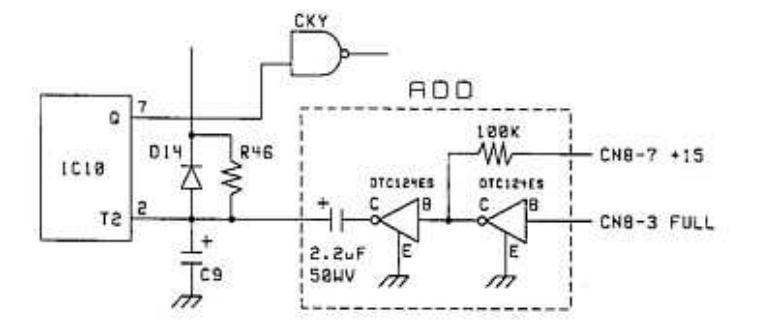
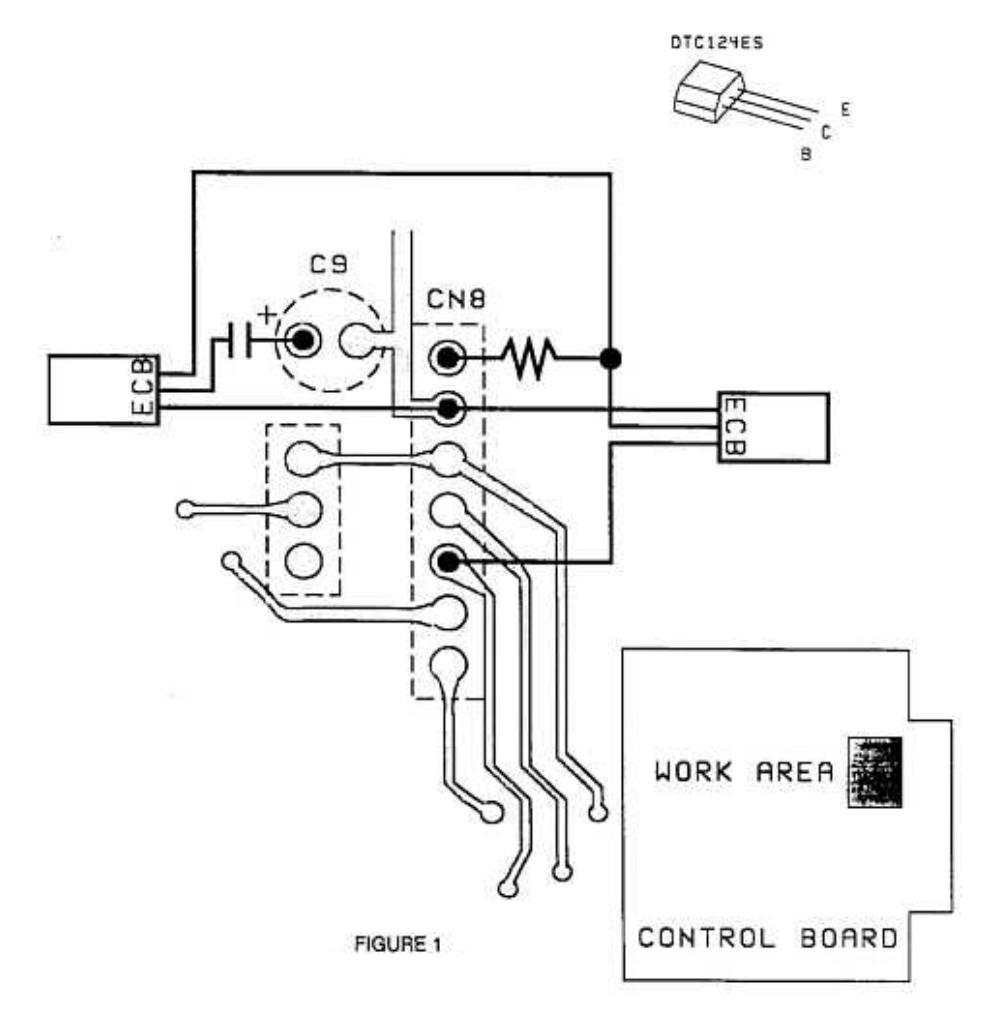
The TS-950SD RX to TX switching time in semi break-in is approximately 10 mS. At the key down, the transceiver momentarily sees an open circuit because the linear's keying relay has not engaged. As a result, the transceiver's protection circuit turns on, causing the output power to be reduced. The following modification will make the RX to RX switching time, in semi-break-in, approximately 30 mS. This modification does not affect full break-in switching. Increasing the switching time to 30 mS may restrict certain long distance high speed communications.

Install the circuit shown in figure 1 on the foil side of Control board A/3.

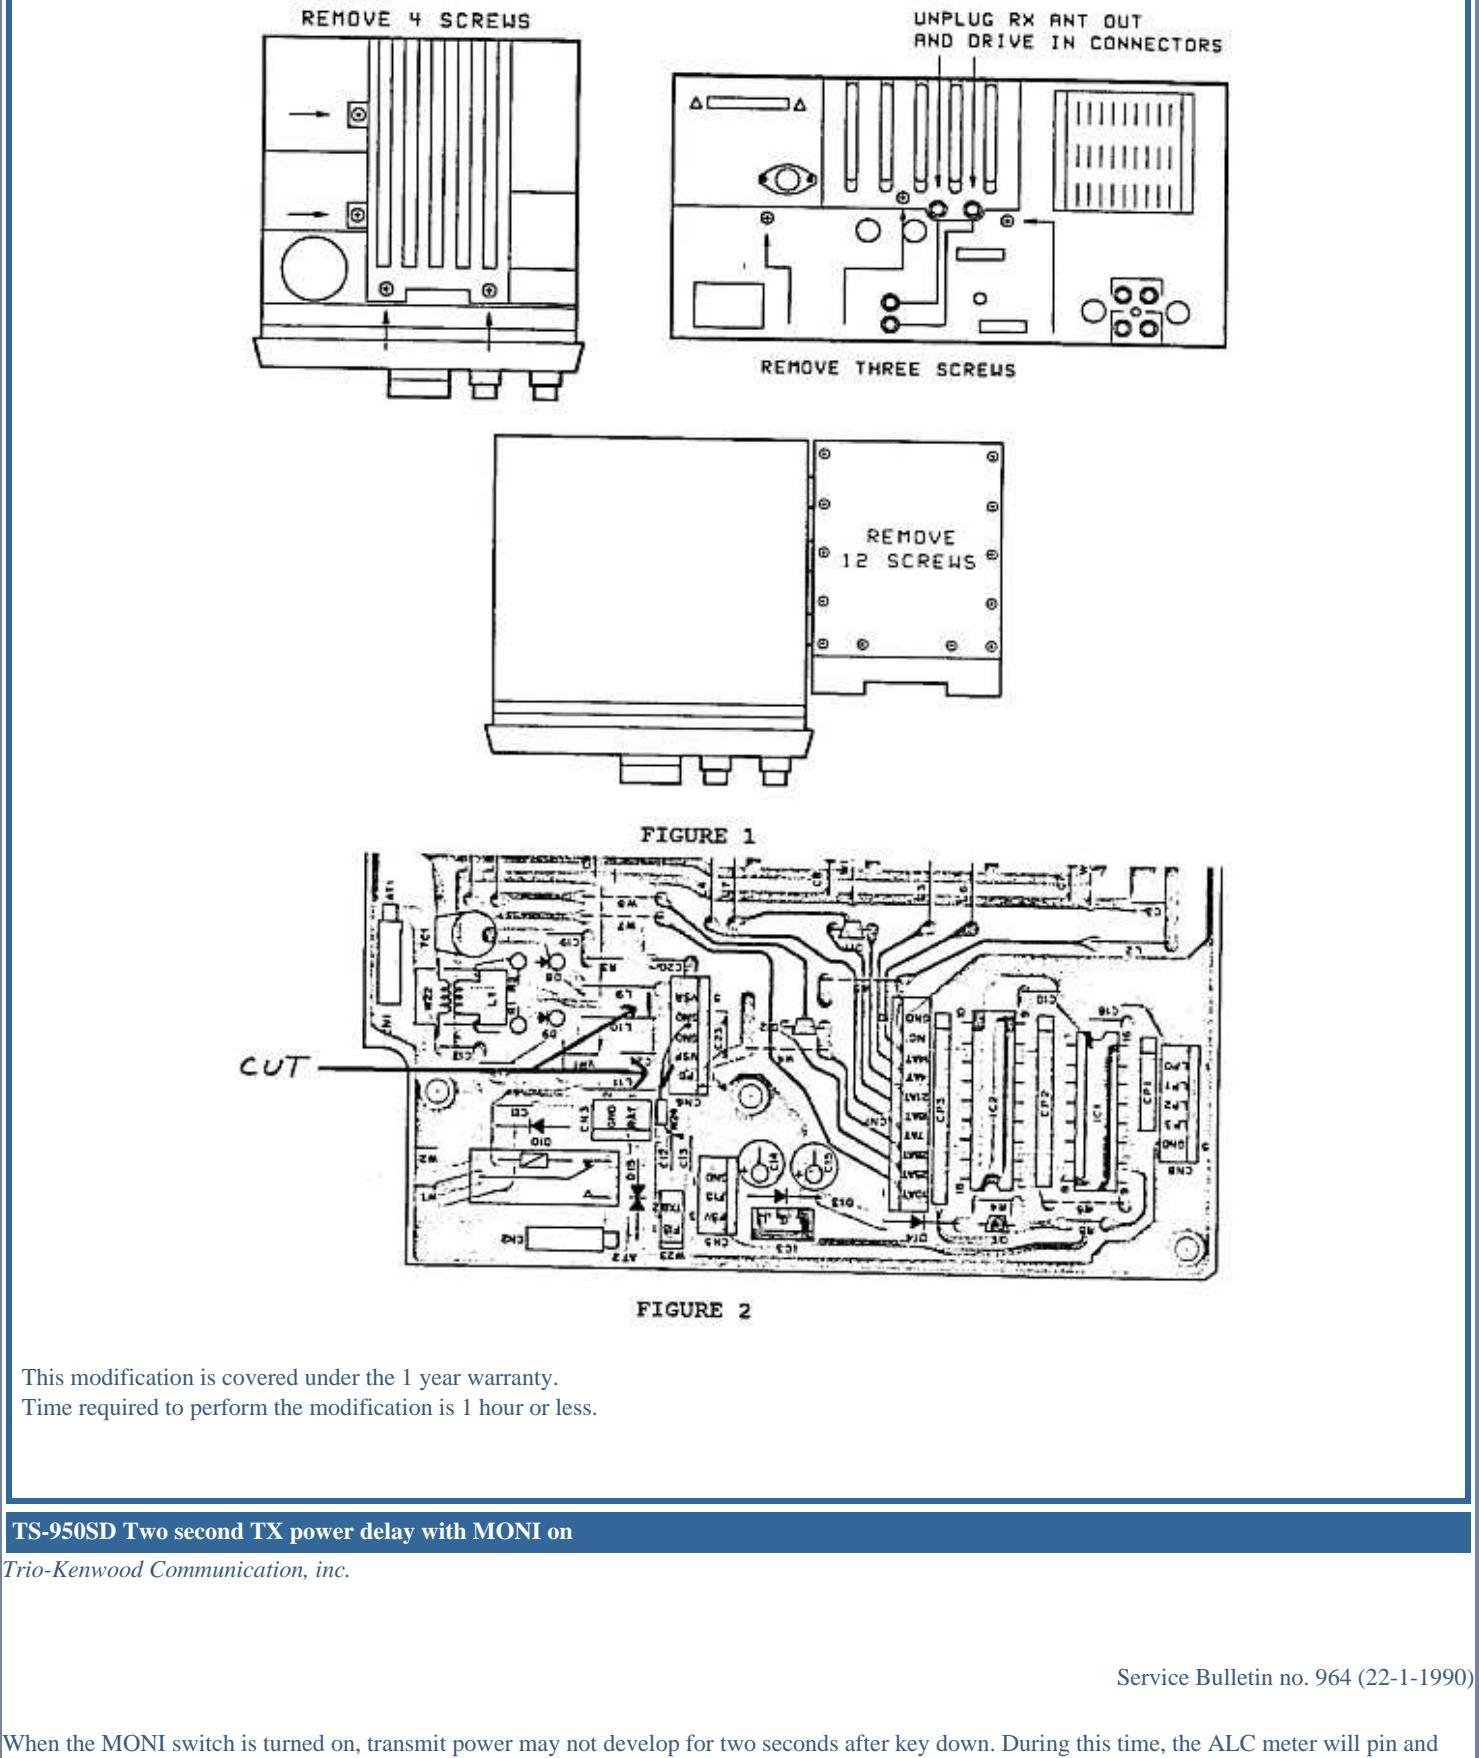
Some early TS-950SD transceivers may exhibit a low Signal to Noise ratio on ten and fifteen meters. In addition, rotating the encoder may allow the user to hear a crackling noise in his headphones. The following modification will correct this condition.

Cut the two foils as shown in figure 2.
