Subaru Emissions System Service

While the implementation of the OBD II standards was intended to bring a level of standardization to emissions diagnostics and repairs, vehicle manufacturers and individual vehicles will continue to have unique design characteristics and repair techniques. This article offers a collection of repair tips and tricks collected from the field, focused on late model Subaru emissions system diagnosis, service and repair.

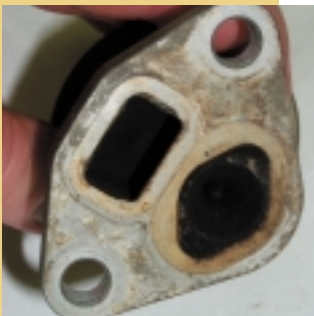
- A metal pipe also connects the backpressure transducer to the EGR valve. The rubber hose at the backpressure transducer end of the pipe may become deteriorated and begin to leak due to engine heat. A weak vacuum signal will keep the EGR valve from fully opening when commanded, which may also cause a DTC P0400.

- Check the components themselves. Carbon from the EGR valve may back up into the backpressure transducer port, affecting its flow. Engine exhaust heat may also damage the diaphragm inside the backpressure transducer, keeping it from operating properly. As exhaust backpressure increases, pressure on the transducer diaphragm increases and more vacuum is allowed to flow to the EGR valve. The transducer can be checked with a pressure pump, but there are no specifications for exactly when and how much it should open for a specific pressure.

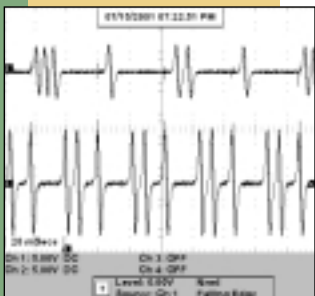
Built into the fuel injection control unit is logic that will shut off the #1 injector if the computer believes that it can no longer control the Idle Air Control Valve. Remember this design characteristic if you are trying to diagnose a "hard" code for the Idle Air Control Valve or a dead miss in the number one cylinder due to no injection at idle. A problem in the Idle Air Control Valve circuit may be responsible. (Component testing shows that it most likely is not the valve itself.)

Also, if the computer is deprived of its "back up power supply," some computers will generate a false code for the Idle Air Control Valve and kill the injector

for cylinder #1. The pin location of this power supply can be found in the Control Unit Module I/O Signal pages of the appropriate Service Manual.
