# Modifications for the Kenwood TS-450

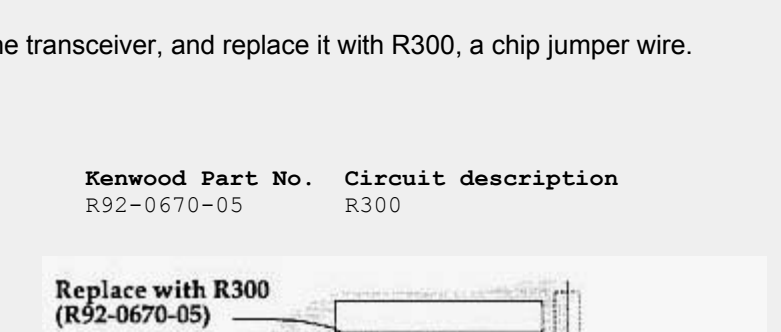
We have received several reports of distorted transmitter audio when using a TNC controller such as the AEA PK-232 or Kantronic KAM, etc. The symptom will generally disappear if the transceiver and TNC units are powered from different sources.

Cause:  
The audio output level from the TNC is generally too high and causes overload of the microphone amplifier circuit. In previous models such as the TS-440S the incoming TNC audio was inserted after the microphone amplifier. With the TS-850S it is inserted before the microphone amplifier. Just moving the insertion point to the output of the circuit is satisfactory since the drive level for FM packet is higher than that required for SSB.

Procedure:  
1. Add a 10 dB attenuator to the PKD line on the IF unit (X48-3090-XX). This will prevent overmodulation of the microphone input circuit.  
a. Change chip resistor R233 from 10 Kohm to 18 Kohm (RK73FB2A183J)  
b. Change chip resistor R234 from 1 Kohm to 8.2 Kohm (RK73FB2A822J).  
c. Delete chip capacitor C173 (100 pF) and add chip resistor R299, 1.5 Kohm (RK73FB2A152J).

3. When adjusting for proper ALC levels with an AFSK RTTY terminal or Packet TNC terminal you should adjust VR-13 on the IF Unit for a reading similar to the one shown in the accompanying diagram.
