Repair Hints

Service Level 3 & 4

6310 / 6310i

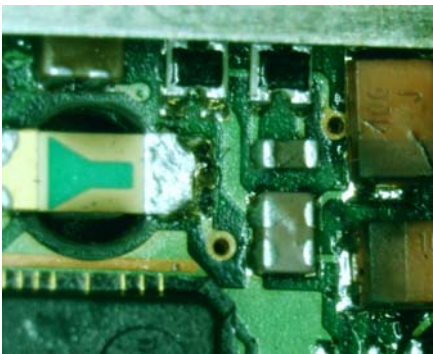
"rework" done with uncontrolled hot air

Reflow with uncontrolled hot air fan is strictly forbidden!

The μ BGA must be soldered with NMP approved μ BGA rework machines (e.g. Zevac / OK-Metcal / Martin) only .

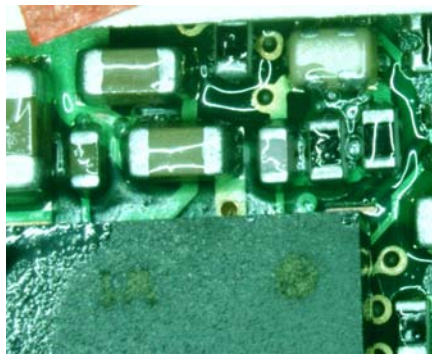
PCB drowned in flux

Before placing a new component remove the tin and clean the PCB, e.g. with help of soder wick and flux cleaner such as "Kontakt LR". Use only the mmended Fluxtype and an appropriate amount of it – avoid to wning the PCB in flux as this will result in additional faults!

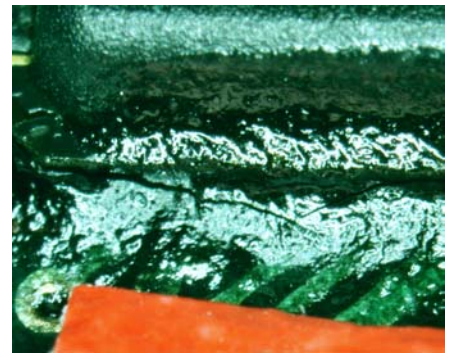
Also check underfilled parts for broken underfill material below. In this case carefully evaluate possible repair actions as the phone probably was exposed to strong mechanical stress.

broken underfill of an μ BGA part

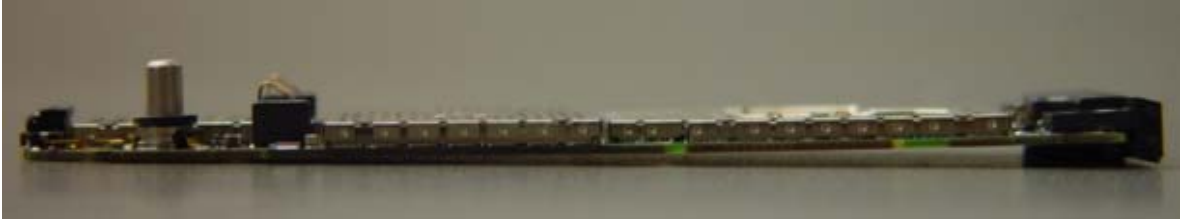
Wrong

For BB shield removing it is important to lay the PWB on level surface in away that the bottom connector does not touch the underground to prevent bending of PWB and cracking of the connector's solderings (See pictures below).

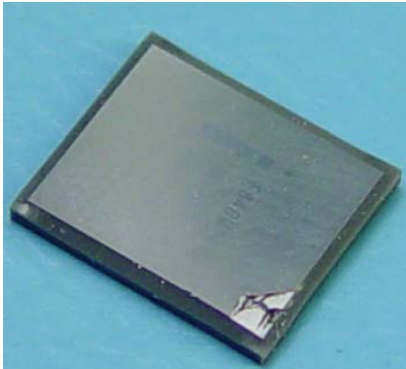
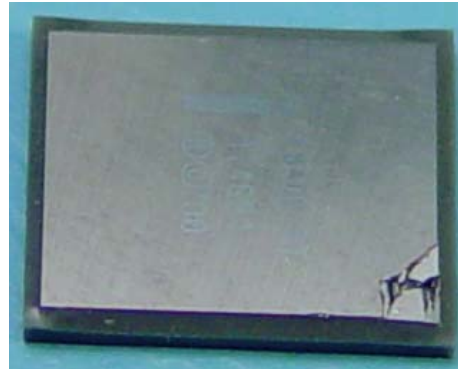
Example of a broken Flash D450:

When removing the BB shield, be very careful because the Flash D450 could be damaged (see pictures on the next page). Start by lifting and bending the lid with tweezers at the marked points 1- 3 (see pictures below). Do not use too much force on the frame because it could be damaged and also the PWB could be mechanically stressed.

Change **Flash D450** in the following cases and if all signals and voltages described above are ok:

After changing the Flash D450, rewrite product code, HW-ID, IMEI and SIMlock settings.
If the fault persists, probably UEM D200 is faulty and not changeable. Change the PWB.

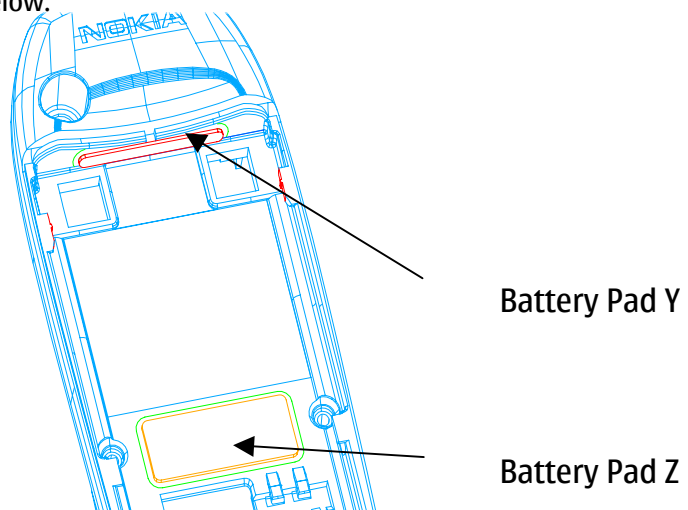
The phone turns off, because the contact pads on the battery and the battery connectors are worn out so that the phone has lost the contact to the battery.

Assemble the Y- and Z-Pads, as in the picture below.

For more information see SB-010 (NPE-4).

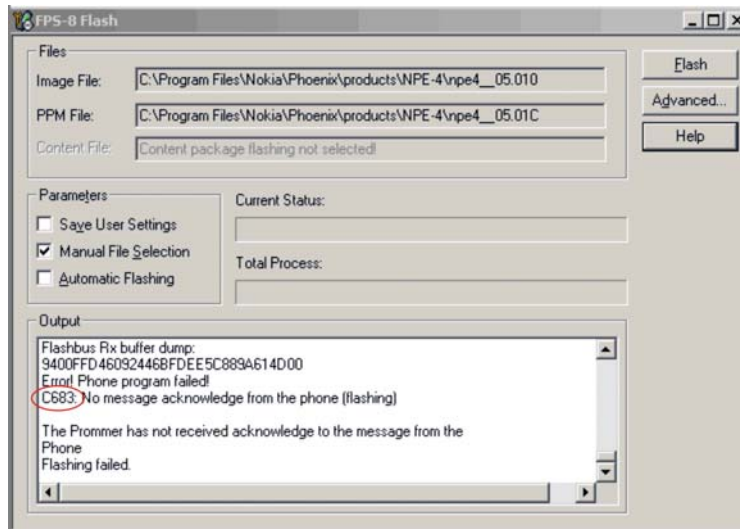
- If the flash update is not succesful, check error messages of the failed flash update (see picture below).

The failure codes **C683** or **C686** indicate in most cases a defective bluetooth module V130 (D200 & D400 also possible).
Other failure code messages give no certain indication about any defective component.
Flash (D450), UEM (D200), UPP (D400) or other defective components could distinguish the same or similar failure messages.

Do not change the flash (D450) or bluetooth module (V130) before ensuring that following voltages and signals are OK!

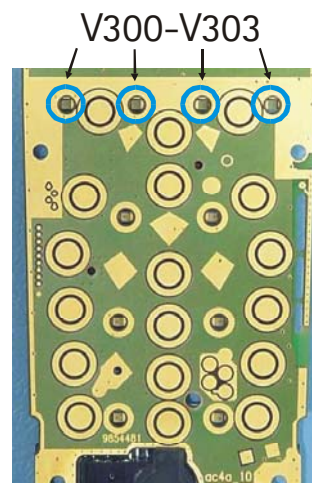
When switching on the phone, the display LED's V300 – V303 (see picture below) show in different levels of brightness. This is caused by the use of different LEDs. In this case change **all** LEDs and assemble the right ones with **spare part code 4864293**.

Note! When changing the LEDs, first the RF frame has to be removed. Be very careful when lifting the frame with hot air. A little drift aside and some small components might be pushed away.

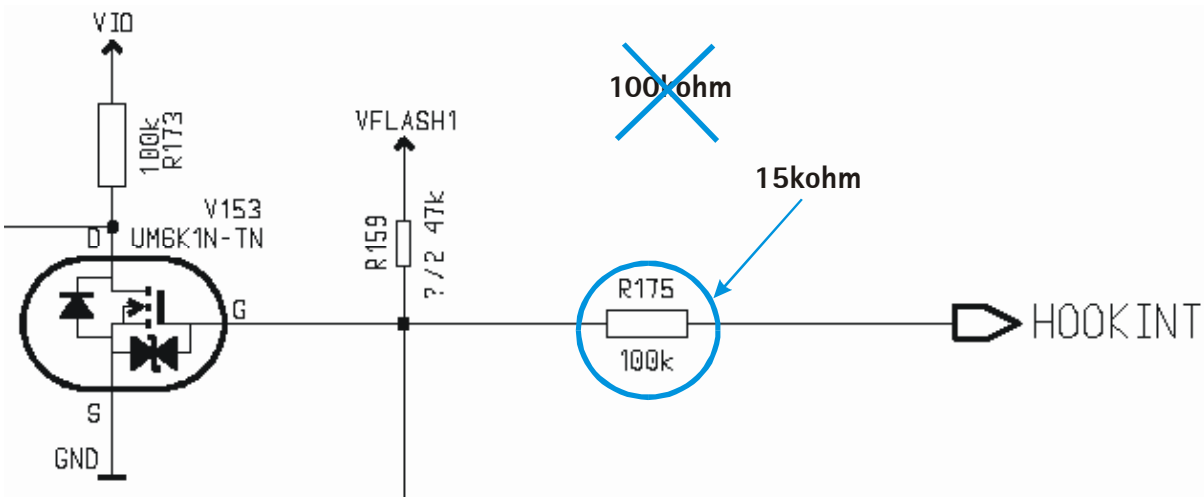
**Sometimes not possible to release “incoming call”
No voice dial possible**

Open the BB-shield and measure the resistor **R175=100kΩ**.
If **R175=100kΩ**, change the resistor to **15kΩ**. (see picture below).
Note! Up to HW-ID 06.01 there is a 100kΩ resistor. From HW-ID 06.02 the value has changed to 15kΩ.
For more information also see **SB 024 (NPE-4)**.
