A monthly publication for GM Dealership Service Professionals

QuadraSteer™ Rear Wheel Steering Introduced

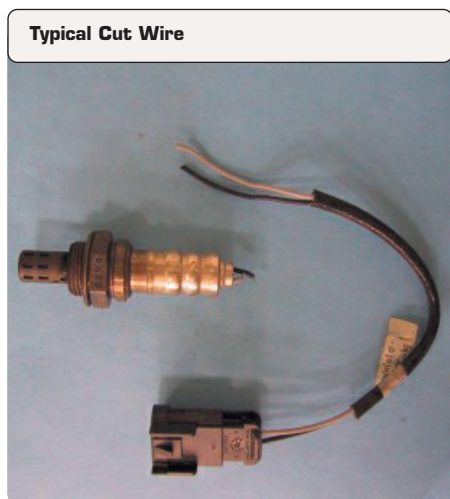
This applies to all vehicle lines and model years, and is about proper oxygen sensor removal techniques. Some of the oxygen sensors returned to the Warranty Parts Center have been damaged during removal.

In one recent sampling of 27 returns, 7 sensors had the wiring pigtail cut off at or near the grommet. An additional 9 sensors had wires torn or damaged from use of a conventional socket during removal. With these damaged sensors, analysis was impossible, defeating the purpose of the Warranty Parts Return program.

There are a variety of special tools and slotted sockets available for oxygen sensor removal which will not damage the pigtail. If space allows, a crowfoot wrench is also appropriate. A suitable tool is needed for installation of the new sensor; using it for removal as well will eliminate damage the wires on the sensor being removed.
