Dealing With Battery Parasitic Drains

Techline News

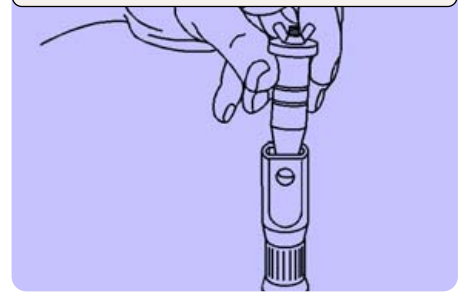
Some customers may comment on a clunking noise under the hood that can be felt in steering wheel. The conditions may be more noticeable when turning at low speeds on rough road surfaces.

Inserting supplied plug into intermediate shaft

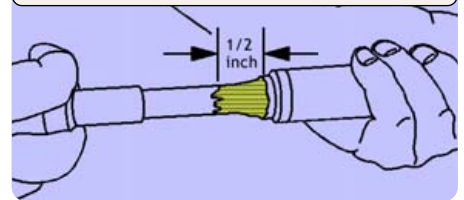
Grease visible on shaft splines

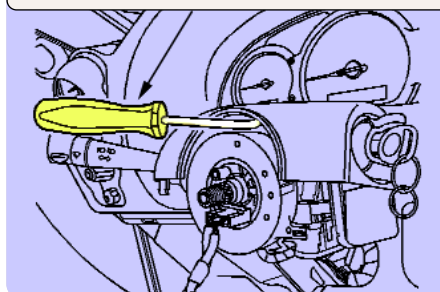
Using awl to push retainer

Using the awl does not require lifting the trim cover high enough to cause damage. The service manual Document 633744 has been updated with this change.
