Tips from Comanche *Flyer* magazines Feb 2002 – Aug 2009

CHAPTER THREE

FUEL SYSTEM

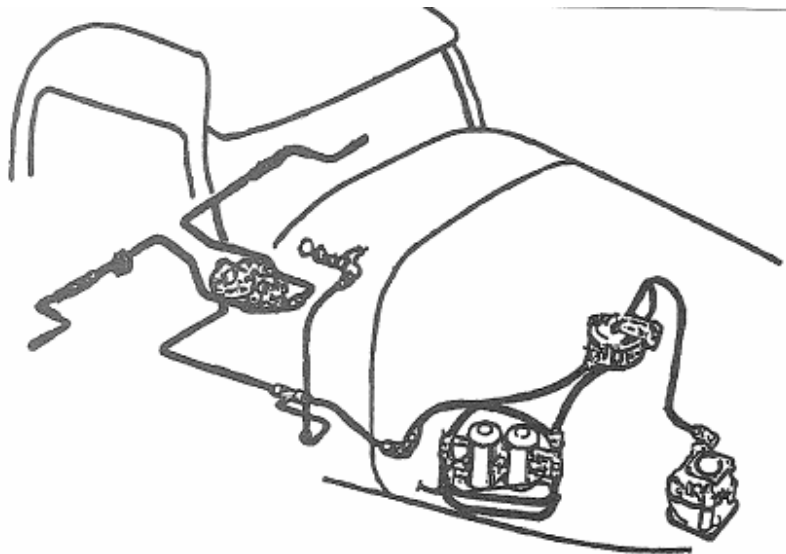
Original Fuel System Configuration with Interrupter type fuel pumps, hoses and connections all located in lower aft section of engine compartment.

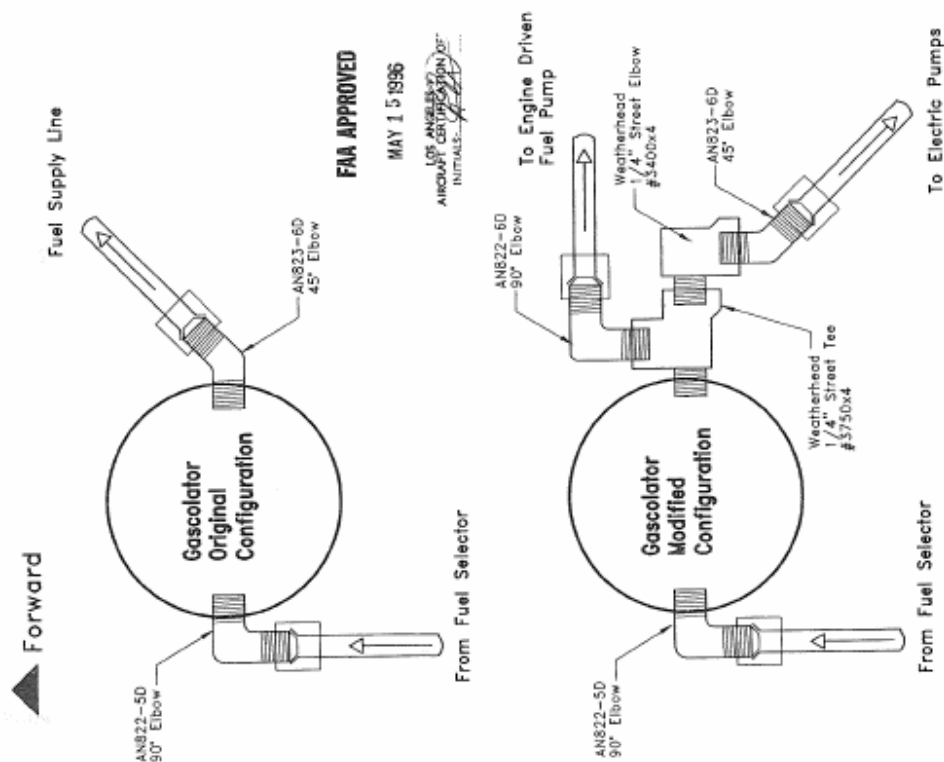
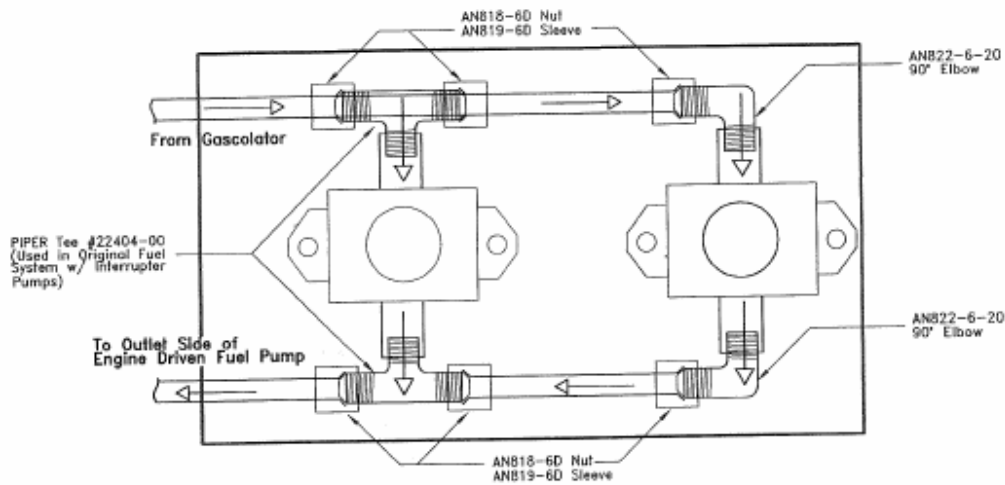
Fuel Pumps and Fittings As Mounted On Right Stringer Of Gascolator Compartment

b. Make and model designation of product to be modified Piper PA24-250, Serial No24-2999, N7782P	
c. Description of modification Replace and relocate the electric fuel pumps from the engine compartment to the gascolator compartment. See attached drawings and information

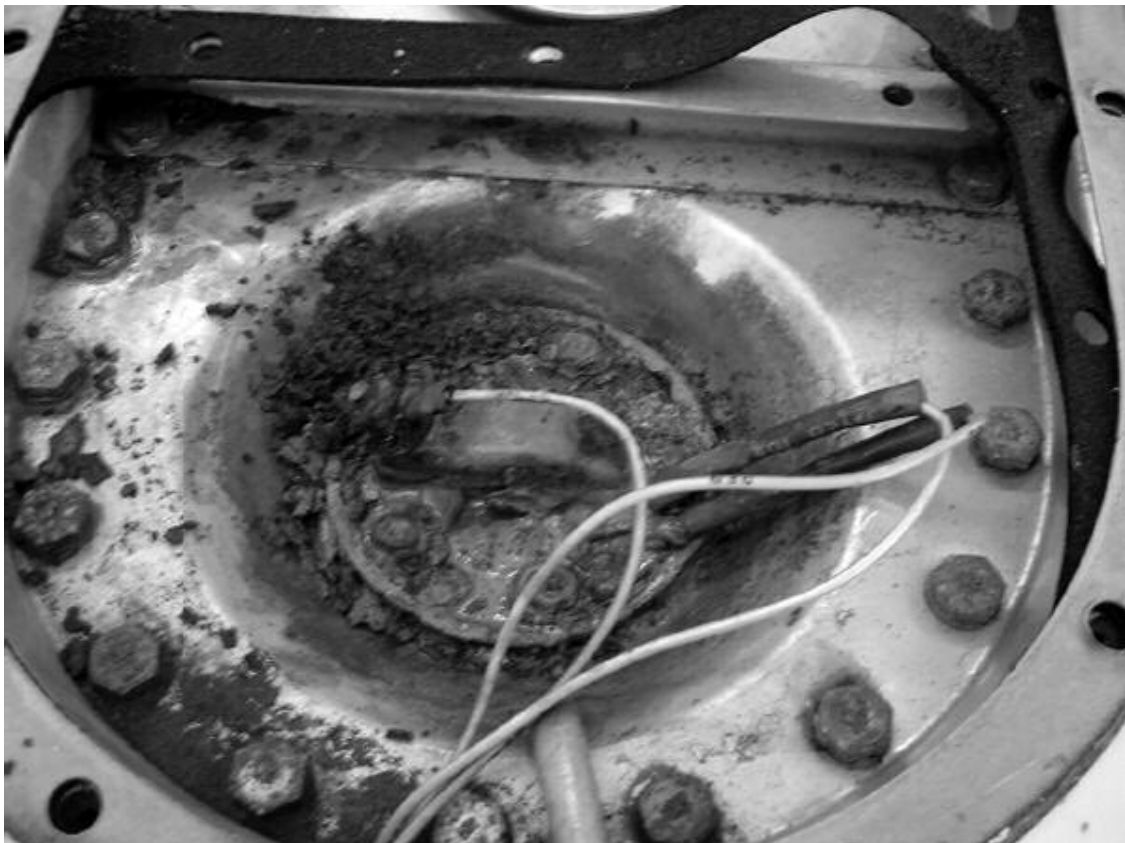
An error in fuel quantity indication can be caused by an incorrect resistance value being transmitted to the display gauge unit. There can be a few sources for this problem. Checking for poor connections should be your first line of diagnosis, secondary would be a component. One cause of incorrect resistance can be from corrosion where water has leaked into the transmitter area from poor sealing of an access cover. Water collects in the depression where the transmitter unit is mounted – take a look there.

This main tank transmitter didn't survive due to the extensive corrosion.

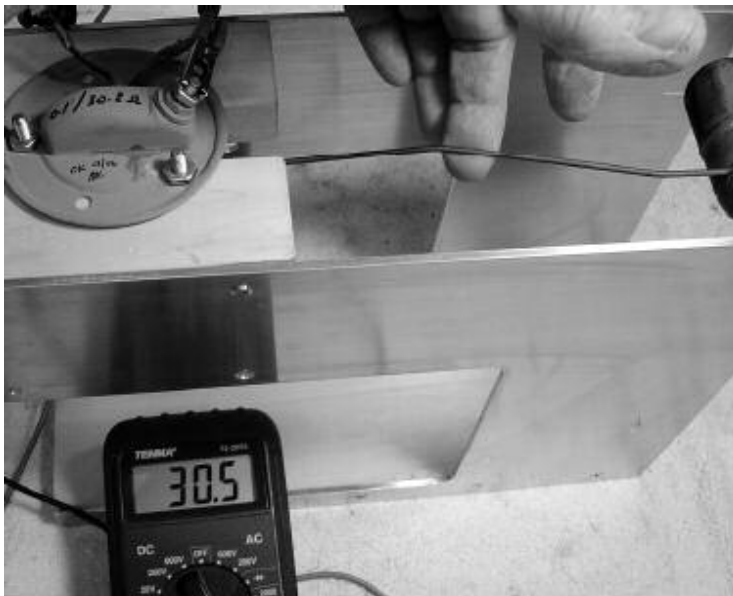
Another cause is internal to the transmitter – a dirty resistance winding (not obvious) inside a fuel transmitter is quite common and easy to check. The internals of the transmitter are simple and diagnosis and repair fairly simple once disassembled. There are cases however where the fuel level transmitter has reached the end of its life, i.e. the wiper button is too worn, broken or missing, or excessive housing corrosion.

A full-range test must be 29.6 to 31.3 ohms for all except the Comanche 400 auxiliary transmitters (they require two transmitters).

Once you have determined necessity, the disassembly method depends upon the type of transmitter you are investigating; most employ the soldered-rivet method, some a cover with securing tabs (400 aux). After disassembly, you should first examine the wiper button condition. If the wiper button is not serviceable, your choice is a replacement transmitter. If the wiper components pass inspection, then use an ultra-sonic device employing a basic (non-acidic) solution bath to clean the wound-resistor element. The ultra-sonic bath device is a Harbor Freight item; alternatively they can commonly be found in the female’s area of the bathroom. Don’t tell her you used it to clean your fuel injectors! Remember the end result of approximately 0 to 30 ohms is required. The 400 Comanche auxiliary transmitters are 15 ohms each because the aux tanks require two transmitters which are connected in series. Be sure to repeat the test procedure after you have cleaned a transmitter.

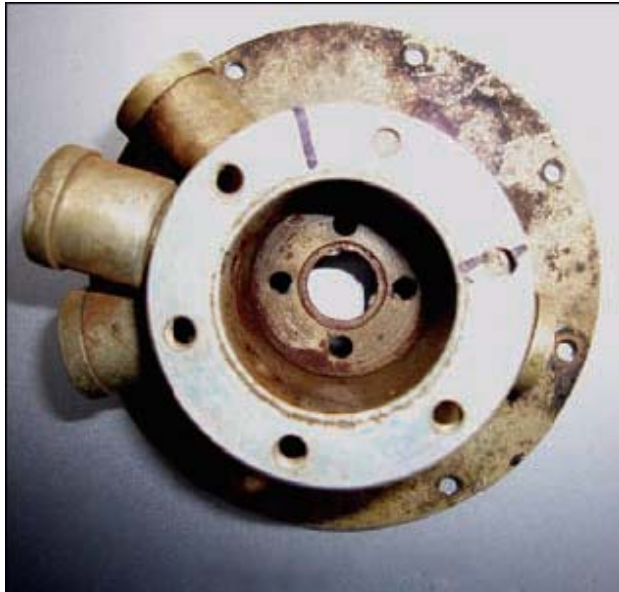
What I discovered was that the design of the valve body traps moisture that is not drained during normal pre-flight, or even when drained using the mandated procedure which calls for 10-25 seconds of draining per tank. This water had, in turn, caused rust to form in the divider area between the upper and lower chambers of the valve. Fortunately for me, my selectors were not as badly corroded as the one shown in the photograph.

Corroded fuel selector body

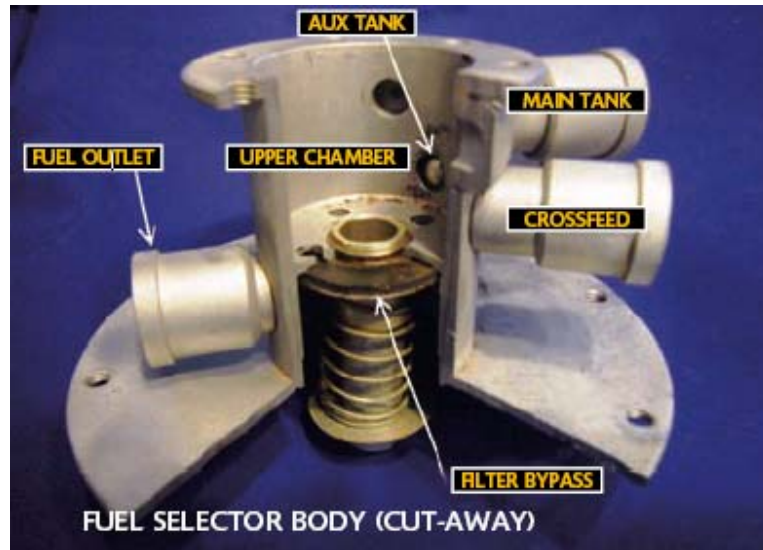
It is easy to tell from the cut-away photo, that the design of the divider between the upper and lower chamber has a tendency to trap droplets of water both above the divider and on the lower side of the divider, between it and the seat of the bypass valve. Sooner or later, the droplets of water will overcome the cadmium plating on the selector body, and rust will form.

In hindsight, it seems that making the body out of cadmium-plated steel was inadequate to withstand the water that was bound to accumulate. The fact that an earlier service bulletin required the replacement of the cadmium-plated bowl, with one made of stainless steel, is evidence that the potential for internal corrosion was not sufficiently taken into account in the design. This occurred after little more than five years in service. The follow-on airworthiness Directives are further testimony to the potentially serious nature of the problem.

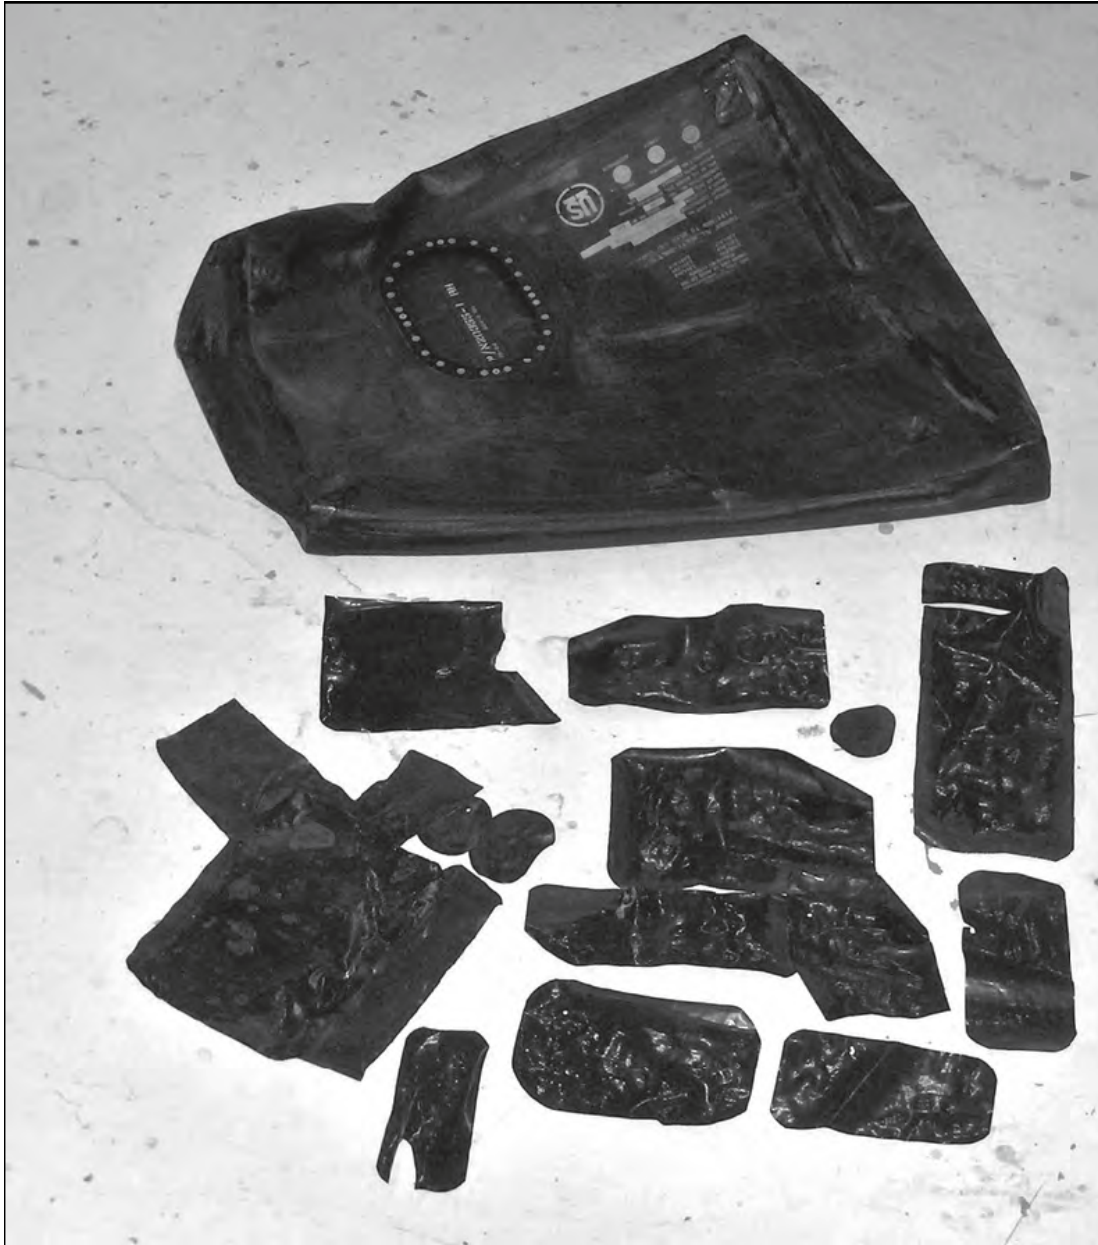
Now, it is always the top surface of a fuel cell that dries out and starts leaking. When a fuel cell is sent out to the repair facility for overhaul, they will pressure it up, find the leaks, then turn the cell inside out and cement patches onto the offending spots, pressure test again and return the fuel cell to service. In most cases, there will be several patches involved, along with multiple retests, before the last leak is repaired.

In the course of this latest inspection, our AME discovered a big patch hanging down from the top of one fuel cell. Then he checked the other fuel cell. Same thing! (We are not making this up.) So he removed the oval access plates, reached his hand inside and ran it inside the top of each fuel cell. Imagine his surprise when patches started falling off in his hand! Why these patches all choose to loosen up, more or less simultaneously, after 19-plus years is somewhat of a mystery, but is beside the point. It takes very little imagination to visualize one of these patches falling off and blocking the fuel outlet — one's bones go soft just thinking about it.

The photo shows one of the fuel cells and the fifteen patches that it contained. There were patches on the patches! The other fuel cell wasn't any different.
