January 2015, Volume 17, No. 1

TECHLINE

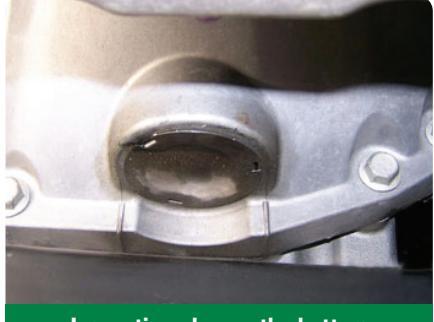
On some 2015 Colorado and Canyon models equipped with an automatic transmission (RPO MYB), what appears to be an oil drip may be found on the inspection plug on the bottom of the torque converter housing or the crossmember.

The fluid may be grease from the assembly of the transmission to the engine that has migrated to the bottom of the torque converter housing. The fluid

Inspection plug on the bottom of the torque converter.

will be much thicker than oil.

If grease is found, clean out the inspection hole and plug with degreaser and reinstall the plug. Clean any other affected surfaces.

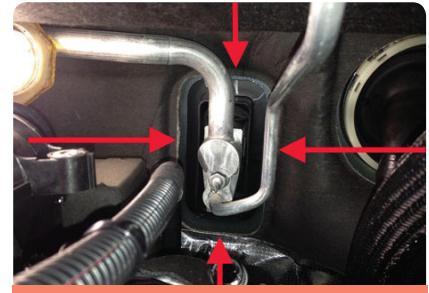
On trucks built prior to October 29, 2014, an acoustic seal may have been knocked out of place during assembly. If this acoustic seal is dislodged or missing, the High Pressure Fuel pump tick sound can be heard easily inside the cab of the truck.

Seal missing

If the seal is missing, replace it with one from Kit Part Number 23135690. Reference the Blower Upper Case Replacement section of the appropriate Service Information to assist with seal replacement.

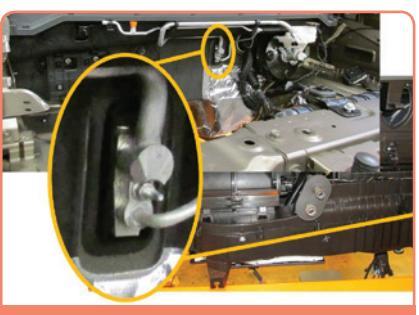
Seal present

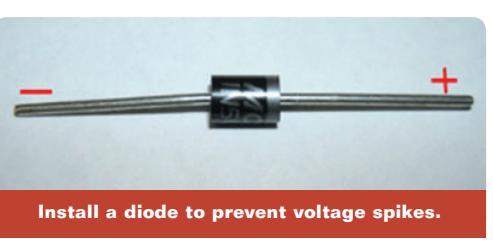
This condition may be caused by the Transfer Case Control Module (TCCM) back feeding voltage into the fuse block with the ignition off. If the TCCM is disconnected, the voltage at the fuses will be gone. If the TCCM is replaced, the issue may only be corrected for a short time. The internal circuitry of the TCCM may have been permanently damaged by a voltage spike, causing the back feed.

In most cases, the voltage spike is caused by an aftermarket accessory, which uses a solenoid or relay, that is wired onto the F30DL fuse or to the X61A I/P Junction Block connector X7, terminal 11, or connector X5, terminal 35. If these solenoids or relays are not properly suppressed, they will produce a voltage spike. The voltage spike can be transmitted onto the Run/Crank Ignition Buss Bar and permanently damage the TCCM.

Install a diode, P/N 12112422, across the coil of the solenoid. Connect the striped end of the diode to the positive terminal of the coil and connect the other end of the diode to ground. Be sure to insulate the diode with heat shrink tubing before installation. Some solenoids/relays may only have a positive post and will get their ground through the mounting bracket. In this case, the striped end of the diode is to be connected to the positive terminal and other end should be connected to the ground of the solenoid/relay.

Insulate the diode with heat shrink tubing before installation.

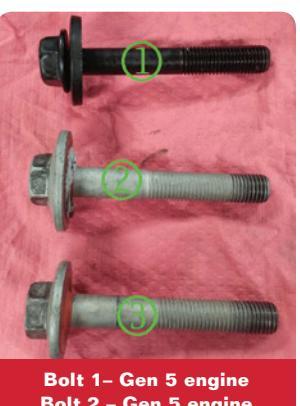
Bolt 1– Gen 5 engine Bolt 2 – Gen 5 engine Bolt 3 – Gen 4 engine

If a Gen 4 bolt is used in a Gen5 engine, it will result in an oil leak.

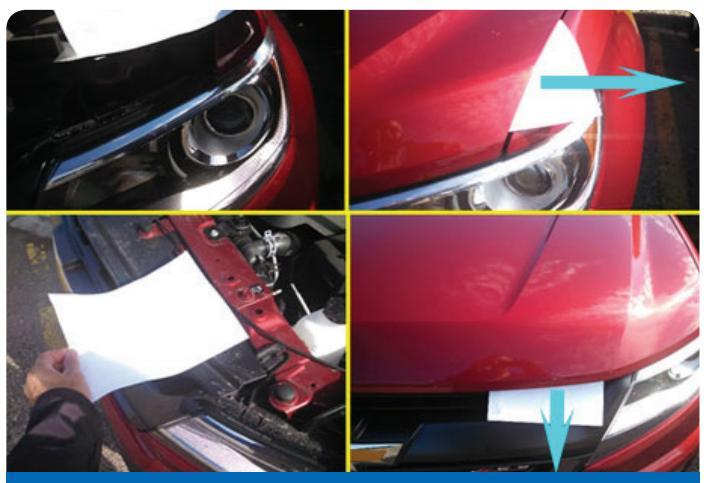
Check for proper contact of the outer and middle bumpers to the hood.

Use a piece of paper to check for proper contact of the outer and middle bumpers to the hood. The paper must not pull free when the hood is closed.

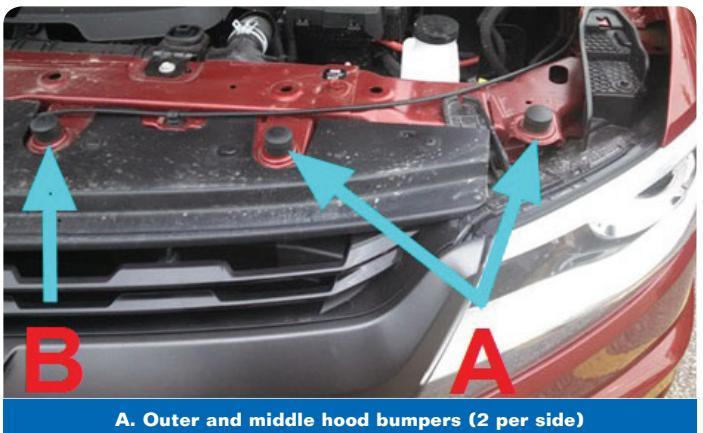
A. Outer and middle nood bumpers (2 per side)
B. Inner bumpers (one on each side of the latch)

If the paper can be pulled loose, the bumpers and latch are not properly adjusted. It will be necessary to raise the outer and middle hood bumpers (2 per side) until the hood is flush with the fenders. Set the height of the bumpers to 22 mm off of the bracket surface and repeat the paper test.

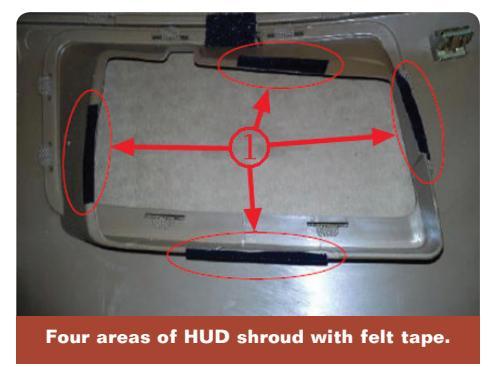
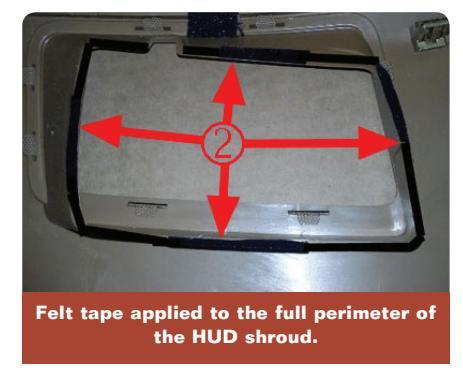
The sound may be caused by the Head-Up Display (HUD) lens rubbing on the HUD shroud. The HUD shroud is part of the upper instrument panel extension.

The HUD shroud may have four areas with felt tape installed, which is inadequate to eliminate the squeak sound.
