Outboard Transmission Diagnosis

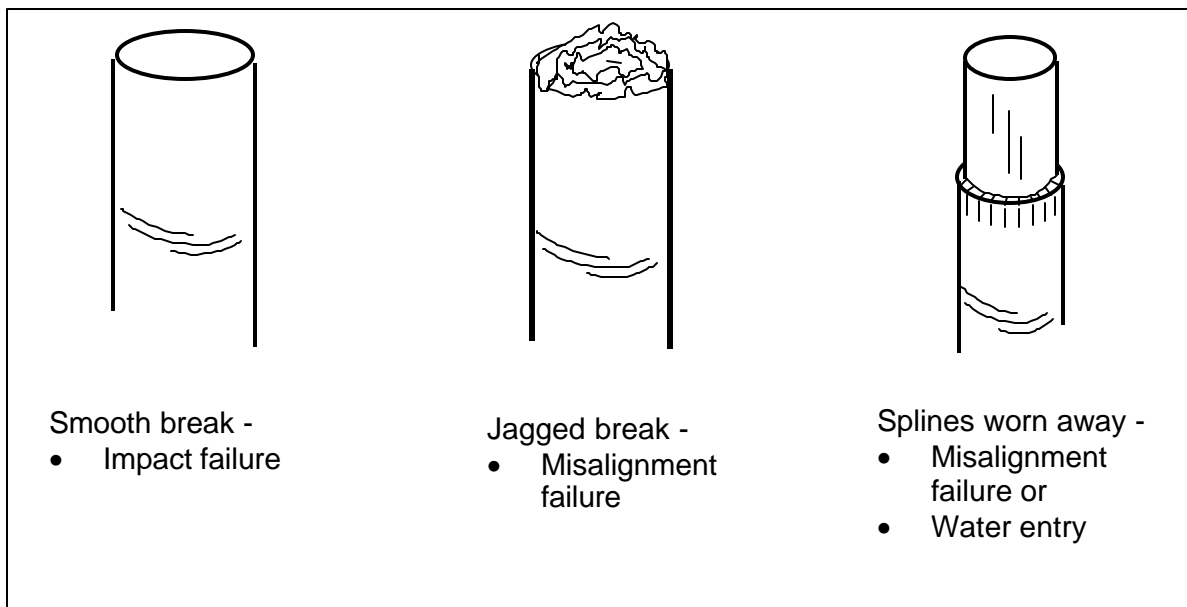
An impact failure is when one end of the rotating shaft is suddenly stopped. This leaves a very smooth break, looks rather like the shaft was cut in a lathe. Impact failure can be caused by striking an underwater object, wrapping a rope around the prop at high speed, selecting two gears at once (usually only possible with electric shift gearcases), jumping out of gear, or even a severe engine misfire. Anything that causes very sudden and high torsional loads in the shaft.

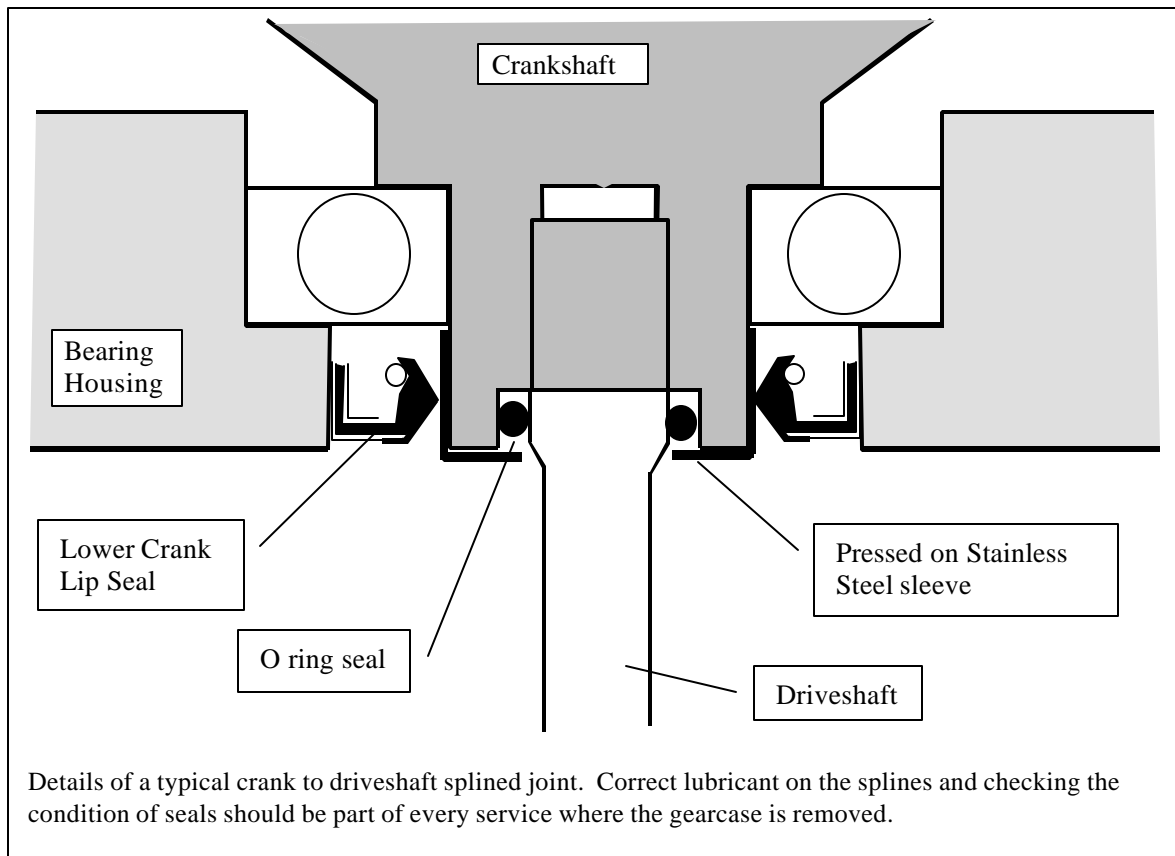
Another very similar cause of rapid spline wear is rust. This occurs where driveshafts (stainless steel) spline into crankshafts (very hard high carbon steel). If any water gets into this joint, the resulting rust on the inside of the crank splines provides a rough, abrasive surface that will then wear away the much softer stainless steel driveshaft. This area can only be lubricated when the gearcase is off the engine and most manufacturers specify a high temperature, high pressure lube like a high molybdenum content grease. However, even the best lubricant is no match for a rusty shaft if water is allowed to get in.

This splined drive to crank shaft joint is normally well above the static water line and sealed with O rings or a lip seal, so water normally has great trouble in getting in. However, if you find a rig where the static water line is too high (where you also risk getting water into the lower cylinders through the exhaust ports) or the seals are missing or damaged, then worn away driveshaft splines will be the result. When this happens you must replace BOTH shafts, to fix the problem. Replacing just the driveshaft can sometimes feel OK, but because the internal crank splines are smaller than original size (rusted away) it will only be a temporary repair.
