SERVICE EDGE

The Laser Printer Tech Quarterly
from Liberty Parts Team

Winter 2011

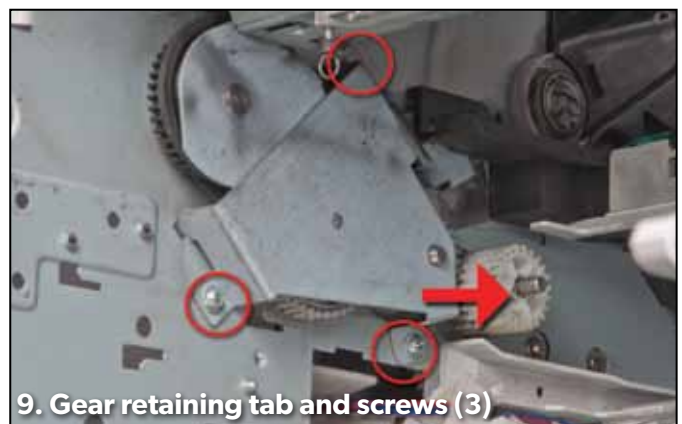
9. Gear retaining tab and screws (3)

A worn-out fuser drive gear, causing grinding noises while printing, is a very common problem in this series of printers. This gear is part of the swing plate assembly, which contains the black fuser drive gear and another white gear. Usually, you only need to replace the black gear, and this is a relatively simple procedure which is available on our website. But occasionally, both gears are worn, and then you will need to replace the entire swing plate assembly. There is no procedure for this in the service manual, so we provide one here.

14. REMOVE SWING PLATE ASSEMBLY! First, remove the white gear that overlaps the front of the assembly by pulling the small retaining tab (arrow, Fig. 9) away from the metal shaft and sliding the gear off. Then remove three screws (circles, Fig. 9) and pull the swing plate assembly out.

When re-installing the new swing plate assembly, make sure that it is mounted flush to the printer chassis, and that the swing arm moves freely.

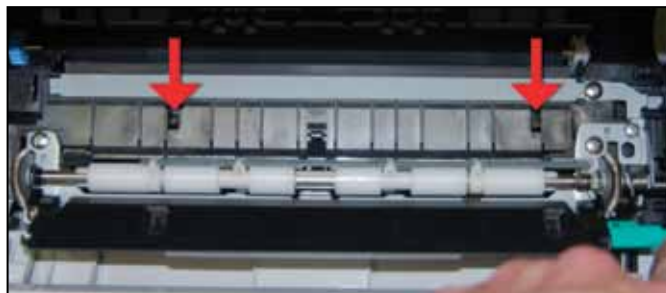
In the case of a broken left or right registration sensor flag in the 42xx/43xx family, something else happens. There are generally three sensors in the registration assembly: left, right and center. A failed central flag causes a 13 Paper Jam message. If either of the other two is broken or impeded, the control panel reads "Waiting for tray to lift," but the tray never lifts, and the "Ready" state is never reached. Note that a failed lifter mechanism would produce a 60.x error.

rection that paper would push it), and when you let it go, it should come back to the forward position. If it does not act this way, it's not positioned correctly. In almost all cases, all you have to do is reposition it.

Check the left and right registration flags.

If the actuator flag is properly positioned and operational, you should be able to push it with your finger toward the back of the printer (i.e., in the di-

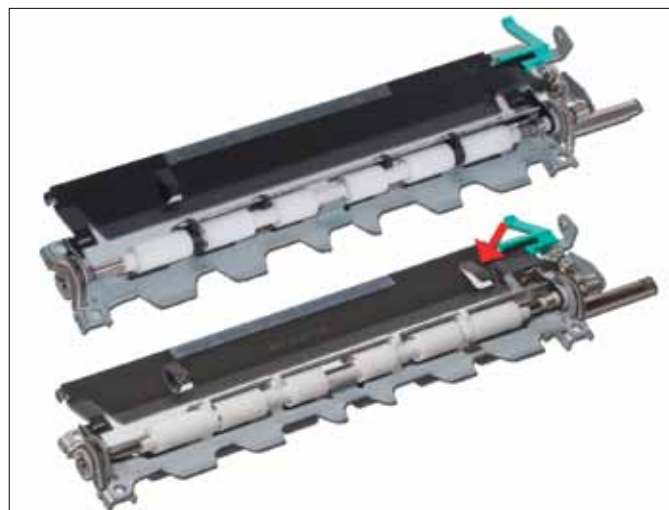
Registration and transfer assemblies of the HP LaserJet 4200/4300 and 4250/4350 families do not interchange freely. The original 4200/4300 registration assembly lacks a clearance notch for a sensor flag on the right side. This makes it incompatible with the 4250/4350 transfer assembly, which has a sensor flag on the right. *To see what happens if you combine these parts, read The Waiting for Tray to Lift error, page 8.*

REGISTRATION ASSEMBLY. On top, RM1-0011-R, the original 4200/4300 registration asm. Below, RM1-1098, showing the clearance notch that makes it compatible with 4200 and 4250 printers alike.

For a 4200 or 4300 printer, the best buy is the original registration assembly, RM1-0011-R. It is not compatible with the 4250/4350.

For 4250/4350 or for stock, RM1-1098-R is the economical choice. It is also compatible with the 4200/4300.

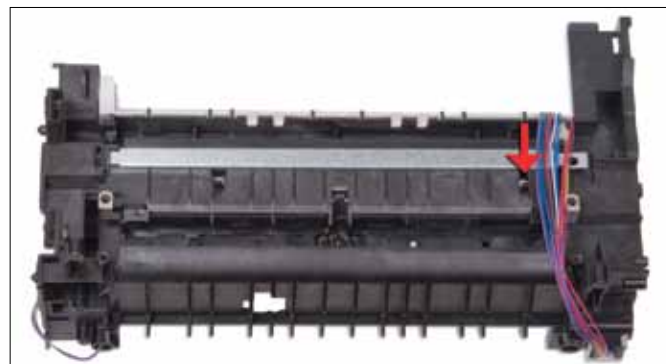
TRANSFER ASSEMBLY. Shown: RM1-0007-190-R, transfer assembly for the 4250/4250, with the additional sensor flag shown. RM1-0007-N will look similar but the extra flag will be non-functional. RM1-0007-R will be missing this flag.

For a 4200/4300, the remanufactured option is RM1-0007-R. It has a 12-wire cable harness, a 12-wire pin connector, and only three sensors. The new OEM part, RM1-0007-N, has a fourth, non-working, right-side sensor flag, so it superficially resembles the 4250 version.

For 4250/4350, RM1-0007-190-R is needed. It has four working paper sensors. Its 15-pin connector to the DC controller makes it impossible to install in a 4200 or 4300.

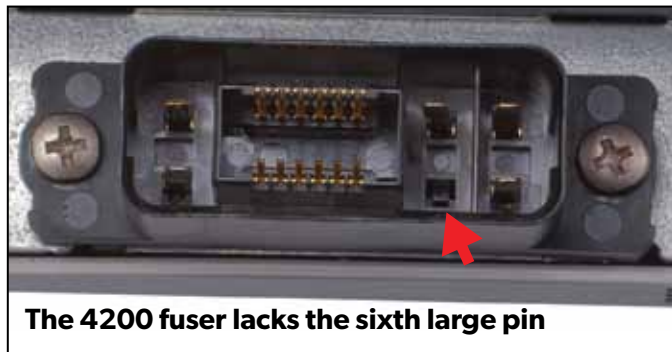
2 If there are five and not six large pins in the connector, it is a 4200 fuser. If it has six, go to three. *Note: The missing sixth pin, present in the other fusers, is for lower pressure roller bias voltage, which is not used on the 4200. Also note that upper roller is Teflon-like film in a 4200 fuser, metal otherwise.*

The 4200 fuser lacks the sixth large pin

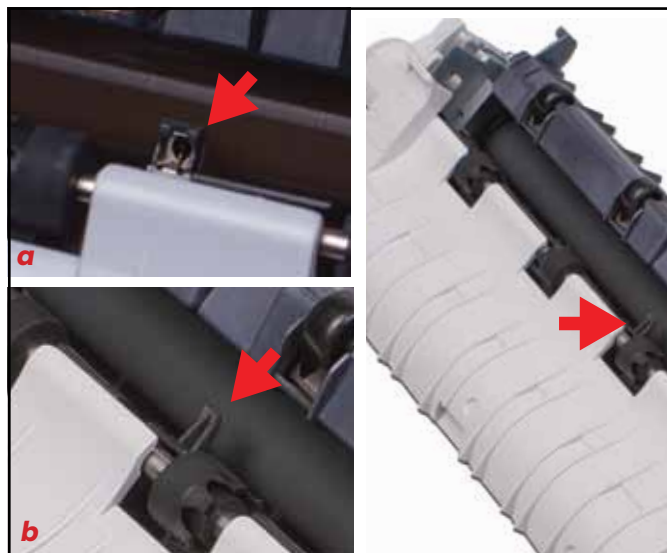
3 Lift the black delivery guide and look at the exit sensor flag in the center. The flag in the 4250/4350 fuser is unique. If the flag on your fuser matches b, go to 4.

The 4250 fuser exit sensor flag, a, is unique.

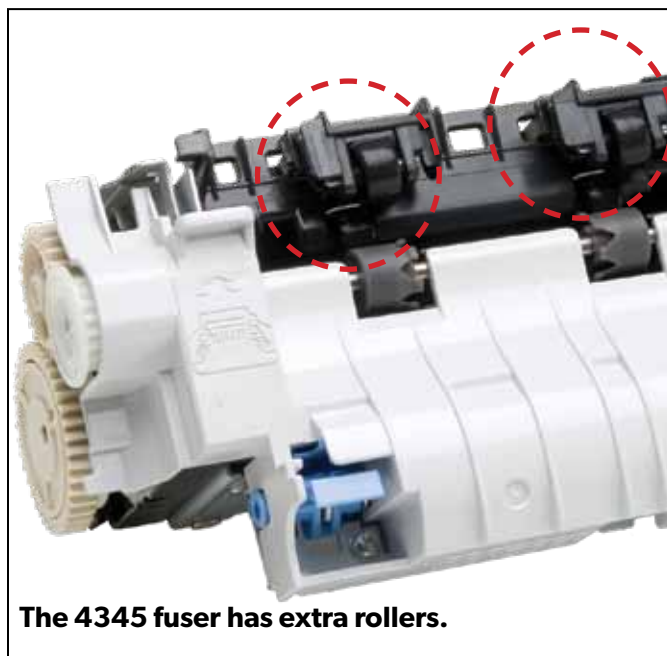
4 If the delivery guide has extra rollers, the fuser is a RM1-1043 (4345). If absent, it is RM1-0101 (4300). If the delivery guide is absent, it is difficult to tell which printer the fuser belongs to. However, this is a moot point, as these two fusers interchange.

The 4345 fuser has extra rollers.
