**PARTS
NOW!**

SERVICE TODAY

APRIL 2003, VOLUME TWELVE, NUMBER 3

LEXMARK OPTRA C720 UNLISTED ERROR CODE

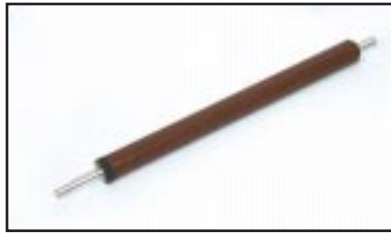
Despite the instant heating, the fixing film assembly does have drawbacks. This part can get damaged if an attempt is made to clear a paper jam with a fingernail file or a letter opener, which can put a gouge in the film on the sleeve and/or the lower pressure roller. In addition, the fixing film assembly and the lower pressure roller are sold separately—not as a whole unit.

The HP LJ 5L lower pressure roller (RF5-1516).

not. There is downward compatibility only, meaning the 6L fixing film assembly and lower pressure roller work in the 5L. There is a catch here too: both parts need to be changed at the same time.

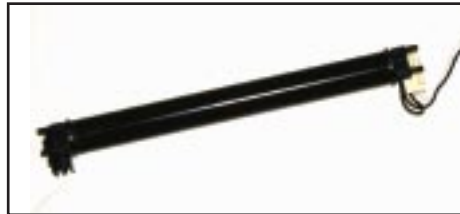
The HP LJ 5L fixing film assembly (RG5-1964).

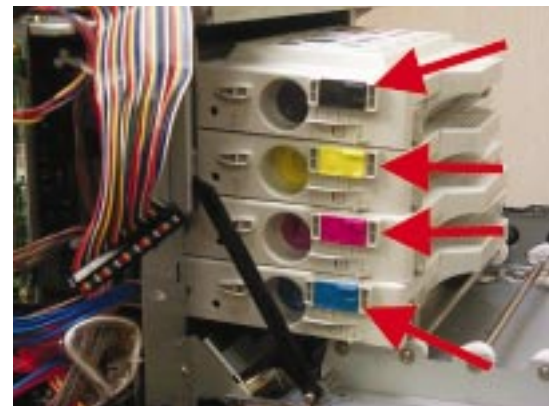
In the case of the C720, it doesn’t use the smart chip system, but instead uses a mechanical system where a colored and specifically shaped tab on the cartridge (Figure 1) trips a sensor lever or metal tab (Figure 2) that breaks a photo sensor beam in the printer (toner key sensor). When this beam is broken, it indicates to

Figure 1 - Arrows denote the toner keys.

1. Correctly re-install the toner cartridges and be sure that they are Lexmark keyed (Figure 1).
2. Bend the tabs on the left side of the cartridge out slightly (Figure 3).
3. Check the left side of the front door for proper seating, if bent too far out, the cams will not push the cartridges into the sensor (Figure

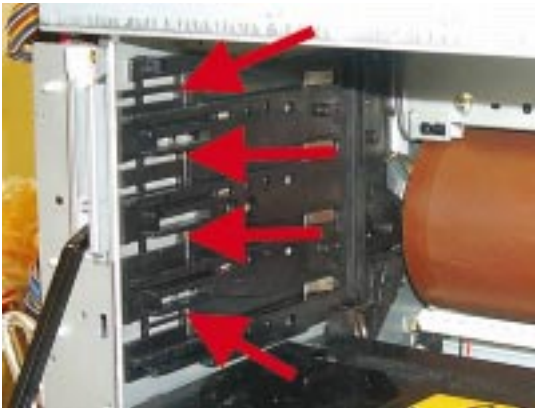
Figure 2 - Arrows denote toner key sensor tabs.

photo sensor beam is not broken because the sensor lever does not move into the beam far enough, or at the correct time.

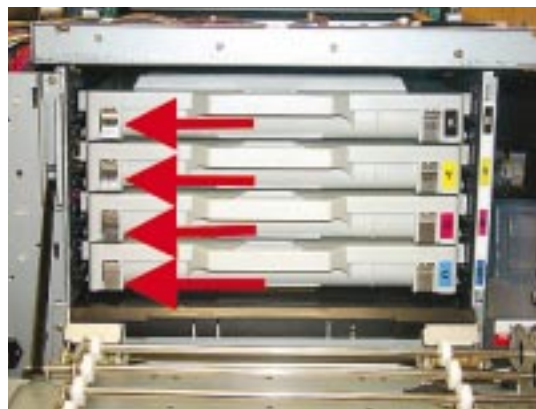
Figure 3 - Bend out toner cartridge tabs (denoted by arrows).

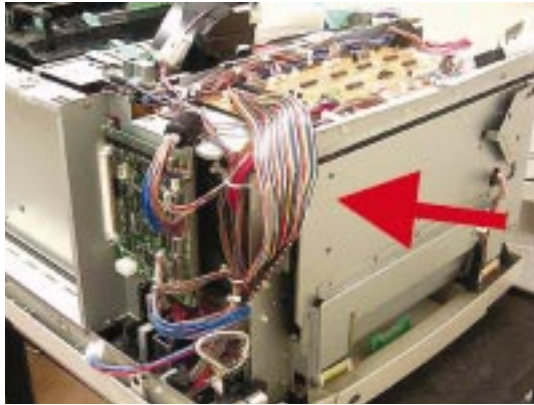
- 4). The front door or cover part number is 12G7029.
 4. Check the toner key sensor (12G7062), connection to the IOD1 connector, DCN 15 (Figure 5). Reseat the connector and replace sensor if necessary.
 5. If all else checks OK, replace the toner key sensor. A common failure is the metal hinge will be bent (Figure 6). Note: This has been prevented in an EC (engineering
- (CONTINUED ON NEXT PAGE)

Figure 4 - Arrow denotes possible bent front door.

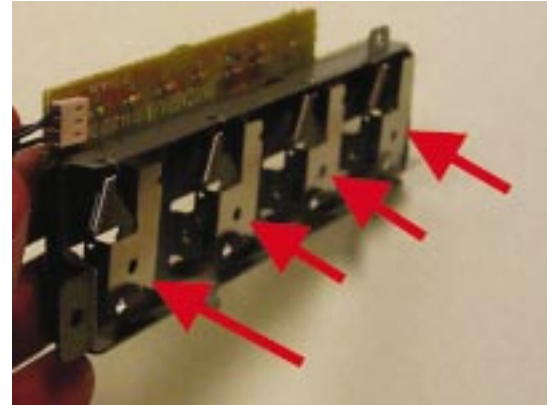
Figure 6 - Arrows denote toner key sensor tabs that bend.

change) on current production printers. See Figure 7 for the location of the toner key sensor assembly.

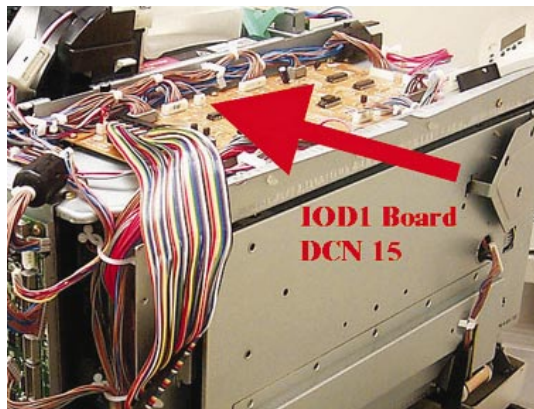
Figure 5 - Connector DCN 15

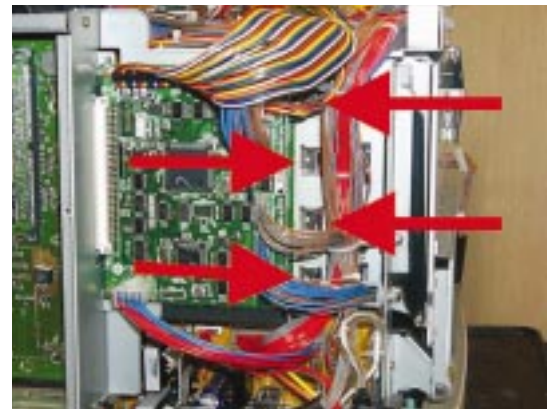
Figure 7 - Arrows denote toner key sensor assembly installed.

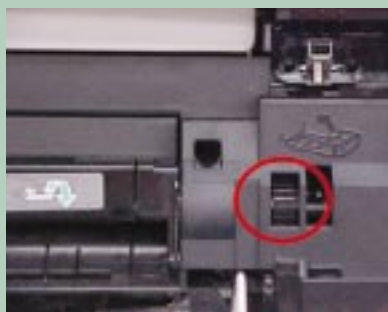
This difference is reflected in the tray 1 pickup assemblies. The 4000/4050 pickup assembly has a cutout in the plastic housing, just below and to the left of the envelope feeder connector. The gear that protrudes through this cutout is what drives the envelope feeder. The 4100 pickup assembly has this gear, but no cutout—because the 4100 envelope feeder doesn't need it.

Figure 1: The HP LJ 4000/4050, with gear circled.

So, if you never used an envelope feeder, these assemblies would be completely interchangeable. But if you do use an envelope feeder, you need to have the correct pickup assembly in your printer. In particular, the 4000/4050 envelope feeder will not work with the 4100 pickup assembly because there is no way for it to get the mechanical coupling that it requires.

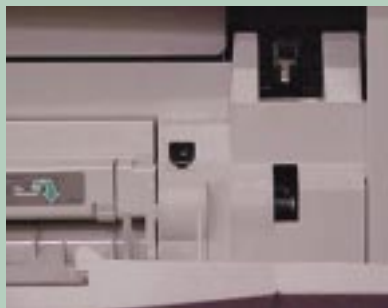
Figure 2 - The HP LJ 4100, with no exposed gear.

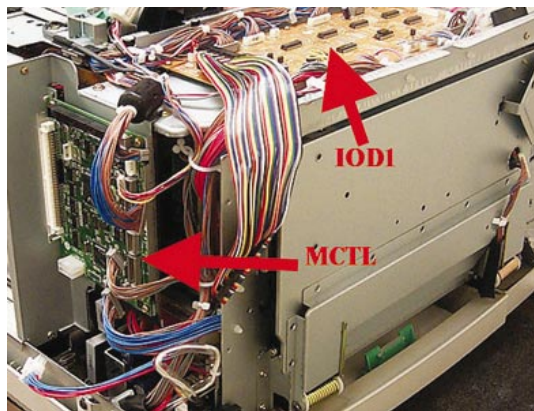
Figure 8 - Arrows denote IOD1 and MCTL boards, as labeled.

6. If the previous steps did not fix the problem, only then replace the IOD1 board, (12G7064) and the MCTL card, (12G7030) as necessary (Figure 8).

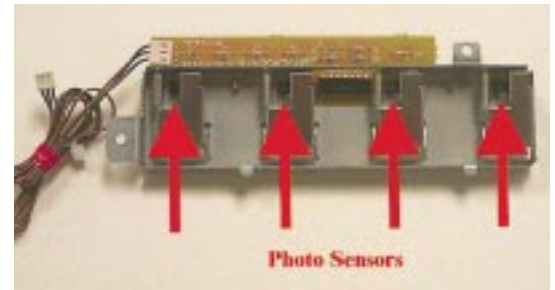
1. Referring to item 5 above—Along with the possibility of the metal hinge (or tab) bending, there is also the possibility that one of the photo sensors on the toner key

Figure 9 - Arrows denote photo sensors on toner key sensor assembly.

sensor assembly could be inoperative (Figure 9).

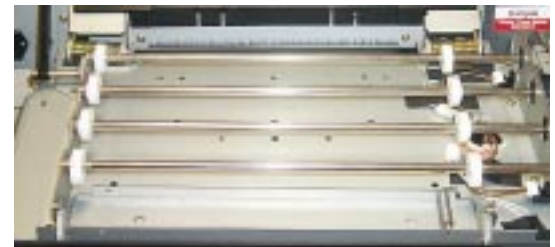
Figure 10 - Front door or cover assembly.

2. Referring to item 3 above. If the cam drive mechanism, clutches, solenoids or one of the home sensors is inoperative, this will cause improper sequencing of the cartridges. If the cartridges don't indicate engagement when they are supposed to, the machine assumes an improper cartridge is installed. So, replacement of the entire door assembly is another possible fix for this problem (Figure 10).
