# E020 Error Code Workflow

- In an effort to assist the field troubleshooting E020 Error Codes, Canon U.S.A., Inc. is introducing this imagePRESS C1 Series E020 Workflow Course. The workflow includes links to valuable information, including error code definitions, theory, practical fixes, and most importantly direction on how to troubleshoot various E020 Error Codes.

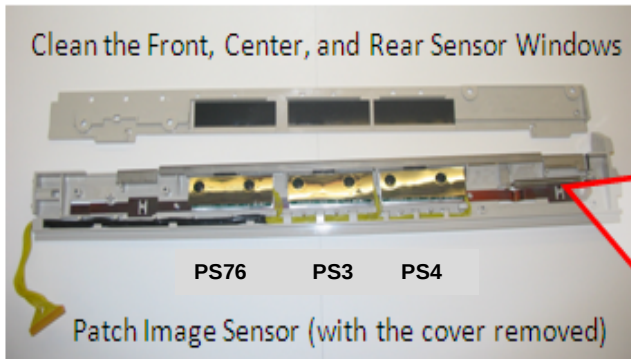
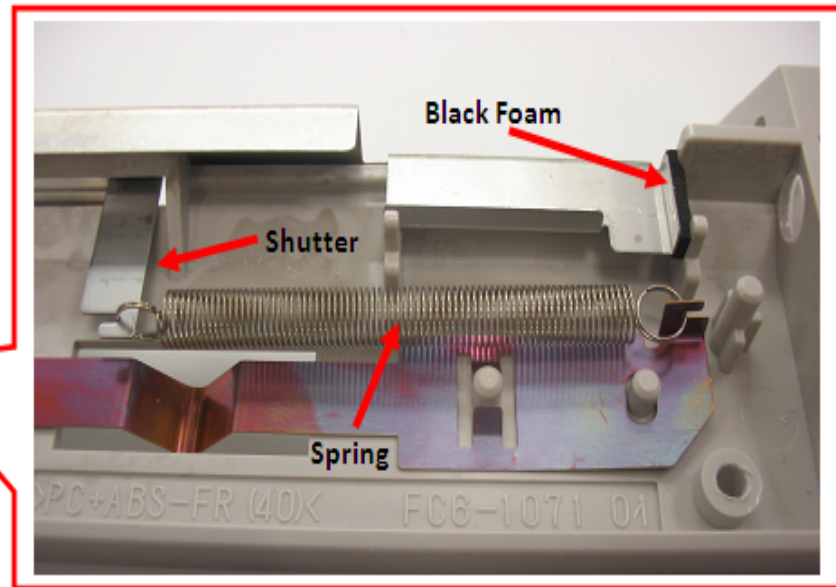
Check the Shutter, the Spring, and the Black Foam for wear and replace the Shutter or the entire Sensor if necessary.

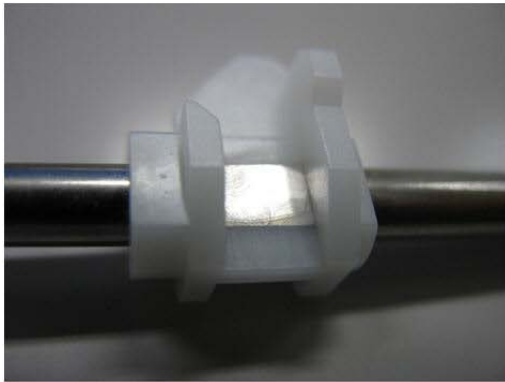
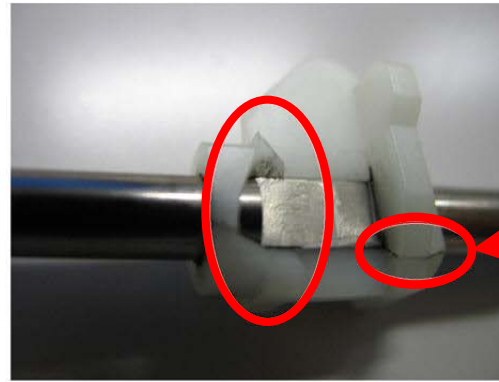
- Check the operation of the Patch Image Sensor Solenoid (SL8) using the Part Check Function in Service Mode. After enabling the Solenoid in Service Mode, it's operation can be verified by listening for clicks made by the activation and deactivation of the component (same as the ATR Sensor on page 15).
- Check the Patch Image Sensor Shutter to make sure it moves freely and that the Front, Center, and Rear Sensors, and the Sensor Windows are clean.
- Inspect the Slide Rod (FC6-1043-010) for damage.

Broken Slide Rod
