## SERVICINGMANUAL

## ZX SPECTRUM®

ZX Spectrum Block Diagram	1.1
Expansion RAM RAS/CAS Timing (Read Cycle shown)	1.2
Keyboard Matrix Interconnections	1.3
ZX Spectrum (Issue 2) Circuit Diagram	1.4
ZX Spectrum (Issue 3) Circuit Diagram	1.5
Keyboard Format	4.1
Speaker Load Input Waveforms	4.2
Expansion Memory 1C Locations	4.3
Issue 3 Links vs 1C Manufacturer and Type	4.4
Printed Circuit Board (Issue 2) Component Layout	5.1
Printed Circuit Board (Issue 3) Component Layout	5.2
Printed Circuit Board (Issue 3B) Component Layout	5.3
Prepared by THORN (EMI) DATATECH LTD for SINCLAIR RESEARCH LTD	MARCH 1984

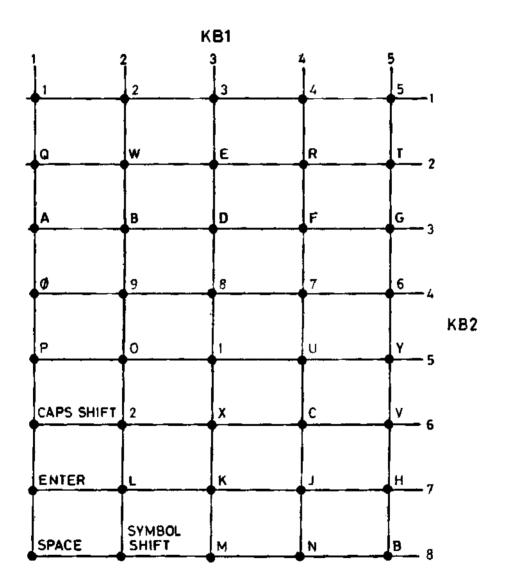
FIGURE 4.1 KEYBOARD FORMAT

fault is with KB2 circuitry or the 8-way membrane, and that if any block of eight keys fail the fault is with KB1 circuitry or the 5-way membrane. Possible keyboard faults are listed in paragraph 2.6

It is recommended that keyboards are better replaced completely since they take a lot of battering and replacement is guite inexpensive. If it is decided that the keyboard is worth repairing then the diagram will show which tail is faulty according to keys in error.

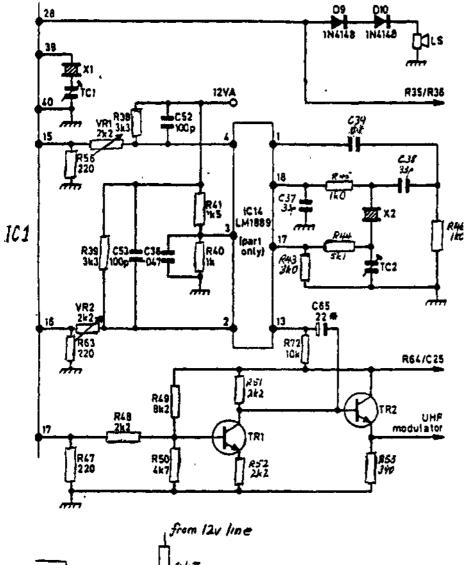
Early circuit showing presets Td, TC2, VRl and VR2 to match the early type boards.

Note:- the different pins 16/17 setup from Id in the generalised circuit diagram shown in the middle pages.
