SERVICE EDGE

The Laser Printer Tech Quarterly
from Liberty Parts Team

Fall 2012

HP CP6015, CM6030/40 “Internal Door 2 Open” Error

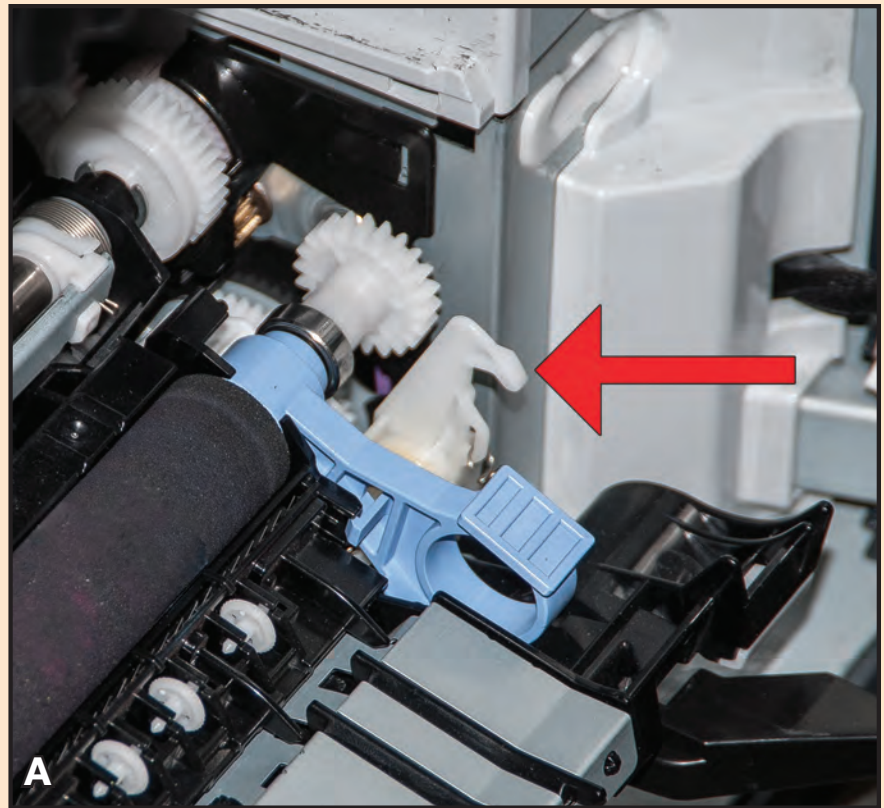
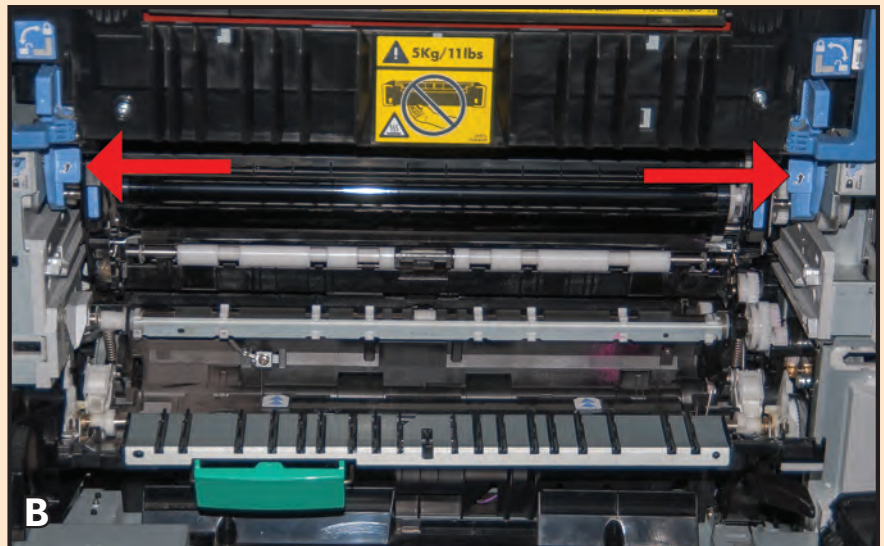
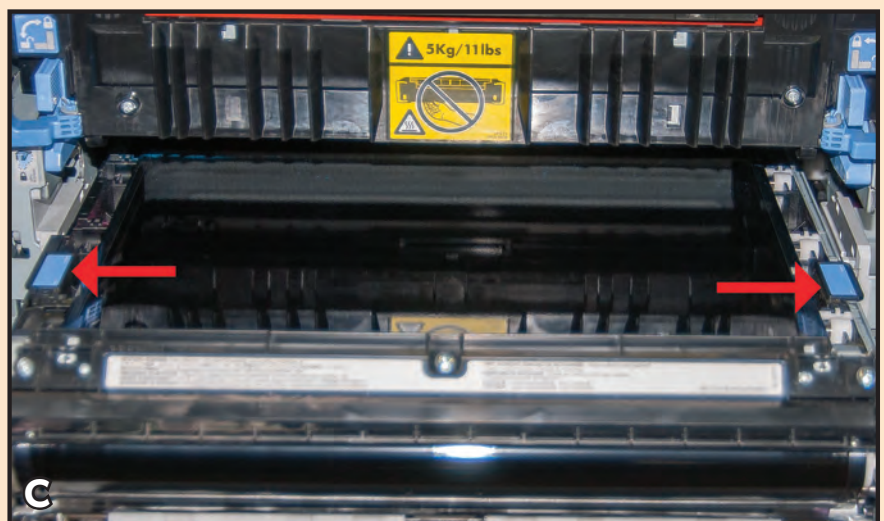
The “Internal Door 2 Open” error in these printer models occurs when the secondary transfer assembly does not latch properly, usually because one of the latching hooks is broken (Fig. A). The hook on the right side is more likely to break, because that is the drive side and gets much more stress. Either way, the solution is to replace the entire secondary transfer assembly (part number Q3931-67909), since the individual hooks are not available. Certain error codes (54.0E.03 on the CP6015, or 54.05.11 on the CM6030/6040) may also require replacement of this assembly. This article will show you how to remove and replace the secondary transfer assembly.

1. Remove the Transfer Roller.

- Open the right door, and then open the transfer assembly by lifting the green handle and pulling toward you.
- Remove the transfer roller by grasping the blue handles and pulling toward you (to re-install it, just line up the arrows on the roller housing with those on the transfer assembly, and push it in until it seats).

2. Remove the Intermediate Transfer Belt (ITB).

- Warning: the ITB...
 - is heavy (about 15 lbs);
 - is susceptible, like the transfer roller, to damage from skin oils; use the handles;
 - is easily scratched, so store it in a safe place while it is out of the printer.

- b. Raise the ITB levers (Fig. B), then grasp the small blue handles and pull the ITB partway out.
- c. Use the larger blue handles on the sides (Fig. C) to pull it the rest of the way out. Make sure the levers are up when re-installing it.

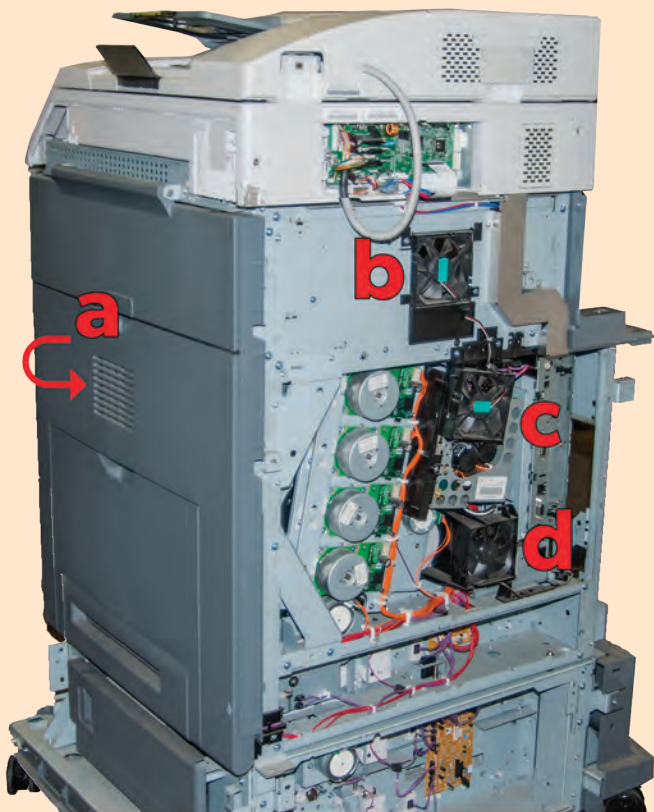
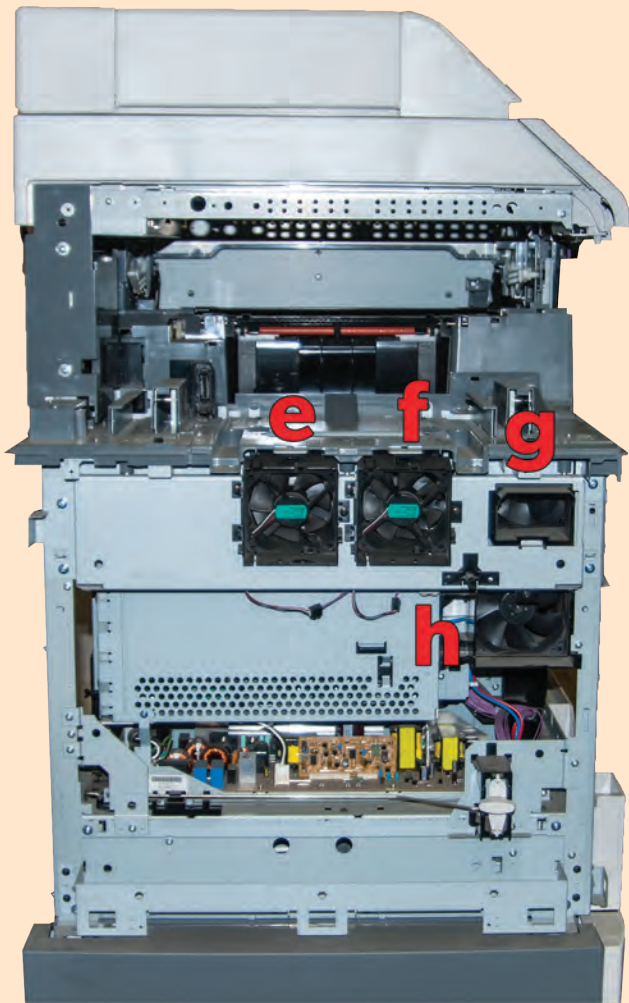
Large printers have a lot of fans. The HP CLJ 4700 family has nine, if you include the one in the optional duplexer.

As with all Laserjets, if a fan fails, the control panel displays a 57.xx code to tell you which fan has failed. One consults the Control Panel Messages section of the service manual to see which fan is indicated by the code. In this case, there is a problem: there is no easy way to tell which fan to order. For example, the 57.06 error is associated with "Control Fan 2," wherever that might be. The part number lists are of little use because all fans are described simply as "Fan."

Code	Ltr	Part #	Location
57.01	g	RM1-2178 [fan and duct asm]	Delivery
57.03	c	RK2-0621	Sub-power supply
57.04	h	RK2-0623	Cartridge
57.05 or 57.05A	*	RK2-0648	Duplexer fan (*not shown, above fuser, below scanner/ADF)
57.06	f	RK2-0621	"Control 2"
57.07	e	RK2-0621	"Control 1"
57.08	a	RK2-0622	ETB
57.09	b	RK2-0621	Fuser
57.0A	d	RK2-0622	Power supply

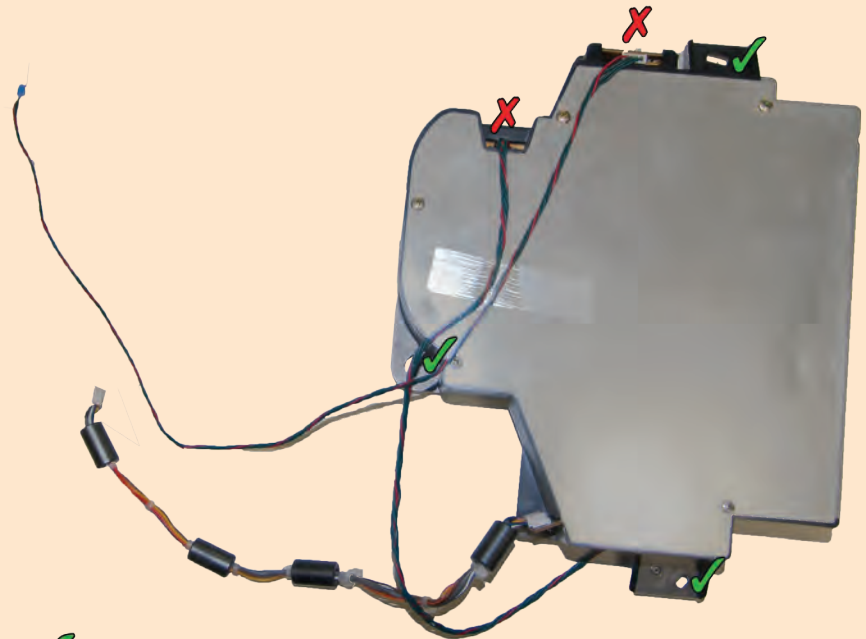
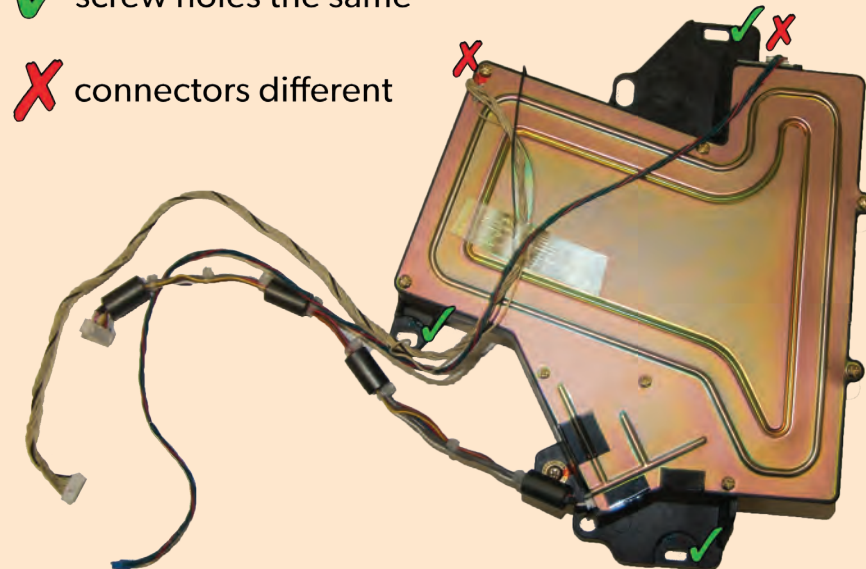
Some T-series printers have print-heads in two radically different versions. In the case of the T630 (56P1396) there are difference in color and cable location that have prompted customers to try to return their replacement. A clue that all is well is the screw holes, which match perfectly.

✓ screw holes the same

✗ connectors different

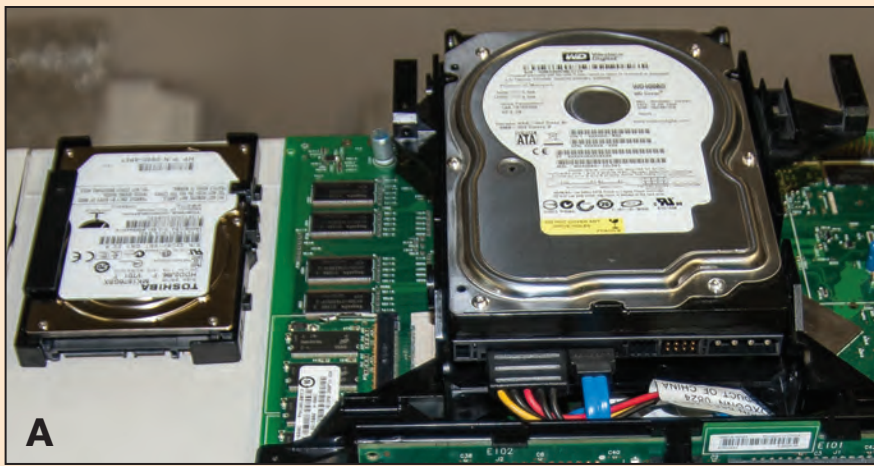
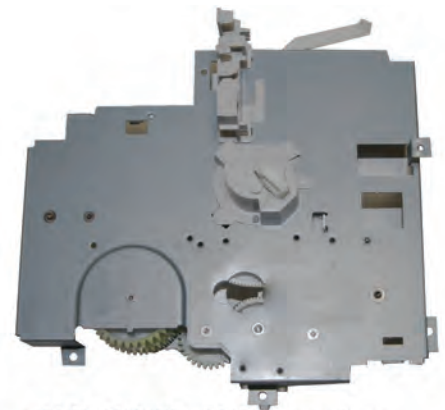
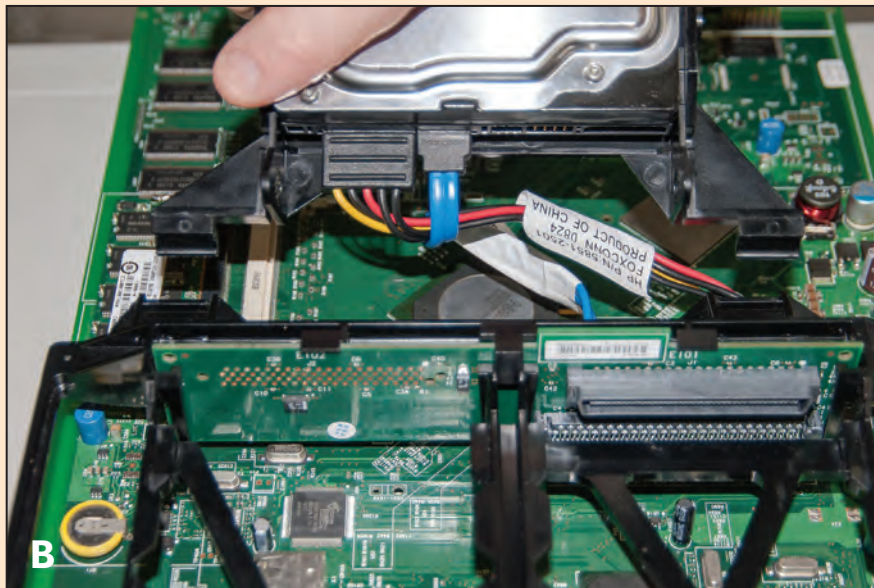
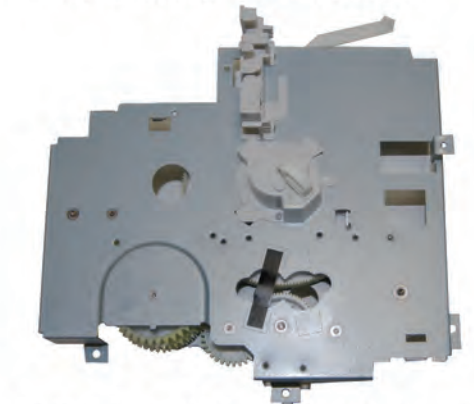
RM1-0001, 4200 version

Sometimes merely a slight difference is alarming. The original main drive assembly for the LJ 4200 was replaced by a version compatible with the 4300. Since the cartridge motor attached in a different location, a second mount hole was added, which overlapped with the original. One of the holes is covered with tape, depending on the model, allowing the customer to remove it if necessary.

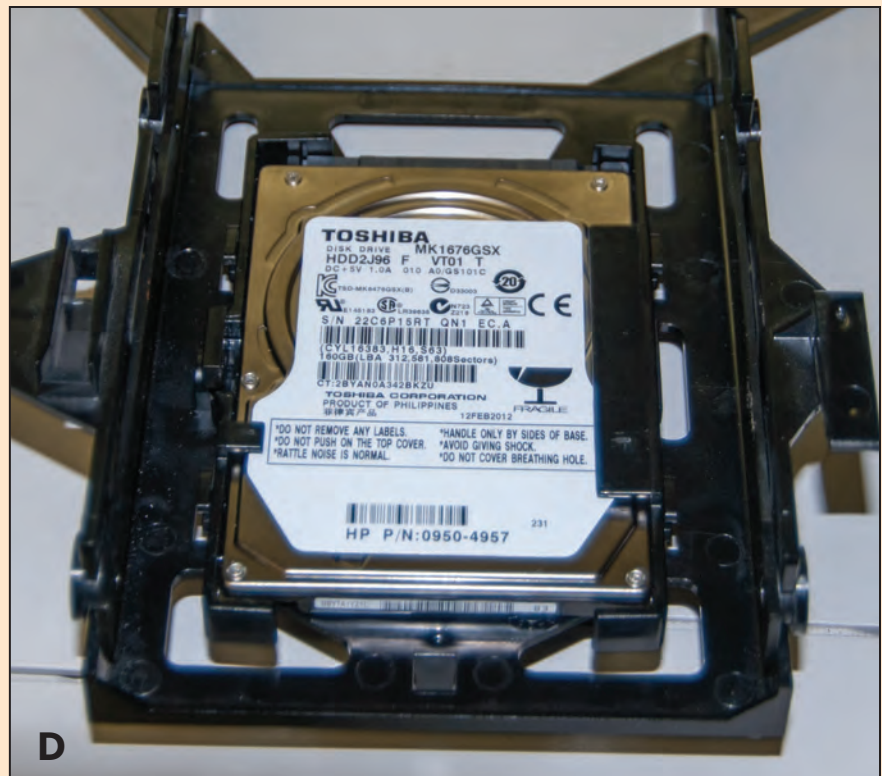
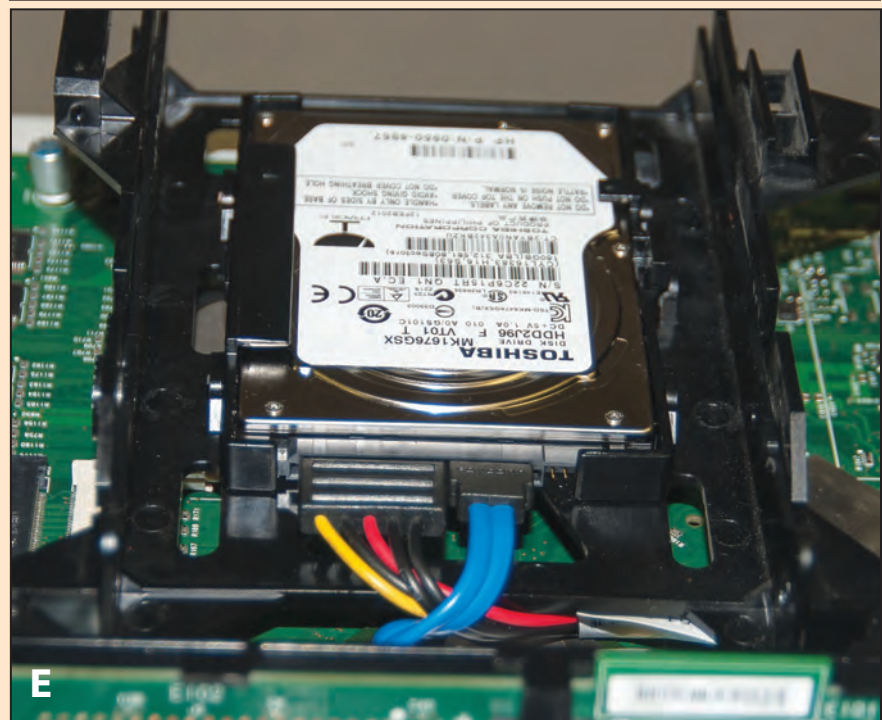
Careful comparison will generally yield a clue to the compatibility of the two parts. Fig. A shows a 3.5 inch hard drive (Q3938-67961) installed on a CM6030/CM6040 formatter. The smaller hard drive to its left is its 2.5 inch replacement (Q3938-67985). If you'd been sent this skinny hard drive, you'd certainly suspect some sort of mistake. However, note the two connectors on the replacement. They seem to match

1. First, disengage the bracket by rotating the free end of the hard drive up away from the formatter, and then lifting (Fig. B). Then unplug the two cables.

2. To remove the hard drive itself from the bracket, you need to remove 4 screws, two on each side. It is possible that different brackets may use different types of screws. On our test bed, they were Allen-head screws, and we used a 7/64-inch Allen wrench (or hex key) to remove them. Once the screws are out, you can lift the hard drive out of the bracket.

3. The smaller hard drive clips into four retainers on the bottom of the bracket. Line up the hard drive and bracket as shown in Fig. C, making sure that the connectors are facing away from you, and then slide the hard drive into the bracket until it locks in. When finished, it should look like Fig. D.

4. Finally, plug the cables into the connectors on the new hard drive, and re-mount the bracket to the formatter. Fig. E shows the smaller hard drive completely installed.
