# SERVICE EDGE

The Laser Printer Tech Quarterly  
from Liberty Parts Team

**Spring 2015**

# STILL WAITING

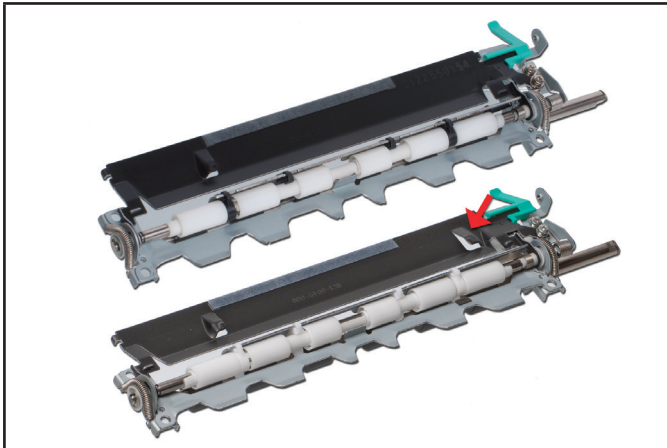
On top, RM1-0011-R, the original 4200/4300 registration assembly. Below, RM1-1098, the 4250/4350 registration assembly, with the additional clearance notch indicated.

The paper width sensors operate through clearance notches in the registration assembly. The LJ 4200 and 4300 have one paper width sensor and their registration assembly has one corresponding notch. The 4250/4350/4345 have two paper width sensors and two clearance notches in the registration. Putting the one-notch 4200 registration assembly in a two-sensor printer blocks a sensor and will cause **WAITING FOR TRAY TO LIFT** to appear at startup.

### 1. CHECK IF WRONG REGISTRATION ASSEMBLY IS INSTALLED

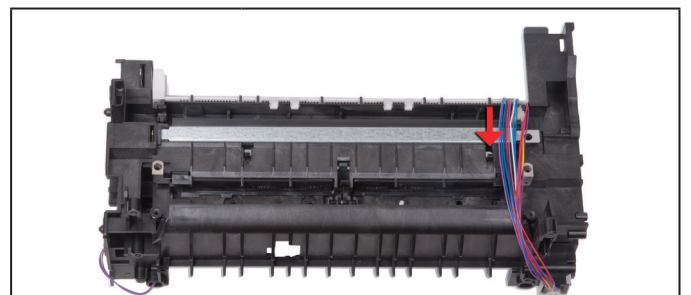
RM1-0007-190-R, transfer block assembly for the 4250/4250 & 4345, with the right sensor flag shown. Don't buy a 4200 version by mistake: RM1-0007-N will look similar but the right flag will be nonfunctional. RM1-0007-R will be missing this flag.

If all else fails you will need to replace the transfer block assembly. Download the appropriate article from our website, [lbrty.com](http://lbrty.com), and make sure you order the correct part. The correct part is **RM1-0007-190**, NOT RM1-0007.
