ELECTROLUX HOME PRODUCTS NORTH AMERICA

2003 Technical Training Manual

2003 Technical Training Manual Table of Contents

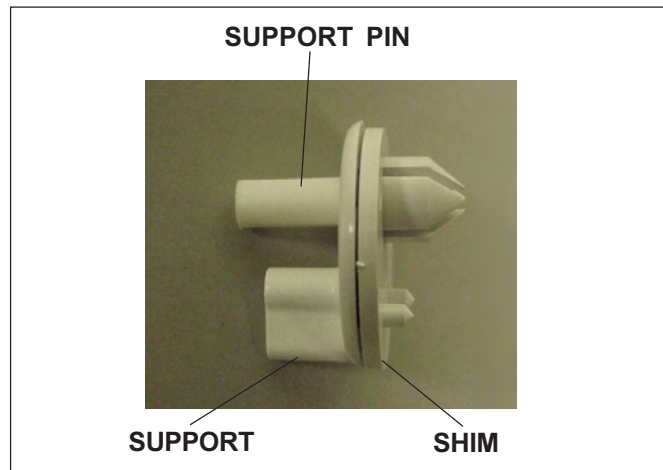
4. Problem: The crisper cover is falling down on Next Gen SxS refrigerators.

Solution: Install a shim (p/n 240523101). To install the shim, remove the crisper cover. Using a punch push the pin in the support through the support (see illustration below). Remove the front crisper cover supports and place shim over support as shown in figure 1. Reinstall the support with the pin out, then install the pin until it is flush with the front of the support. Reinstall the crisper cover.

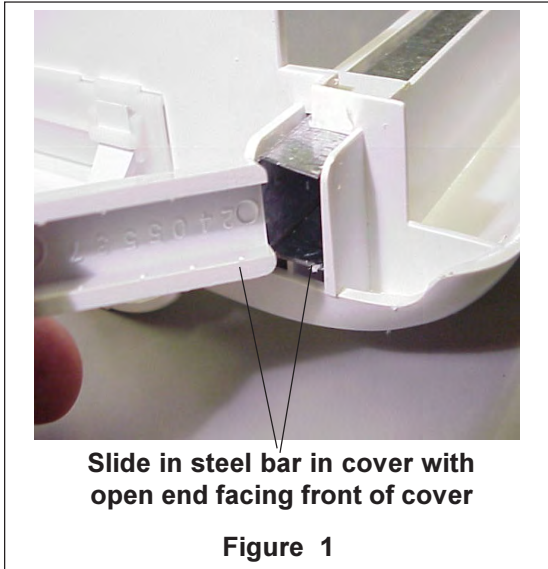
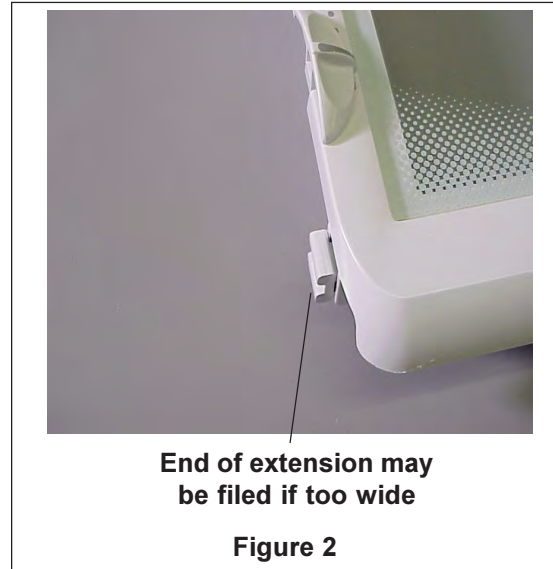
6. Problem: Crisper cover will not stay on support in Top Mount refrigerators.
 Solution: Order and install two cover extensions (p/n 240553701), one for each side of the crisper cover. Remove the cover and slide the extensions into the steel support running through the front of the cover (see Figure 1). Push the extension in with the open end toward the front until it rests against the cover (see Figure 2). The extensions may be filed off if they are too wide and cover will not fit in product.

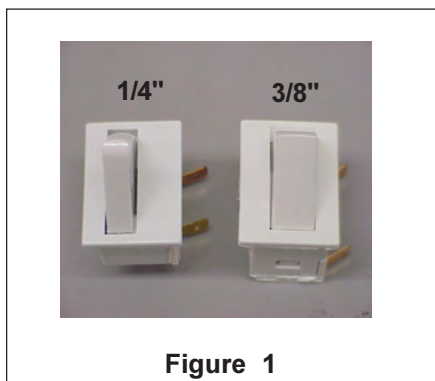
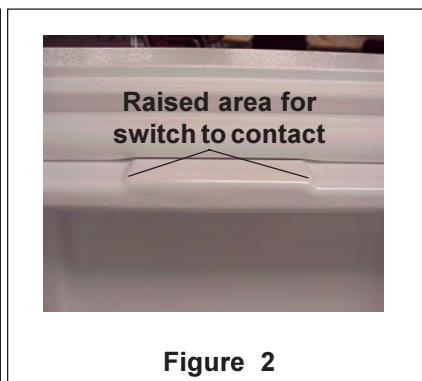
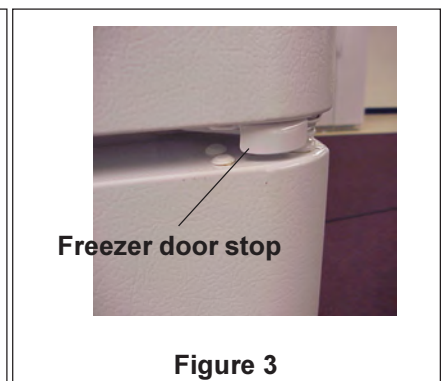
7. Problem: The food compartment light switch is catching on the inner door panel of Next Gen Top Mount refrigerators.
 Solution: First check to see if the unit has the new light switch installed (see Figure 1 below). The new switch has a 3/8" wide actuator, the original switch had a 1/4" wide actuator. There is now a raised area added to the inner door panel to add additional surface for the switch actuator to make contact (see Figure 2 below). The raised area was added between January and May 2002, one production line at a time. In some cases the food door may need to be raised, this can be accomplished by adding a nylon washer or washers (p/n 240311301) to the post at the bottom food door hinge. Use caution when adding over 2 washers because the food door could start to make contact with the door stop on the freezer door (see Figure 3 below). Contact with the door stop can cause damage to the top of the food door. If over two washers are needed to be added, you will also need to add a washer to the bottom freezer door hinge pin to raise the freezer door.

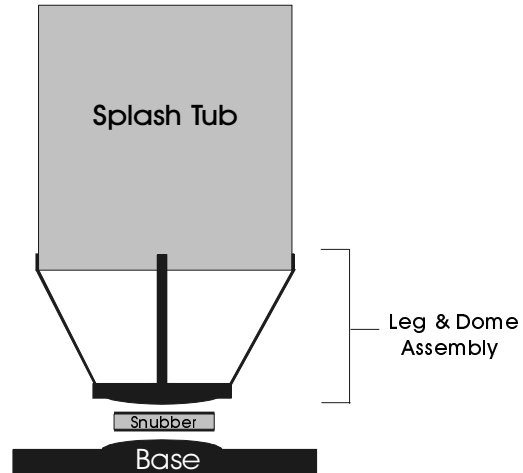
6. Problem: Very irritating squealing sound when top load washer is spinning or coasting to a stop after the spin cycle.

* The snubber is a ring that is located between the convex (domed up) center portion of the base and the domed down center portion of the leg & dome assembly. It has teflon strips at the top and bottom edges that slide easily on the base as well as the underside of the leg and dome assembly. This system makes the machine very stable by providing isolation between the leg & dome assembly, which carries both the inner and outer tubs, as well as the main motor and transmission and the base; which is of course connected to the cabinet. This means that the machine is capable of spinning out of balance loads that washers made by other manufacturers cannot.

* As simple as this system is, if one of the strips is bent or there is some foreign material on the base in the snubber area, the result can be an extremely obnoxious scratching or squealing sound. A very similar sound can be produced when the belt is worn but the difference is that a snubber noise can be produced during the spin cycle or when the cycle has finished and the spin tub is coasting to a stop. A worn belt noise can only be produced while the motor is actively engaged in spinning the spin tub. If it is discovered that the belt is worn and the base has black, shredded belt residue then it may not be necessary to clean the snubber area (belt residue generally will not cause a problem with the snubber). It will be necessary however, to find the cause of the belt failure.

Solution: If snubber is dirty with foreign material (sand/dust or grit), clean the base. If the snubber is damaged, replace it.

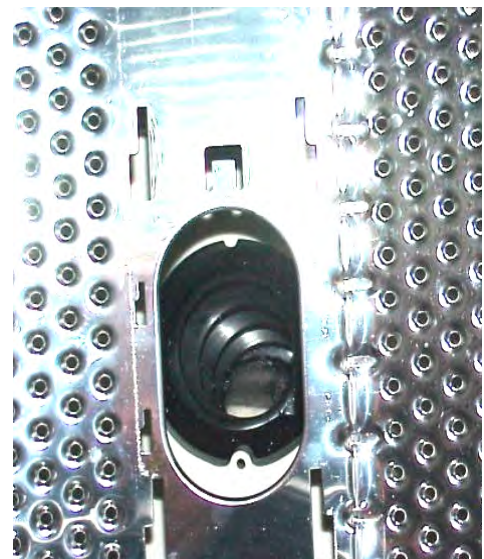
* To check to see if this is happening, one of the vanes must be removed to gain (limited) access. The only vane that can be removed is the vane that is located on top of the seam of the inner tub. In production, the drum consists of a rectangular piece of stainless steel that is rolled into a cylinder shape and seamed together. Locate the vane on the seam and remove the two screws to the right side of it. Pull back (toward you) on the vane and swing it to the left and remove. By turning the spin drum, the area between the tubs can be accessed. The picture on the right shows the view of the drain trap from under the vane. If this is the source of the odor, you will observe the inner ridges of this drain trap to be covered with thick, globs of fabric softener. If this is the case, a bottle brush (or a condenser coil brush) can be used to clean it out. (For more information on odor complaints, see Service Bulletin Vol. 99, Issue #8, page 33.)

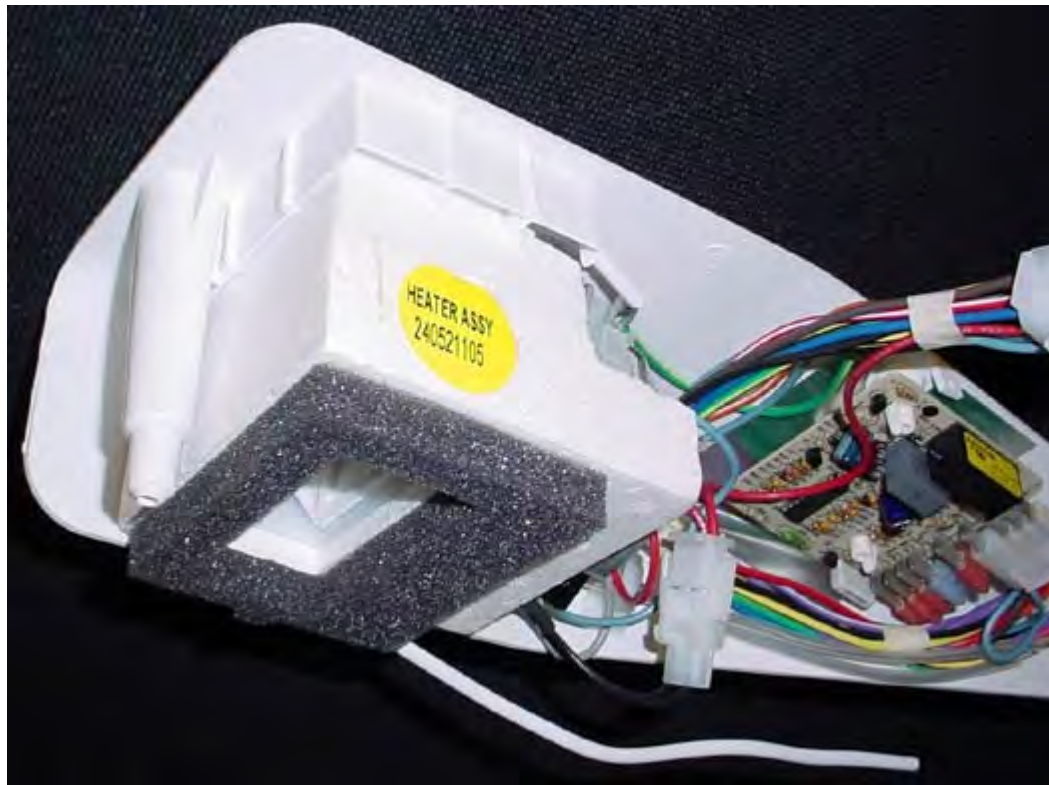
PROBLEM: Control box kit 5303918282 doesn't have the damper heater.

SOLUTION: All 5303918282 control box kits are being subbed to part number 5303918283. A running change has been made to the 5303918282 damper kit by adding the damper heater assembly to the kit. Some shipments of the 5303918282 control box kits were delivered with the heater assembly installed and some without. Please examine your current stock of the 5303918282 to determine if your kits contain the required heater. Check for a yellow sticker that says HEATER ASSY as indicated in the photo below. The damper heater is not available through the parts department as a separate part for the older 5303918282 kits. It is a difficult job and should be installed at the factory. However, if you feel you are capable of installing the damper heater, contact the Tech Line and they can ship you the heater.

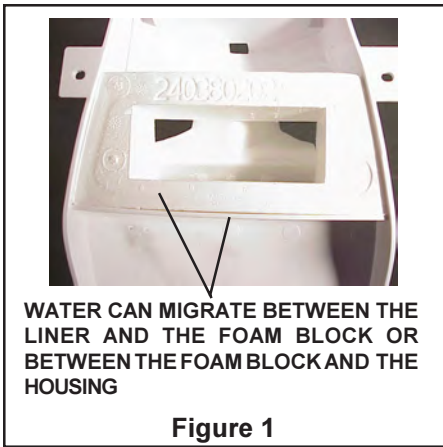
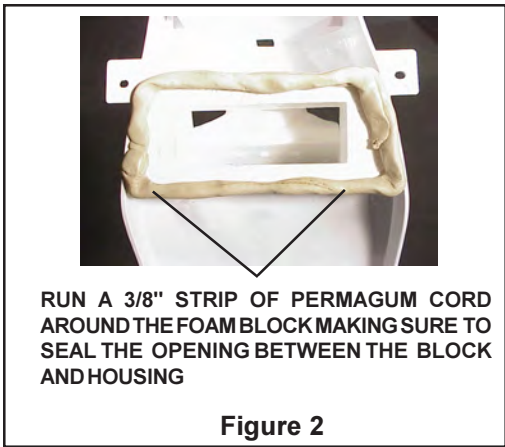
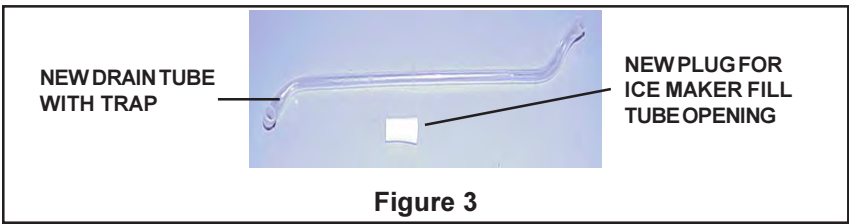
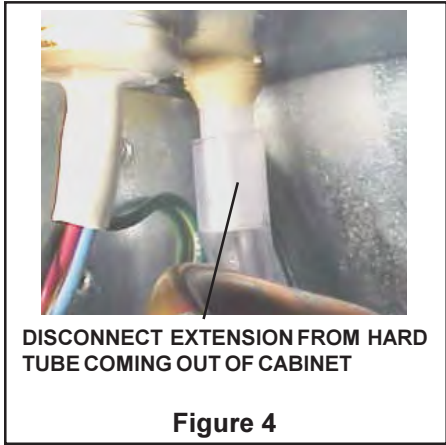
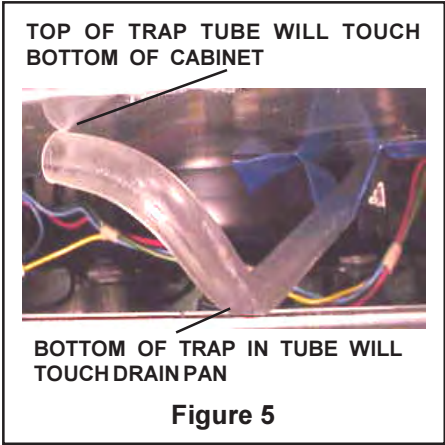
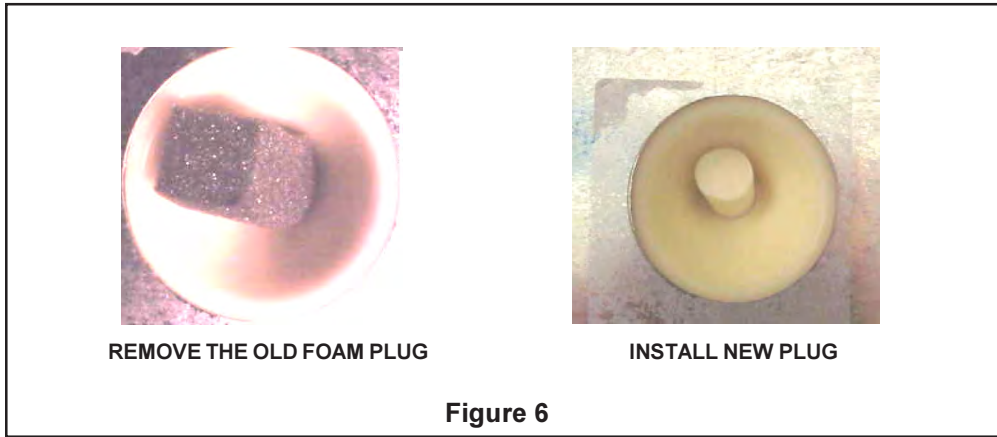
PROBLEM: Frost and ice beads are forming on the evaporator cover of Top Mount Refrigerator models.

CAUSE: Frost will form from air leaks or a door left open. Also, large amount of frost may form from heavy use in a high humidity environment.

Frost collecting inside of the air duct in front of the fan cover can be caused by air leaking into the cabinet. This can come from the door seals, ice maker fill tube, and if the cabinet is not well sealed; it can come up the defrost water drain. There is now a kit, part number 5303918285, that has a new seal for the ice maker fill tube opening (only used on products without an ice maker) and a new drain trap extension that has a trap in it to hold water. (See Figures 3,4, 5, and 6 on next page.) This kit can be used to correct cabinet air leaks and ice maker fill tube air leaks. If the air leak is from the door seal, it may not be of much help, so check the door seals. When checking the door seals, check between the seal and the cabinet. Also pull the seal out of the channel in the door panel. The seal should be difficult to pull out. If it comes out easy, the air leak can be between the door and the door seal. If the gasket is loose in the channel, run RTV sealer in the channel and reinstall the gasket.
