Service & repair hints of NOKIA 3210

Service & Analysis Center

The purpose of this document is to provide some further service information for NOKIA 3210 phones.

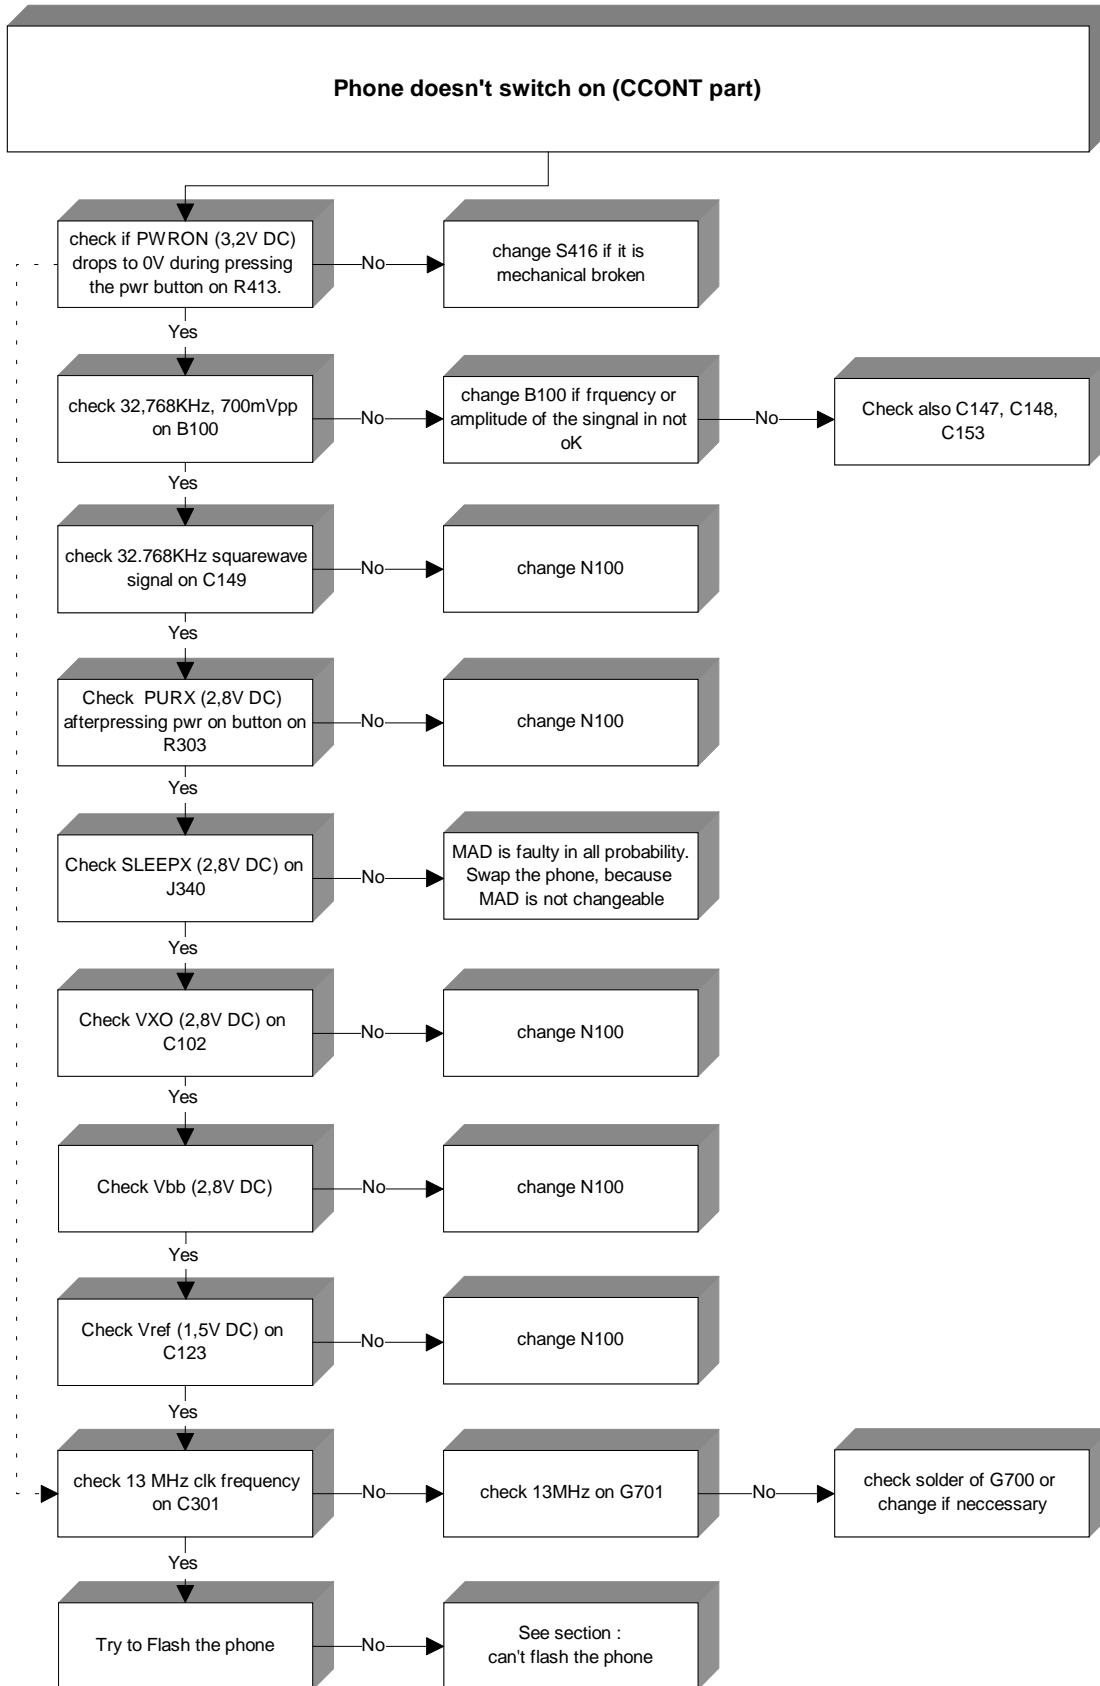
Doesn't Switch on

Battery connectors X101/ X102 / bend out dirty

Power on/off switch S416 faulty/ mechanical broken

L102 poor soldering

N100 CCONT faulty

B100 faulty 32,768KHz

G701 faulty 13 MHz

VB to R132 board faulty

D200 MAD faulty

V105 DC/DC converter faulty

- Check if VBATT and Gnd are connected

- Check if 3,2V on R413 drops of 0V during pressing the Power on button

- Check the soldering of L102
- Check the resistance in "off mode=0Ω"
- Resolder L102 or change it

- Check if 3,2V on R413 drops of 0V during pressing the Power on button
- Check if there is a 32.768 kHz square wave on C149
- Check if PURX on R303 goes up to 2.8 V DC
- Check if VXO on C102 goes up to 2.8 V DC
- Check if VBB on C117 goes to 2,8V DC
- Check if Vref on C123 goes to 1,5V DC

- Check 32.768 KHz ; 700mVpp clock signal on B100
- Check also C147, C148, C153

- Check VCC 2,8V DC on G701
- Check 13 MHz output frequency; 1,2 Vpp on the output pin

- Check the battery voltage 2,6V on L102
- Check the same voltage on R132
- Check if the connection from R132 to L102 are 0Ω
- Don't forget to put the additional label on the PCB, it save the layer (see Service Bulletin 11)

- Check if there is a 32,768 KHz square wave on C149
- Check the 13MHz main clock oscillator on C301 800mVpp
- Check VBB 2,8 V DC on C117
- Check PURX 2,8 V DC on R303 (comes from CCONT)
- Check SLEEPX 2,8 V DC On measurement point J 340
- MAD are probable faulty
- MAD are not interchangeable swap the handset

- Check the voltage difference on the diode V101 Anode: 2,6V DC, cathode: 3,2V DC
- Check the 600KHz switching frequency on pin 4, 5, 12, 13 from V105
- Check the 1,2V operation voltage on pin 15 from V105
- Check if pin 3 from V105 have low status ≈0V, if not check V109 and the respective voltage dividers R131, R132, R134, R143, R144
- Change the V105

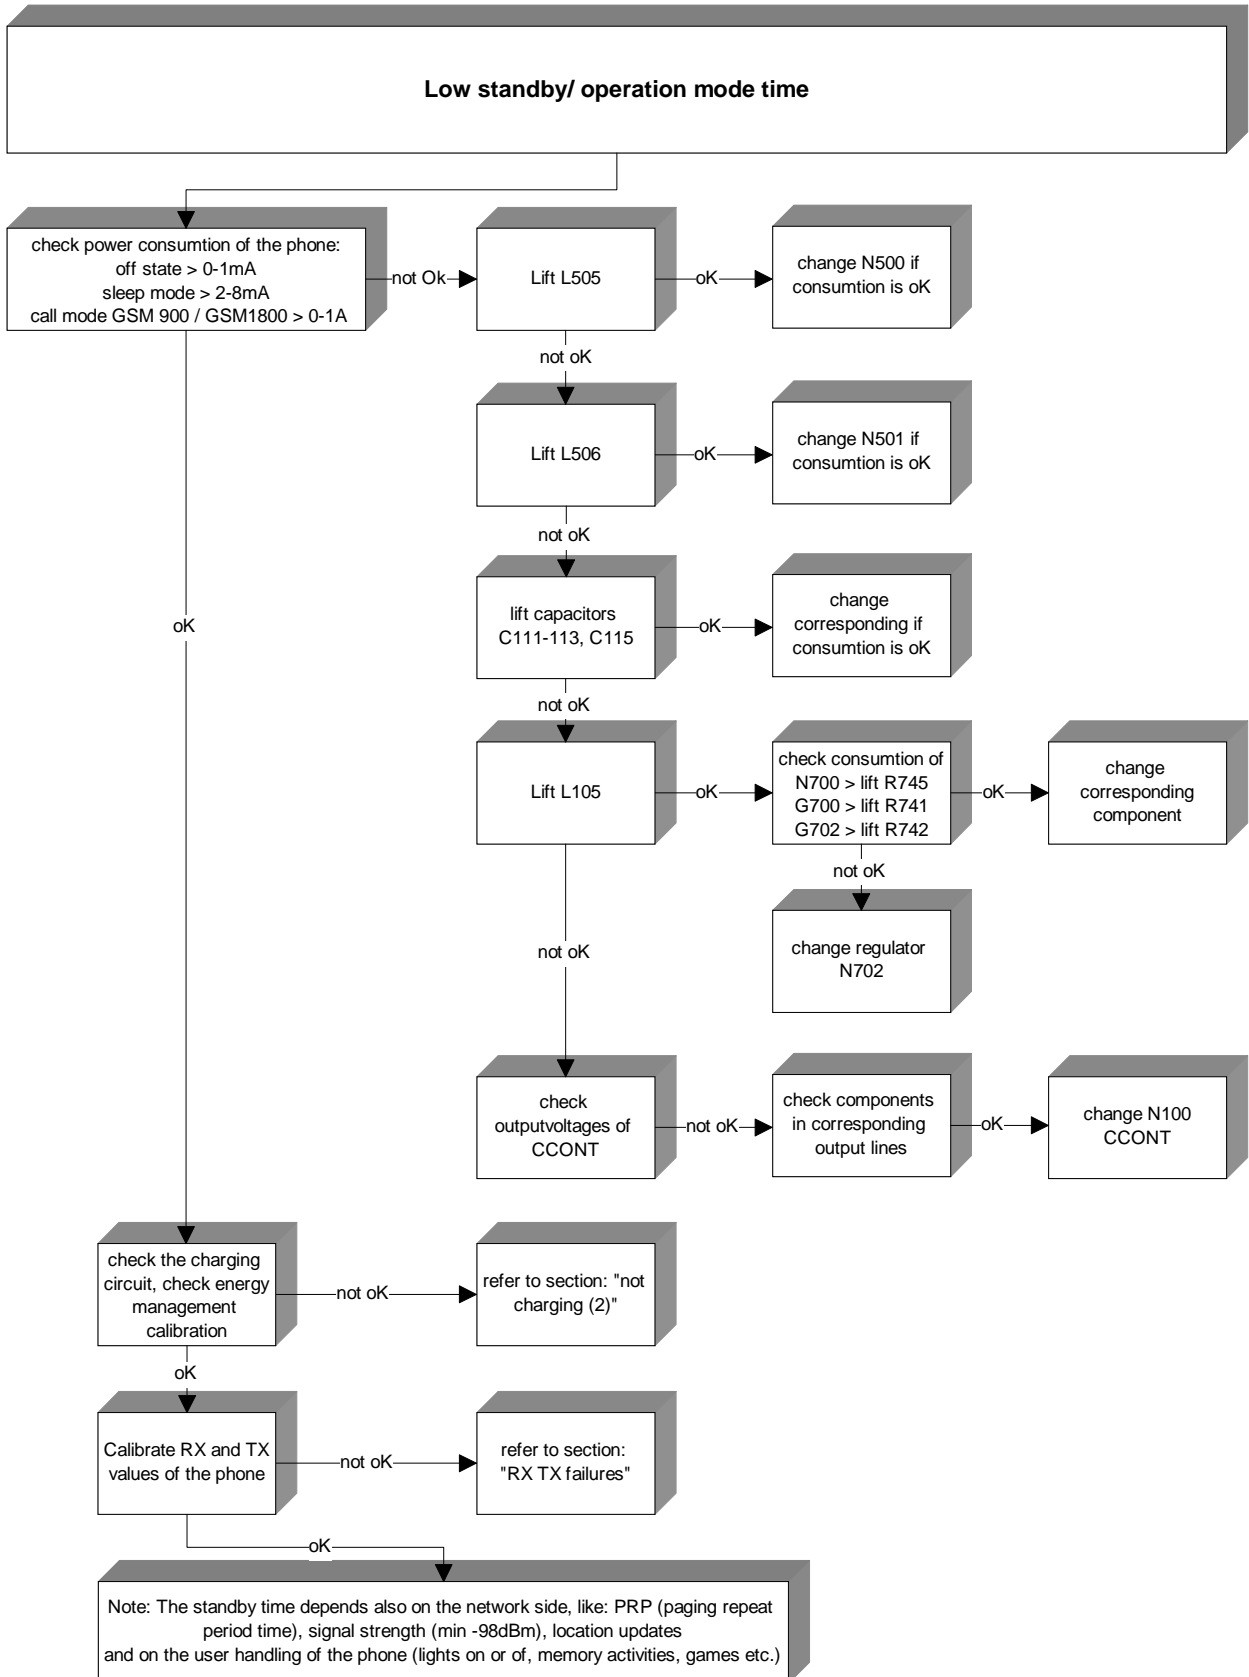
Low stand by time/ operation time

C111, C115, C113 faulty

- Check the current consumption in different operation modes (refer to the table below)
- Check if the high current consumption comes from the VB, Vout or output voltages of CCONT
- Disconnect coil by coil L105 (→N702) L505, L506 (→PA's) and check consumption again
- Check and disolder C111, C115 and C113
- calibrate Battery value if charging stops to early or battery is to hot after charging (see also chapter "Not charging)

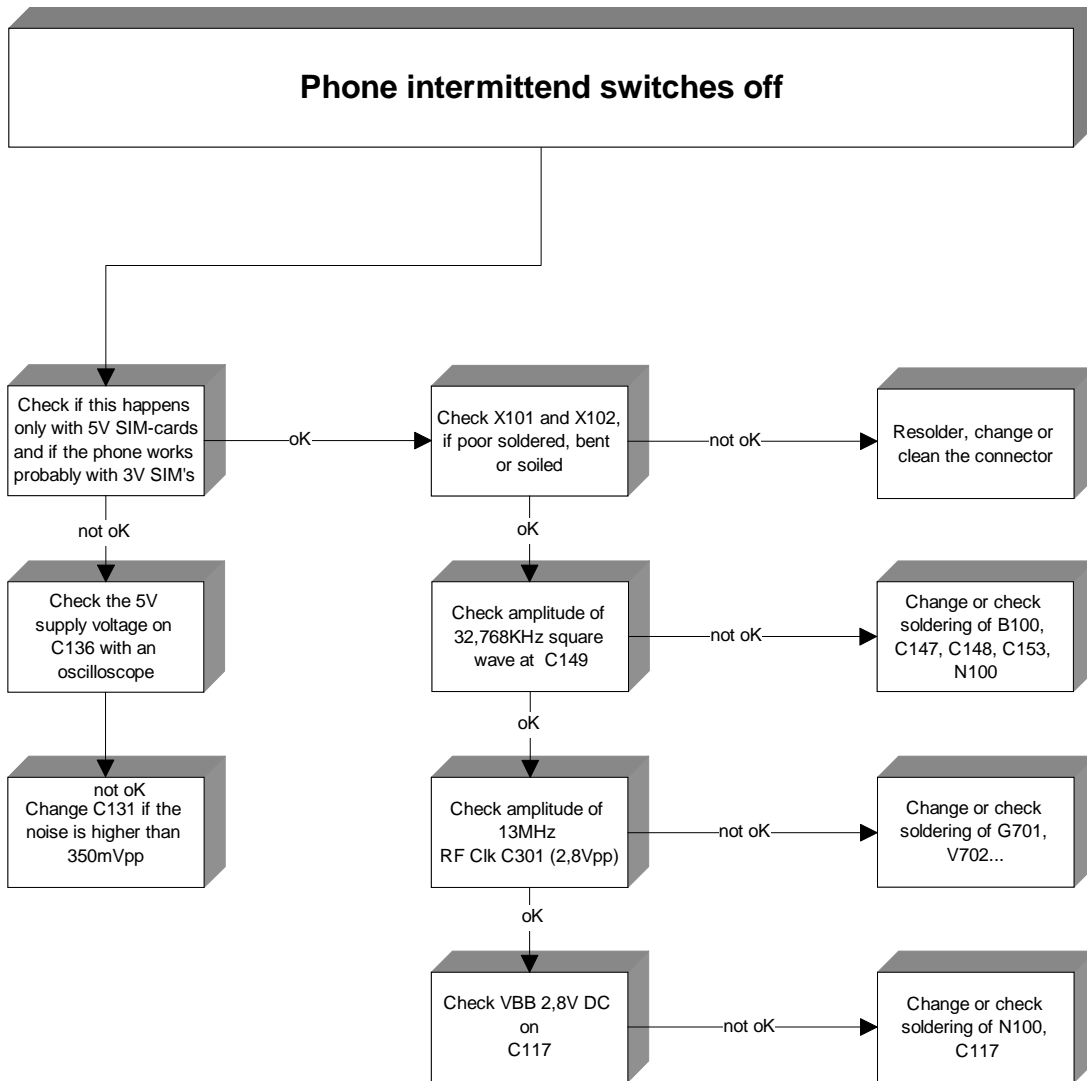
Phone switch it self off

C136 10µF/10V

- Check, if the handset doesn't switch off with 3V SIM-Cards
- Check that the 5V VSIM voltage on the capacitor C136 is approximately 4,8V-5,2V with maximal 350mVpp noise overlap (view the diagram below)

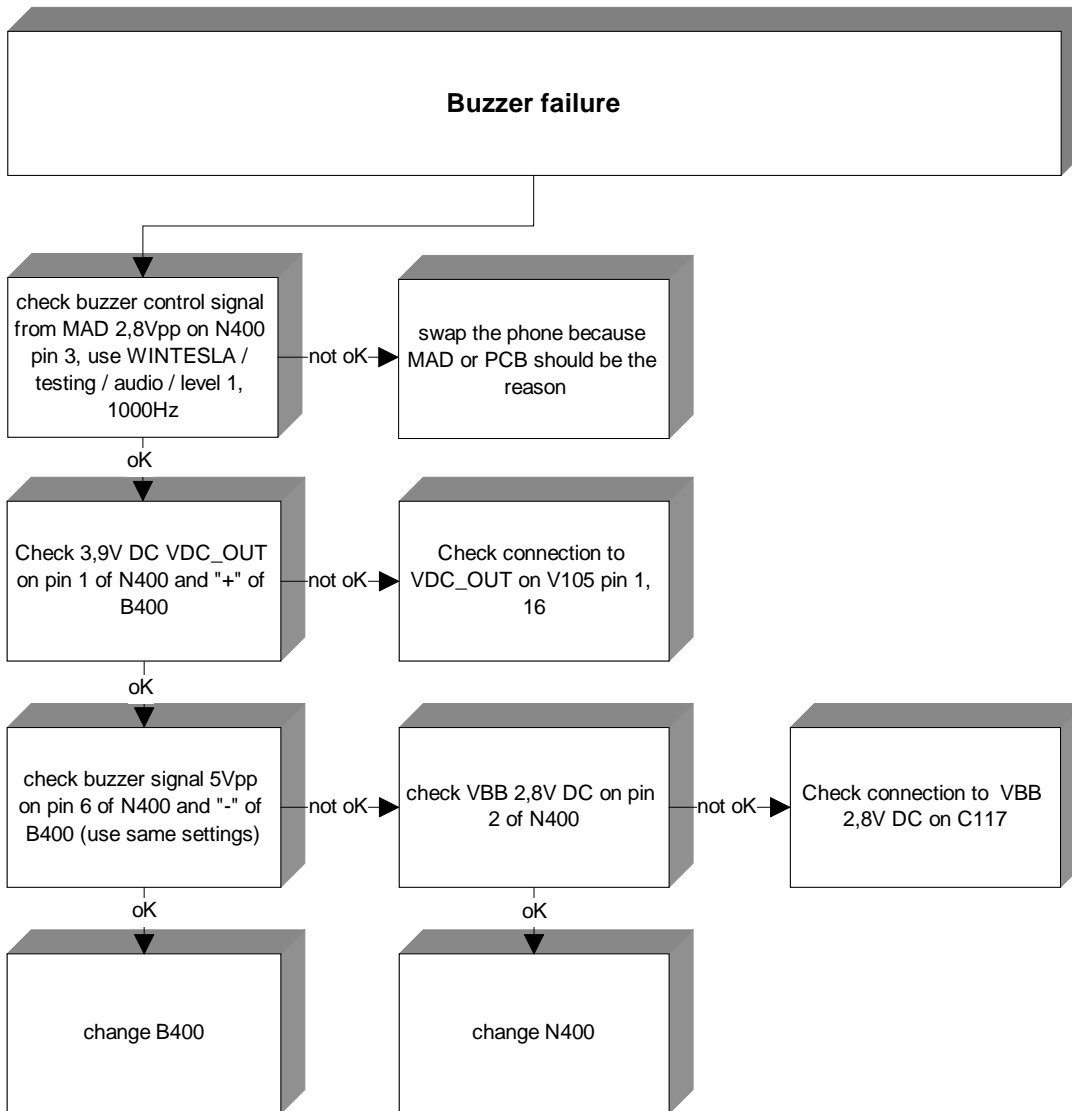
Buzzer failures

B400 / board connections broken

- Check the buzzer control signal from the MAD on pin 3 of N400 2,8Vpp 1KHz (use [WINTESLA / testing / audio Level 1, 1000Hz](#))
- Check VDC_OUT 3,9V DC pin 1 N400 and "+" of buzzer
- Check VBB 2,8V DC on pin 2 N400
- Check the buzzer Signal on "-" of buzzer ≈ 5Vpp 1KHz
- Check the board connection pin 6 of N400 to "-" of buzzer
- Change the buzzer

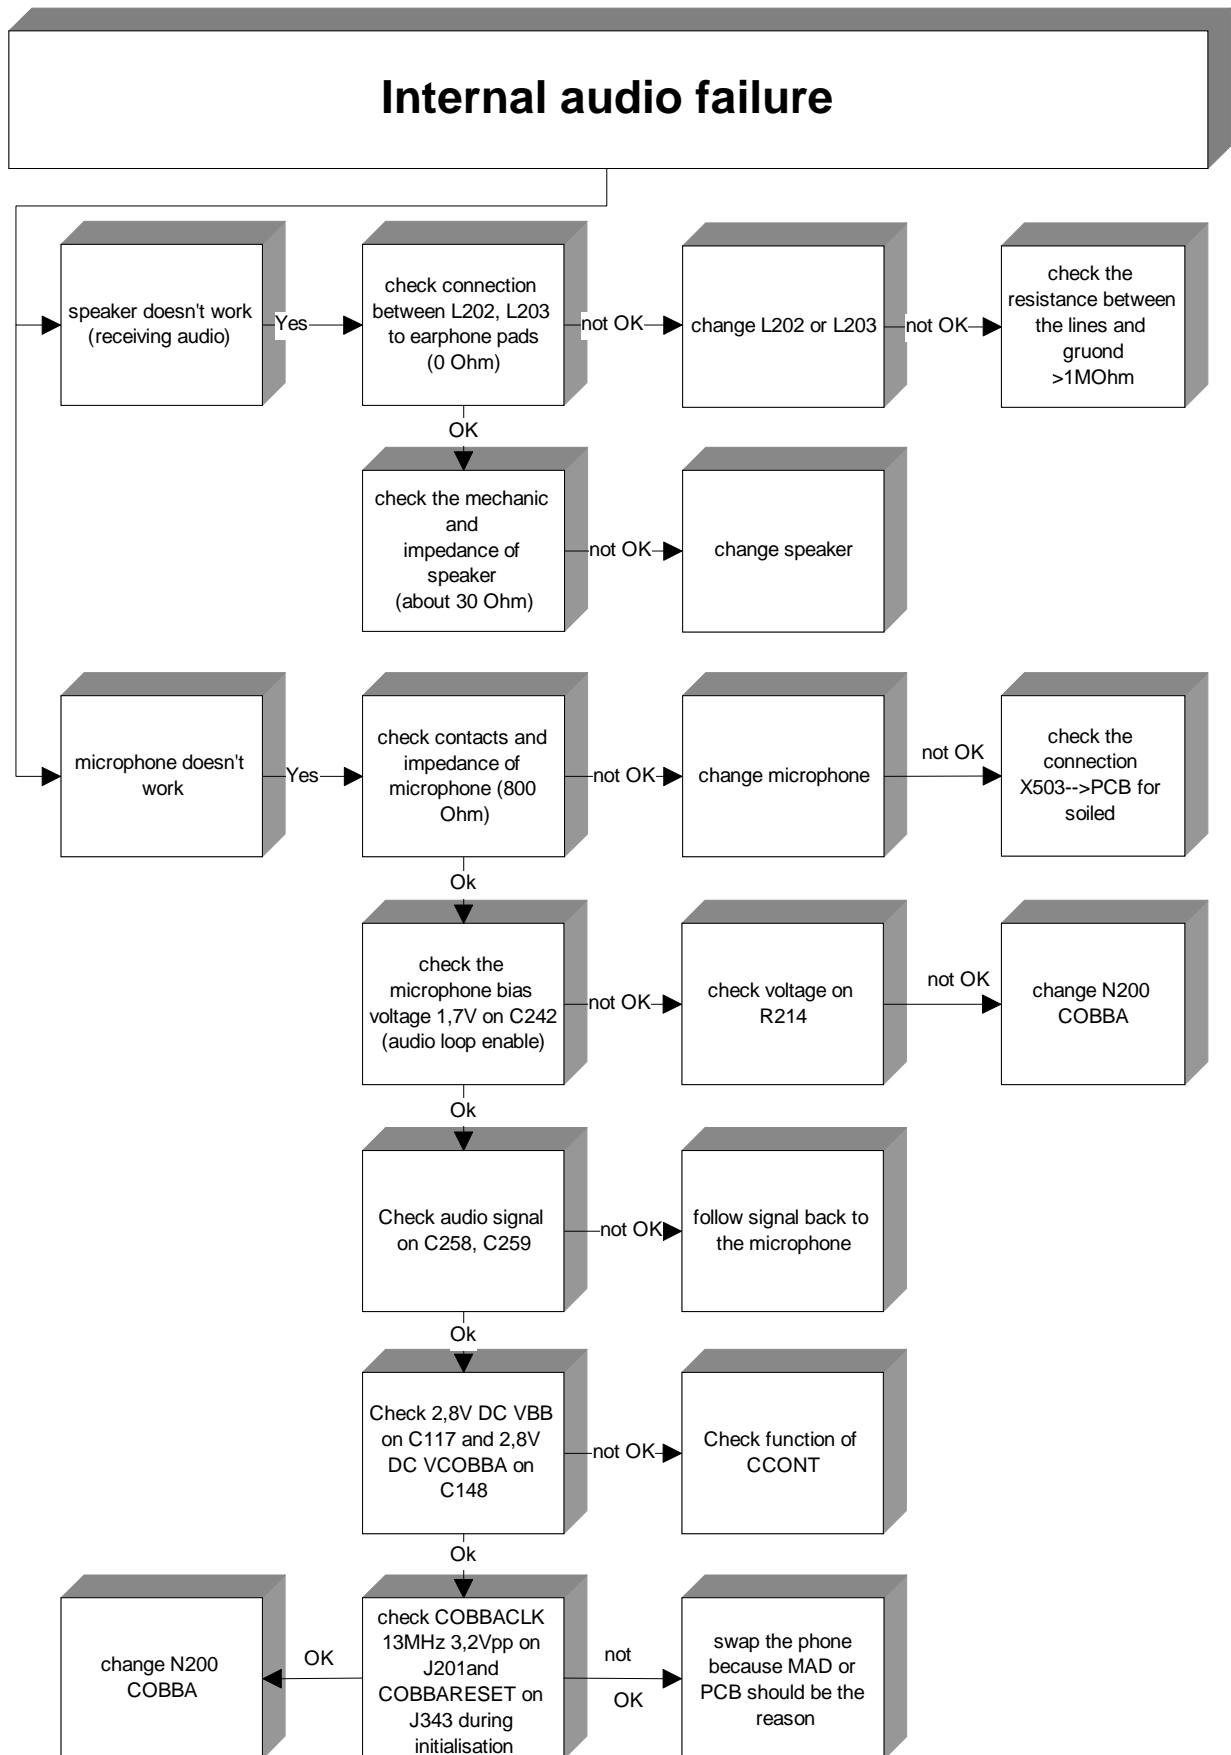
Internal audio failures

L202, L203 faulty

No / quiet / distorted receiving audio signal

No / quiet / distorted transmitting audio signal

X503

N200 COBBA faulty

- Check resistance from L202, L203 to the earphone pads normal 0Ω
- Check the resistance also from L202,L203 to ground and between both lines (normal high resistance $>1M\Omega$)

- Check the mechanic of speaker, contacts, membrane, soiling
- Check resistance of speaker (about 30Ω)

- Check contacts of microphone
Check resistance of microphone (about 800Ω)
- Check the microphone voltage 1,7V DC on C242 ([wintesla/ Testing/ Audio/ internal/ Loop on](#))
- Check the audio signal on C258 and C259

- Check microphone spring contacts
- Check spring contacts to the board (change connector if bent)
- Clean the contact pads on the board

- Check VBB 2,8V DC on C117 near to CCONT
- Check VCOBBA 2,8V DC C148 near to COBBA
- Check COBBACKL 13MHz 3,2Vpp on J 201
- Check COBBA reset impulse during the initialisation routine on J343 (see the diagram "CONBBA RESET")
- Change COBBA and write the IMEI and SIM-LOC DATA back to the phone
- If the error persist the MAD or the Board (PCB) should be the reason
- SWAP the handset because MAD is not changeable

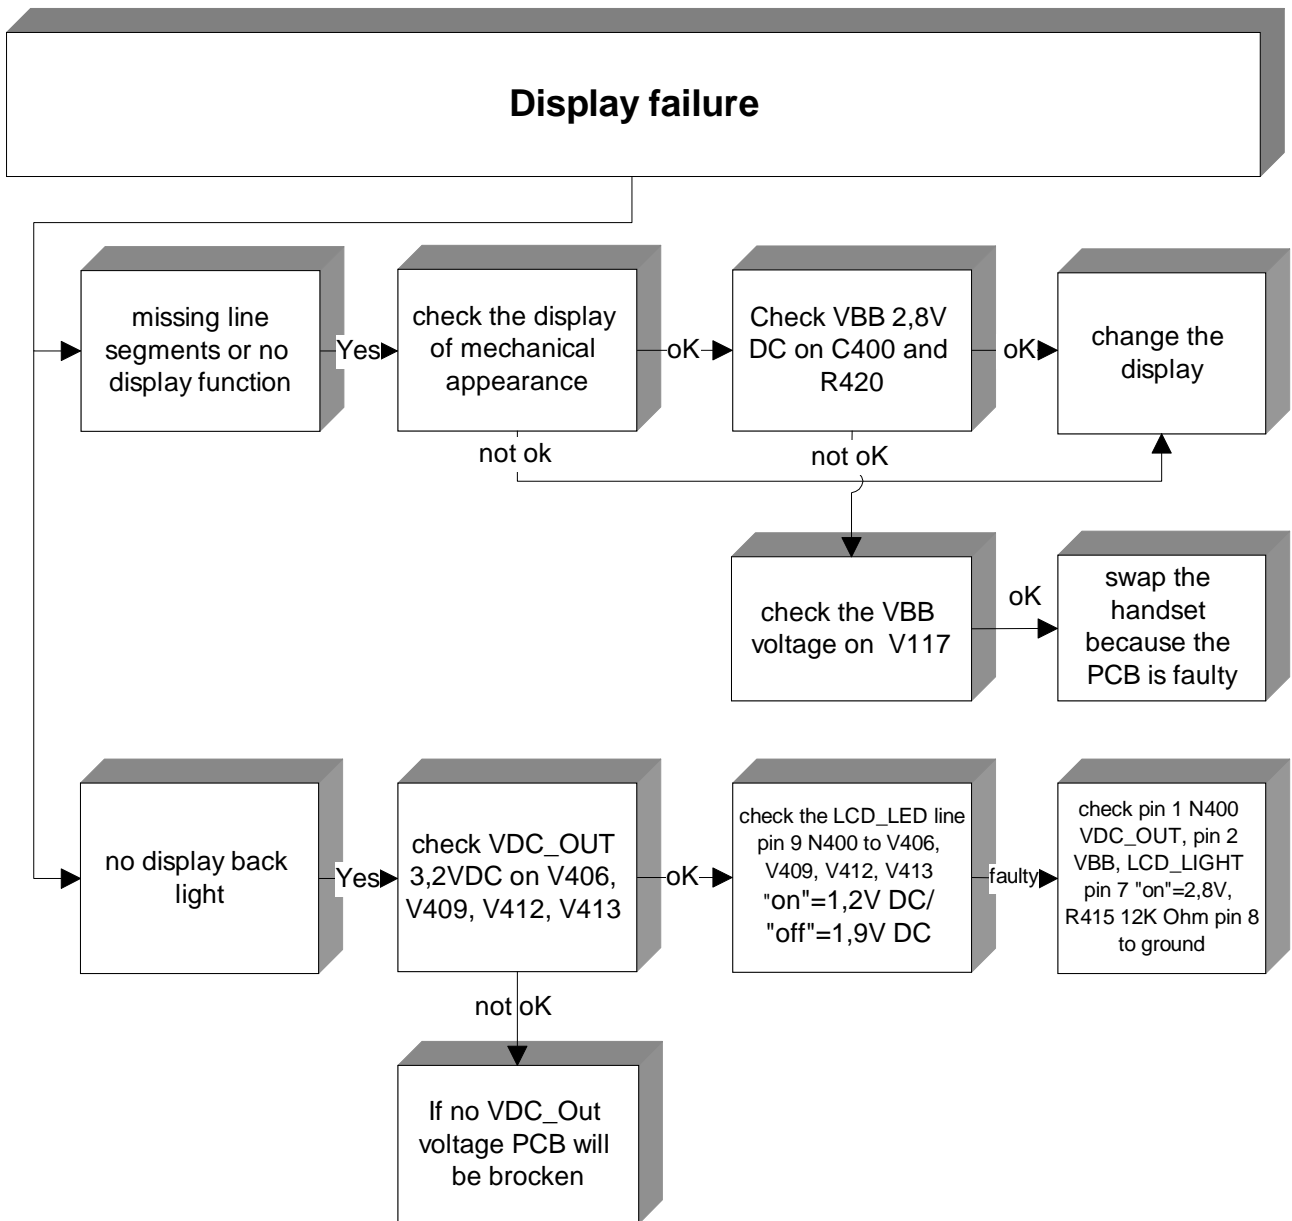
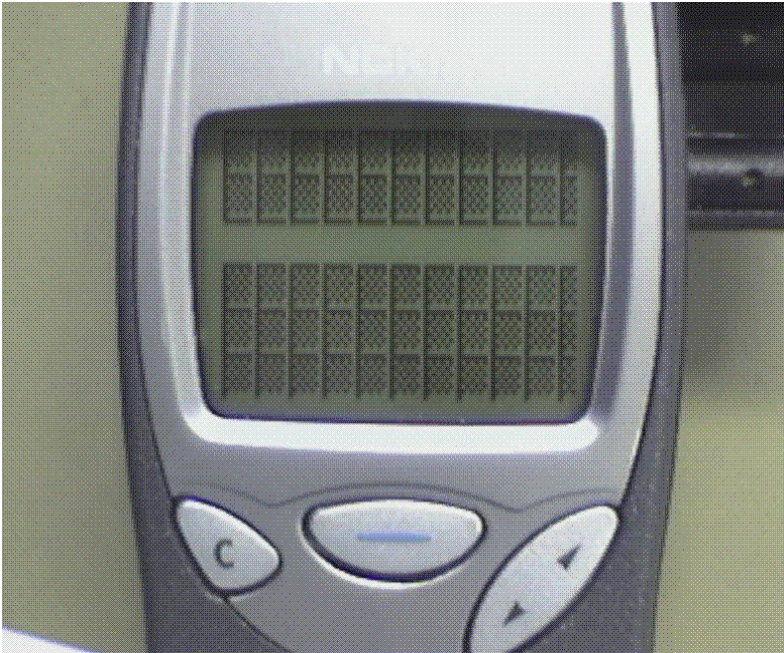
Figure 5: Faulty display

Black lines on the display or no display function

No display back light

- Check if the display have some mechanical breaks around the corners
- Check VBB 2,8V DC on C400 and R420
- Change the Display

- Check VDC_OUT 3,2V DC on V406, V409, V412, V413
- Check the LCD line pin 9 of N400 and cathode of V406, V409, V412, V413 Light "on"=1,2V DC ; "off"=1,9V DC. ([Use Wintesla/ Testing/ userinterface/ 1.Test Pattern "on"](#))
- Check the LCD_light enable line on pin 7 / N400, LCD_LIGHT "on"=2,8V DC
- Check the resistor R415 12KΩ pin 8 / N400 to ground

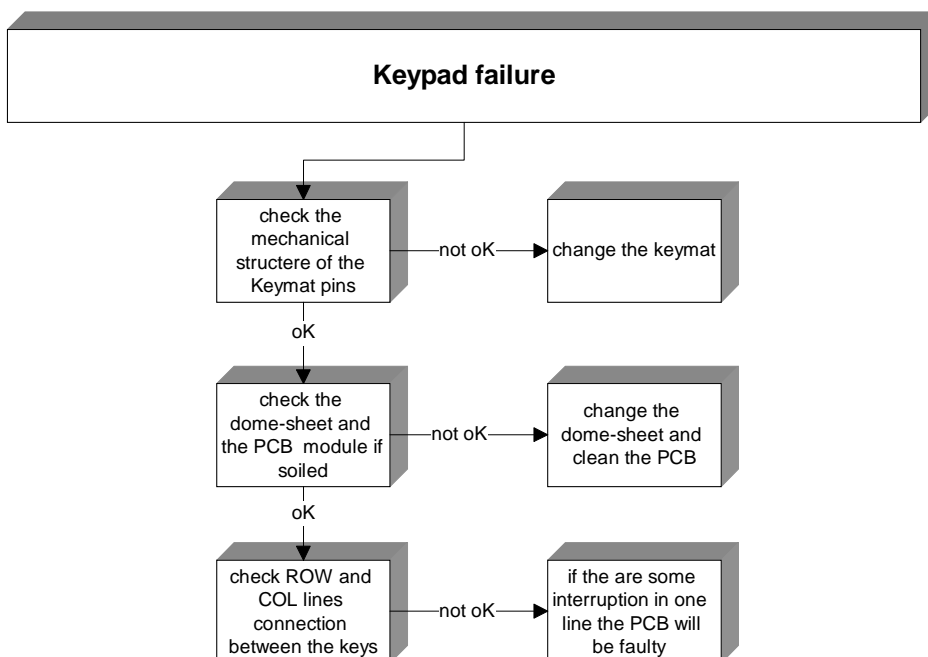
Keypad failure

Keymat mechanical faulty

Board / Dome-sheet soiled

Board failure

- Check the bottom of the keymat if no pins are broken or mechanical damaged

- If there are only one or two keys without function, check and clean the board and dome-sheet if soiled

- If there are four keys without function and all of them are on them same ROW or COL line, check the connections between the keys and ground
- If any line is interrupted between the Keys, swap the handset because PCB is faulty

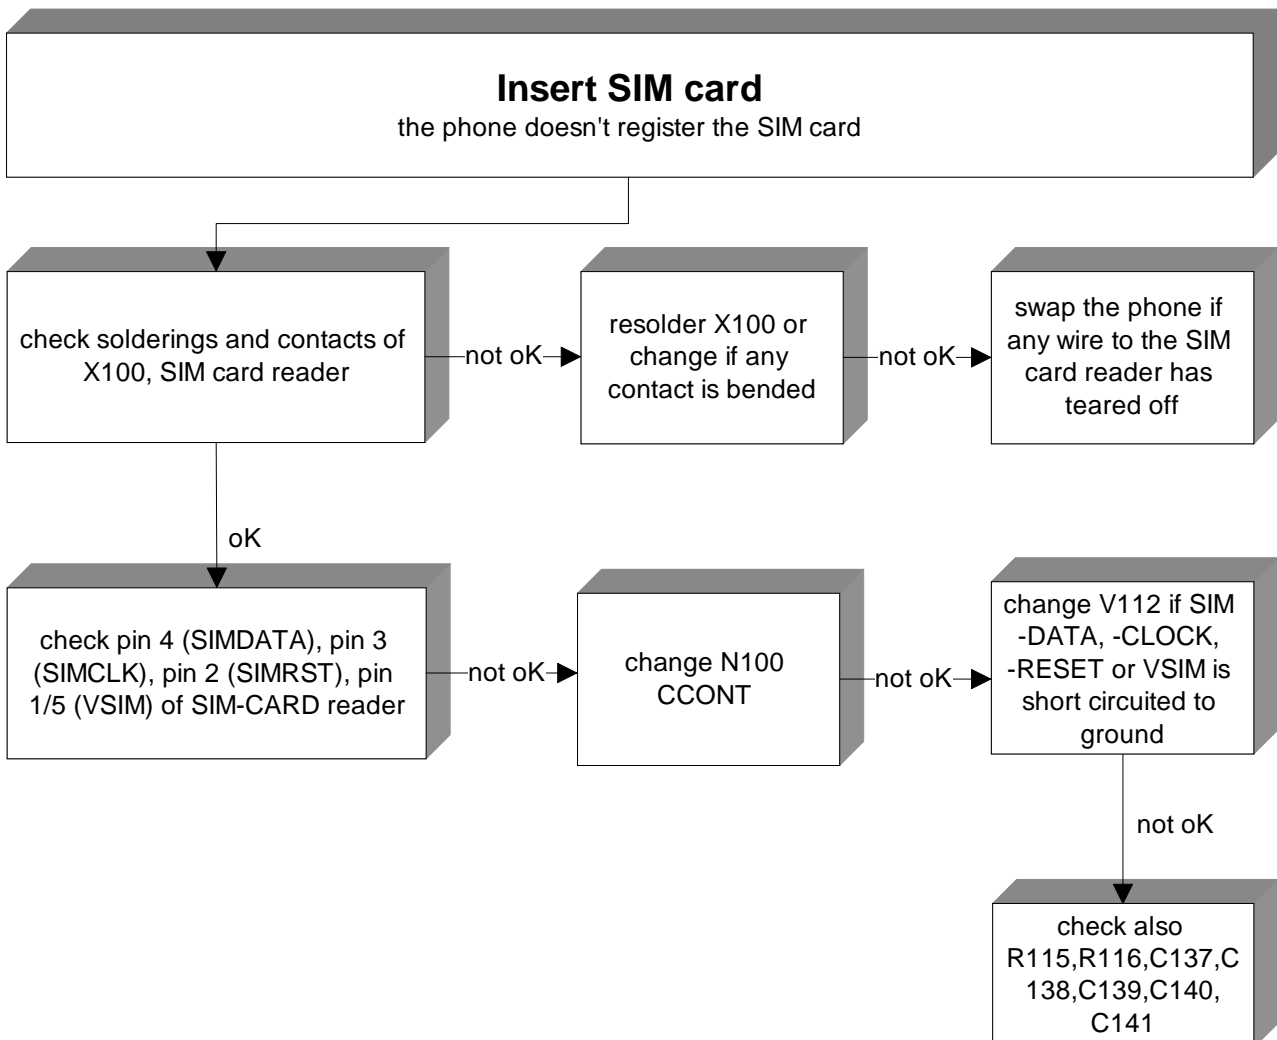
Insert SIM CARD

X100, SIM card reader

N100, CCONT

V112

- Check soldering
- Check contacts (change connector if bent)

- Check SIM card –DATA (Pin 4 SC-reader), –Clock 3,25MHz (Pin 3 SC-reader), –Reset (Pin 2 SC-reader) and VSIM 3V/5V DC (Pin 1/5 SC-reader) depends to the SIM card

- Change component if SIM –DATA, –Clock, –Reset or VSIM is short circuited to ground
- Check also R115, R116, C137, C138, C139, C140, C141 for short circuit or not capacity
