Altair[™] Louvre Window Trade Troubleshooting Checklist

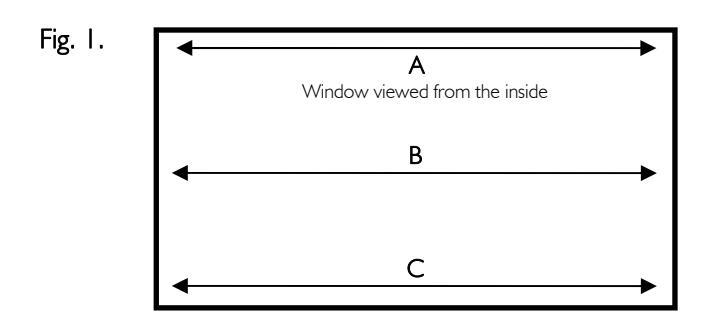
- 5. Have the Breezway 6mm rebated Western Red Cedar or Kwila blades been used?
- 6. Are the frames in which the galleries are installed true and square? Dimensions A, B, & C (Fig. 1.) should be the same. If B is less than A & C, the middle section of blades could be tight to operate. Conversely, if B is greater than A & C, the top and bottom blades could be tight to operate.

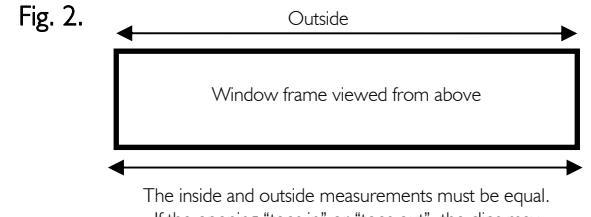
- 7. Dimension A, B, & C must be equal on both the inside & outside corresponding points of the window's frame or the blades will be tightening due to the reduction of the opening width during "opening" (Fig. 2).

If the opening "toes in" or "toes out", the clips may bind on the U channel during operation.
