123 SW South Street, Port Saint Lucie, FL 34953

Inspection Date: 03/27/XXXX

Prepared For: John & Jane Doe

Prepared By: Florida Building Inspector 10380 SW Village Center Drive Suite 123 Port Saint Lucie, FL 34987

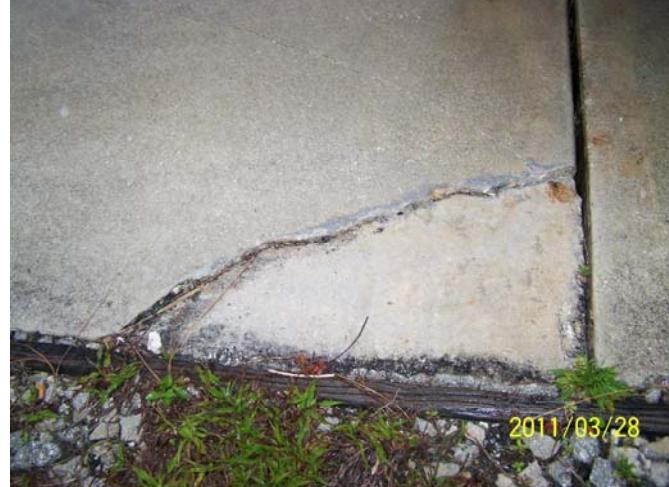
Driveway cracks

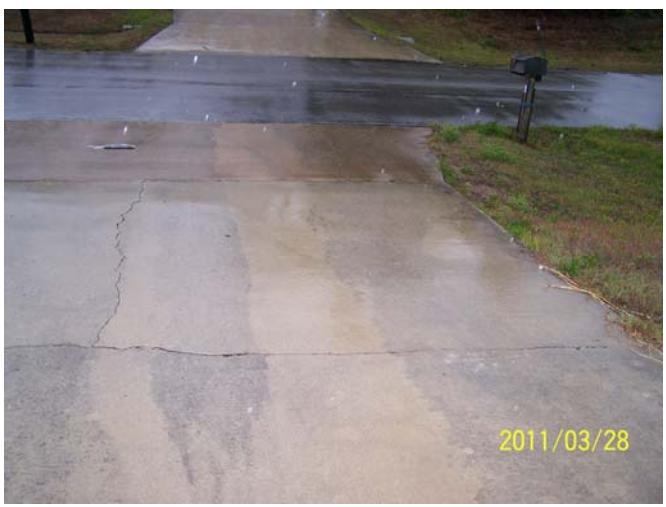
Driveway cracks

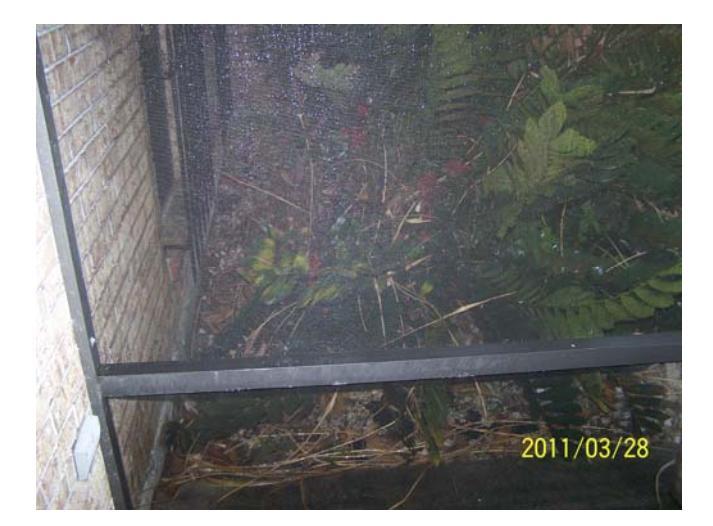
Negative grade in front

Any system of grading or landscaping that creates positive drainage (moving water away from the foundation walls) will help to keep a basement dry. Where negative grade exists and additional backfill is suggested, it may require digging out around the property to get a proper pitch. Dirt shall be approximately 6" below the bottom sill and should not touch wood surfaces.

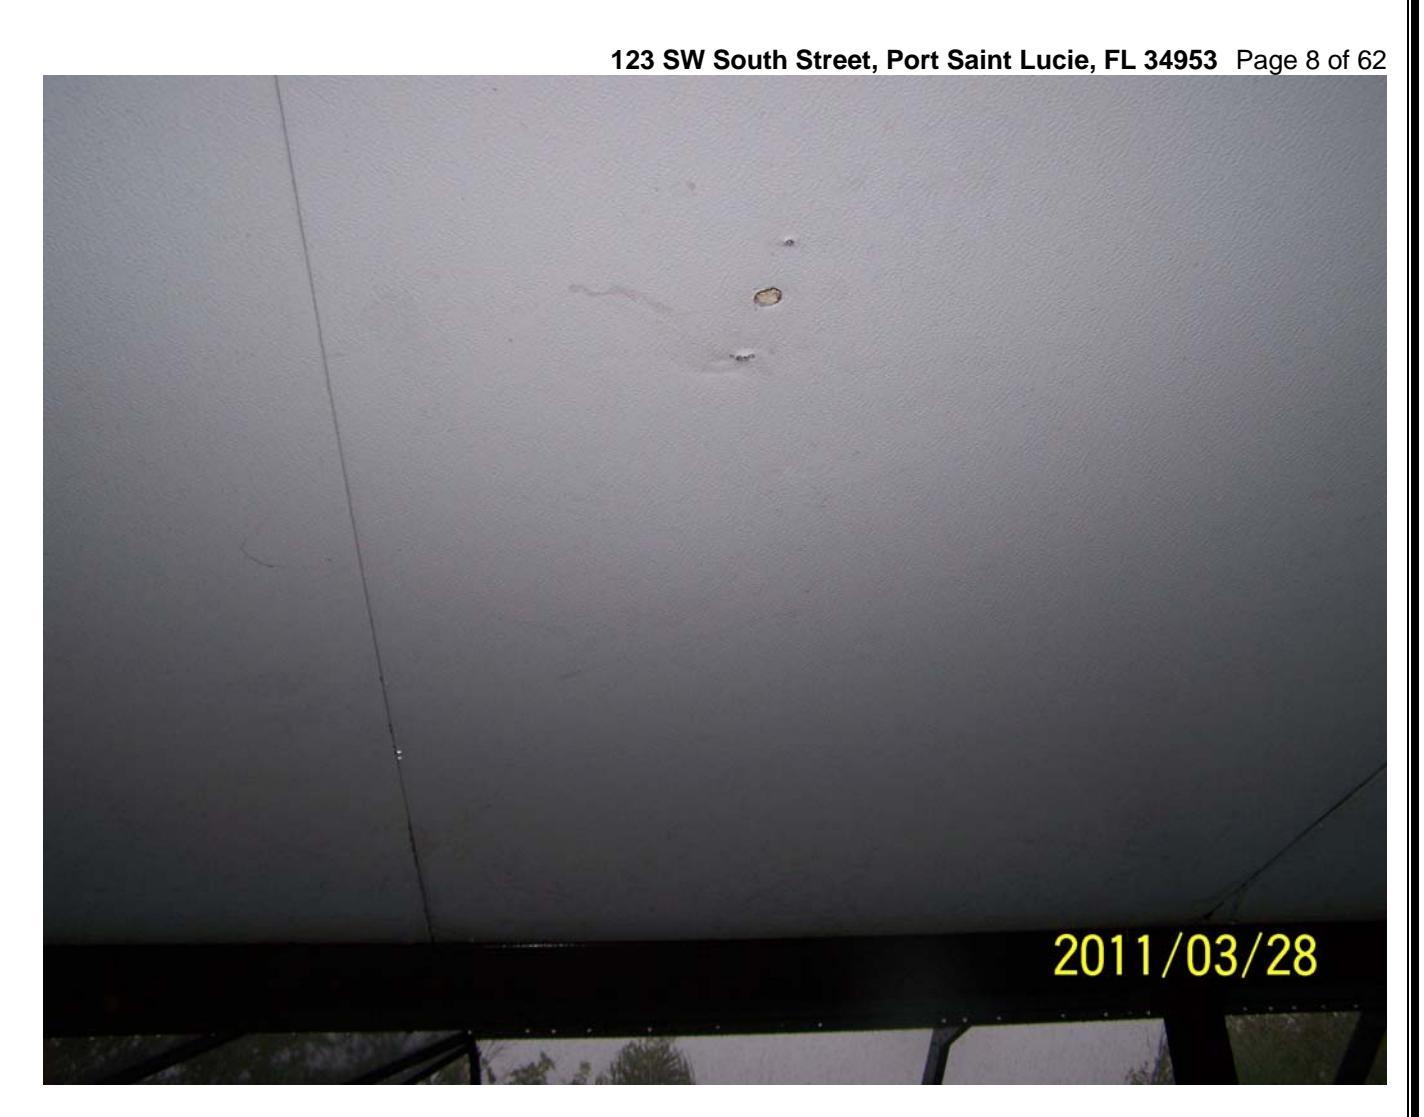
Ceiling with holes – rear pool enclosure

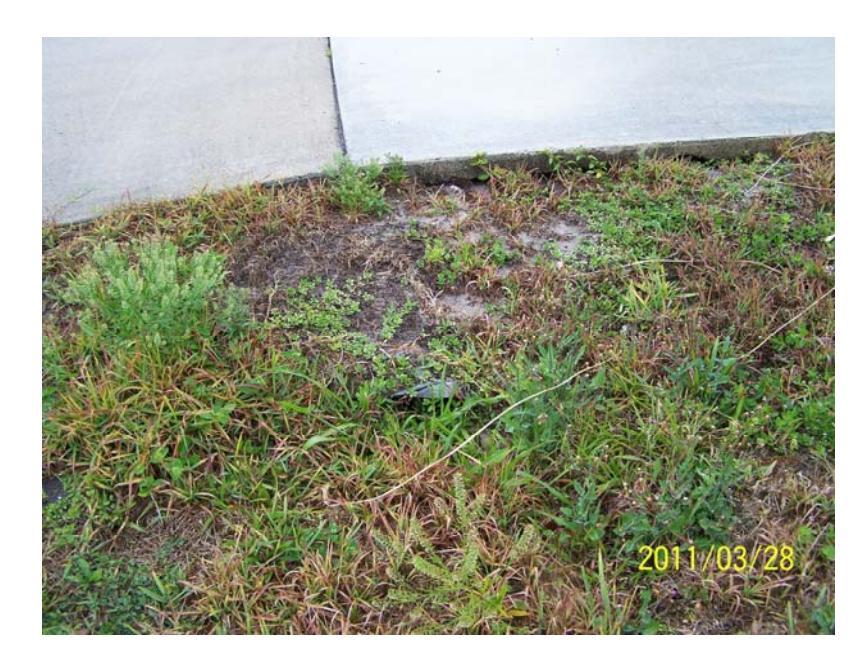
Pipe end – under driveway – swale area

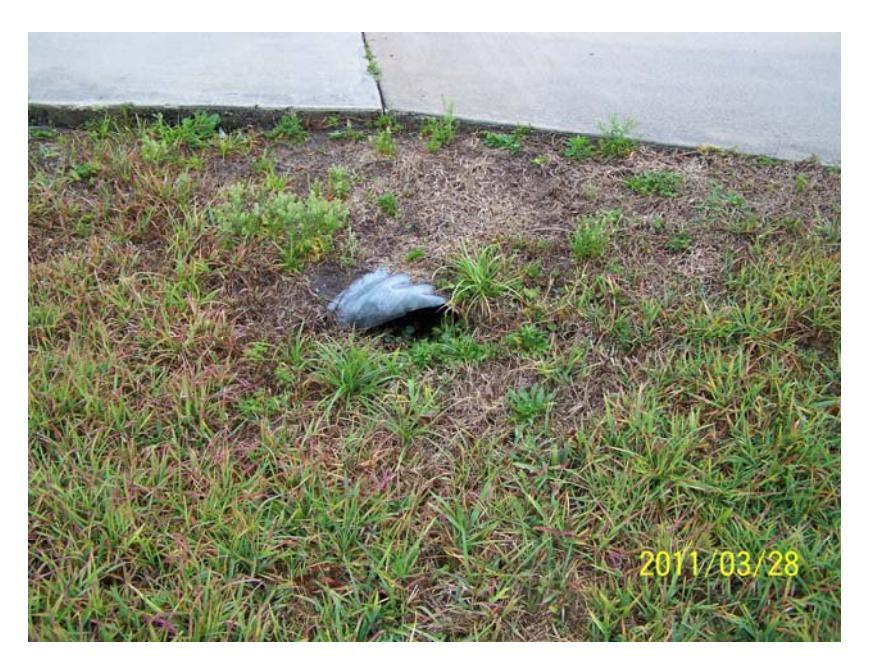
Pipe end – under driveway – swale area

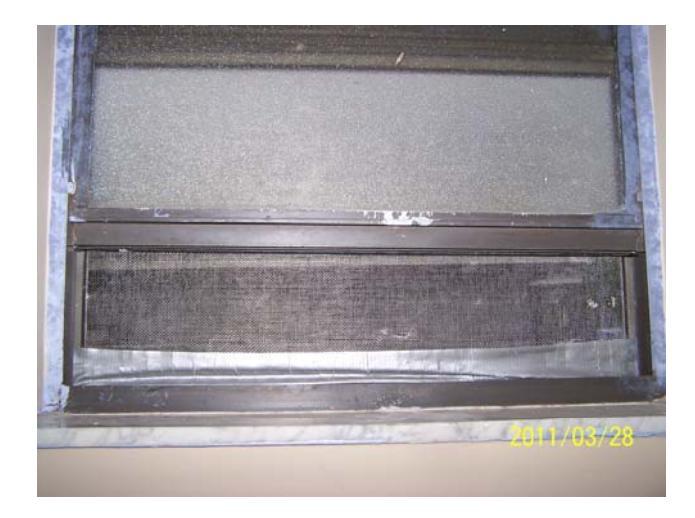
Torn screen - master bedroom bath window

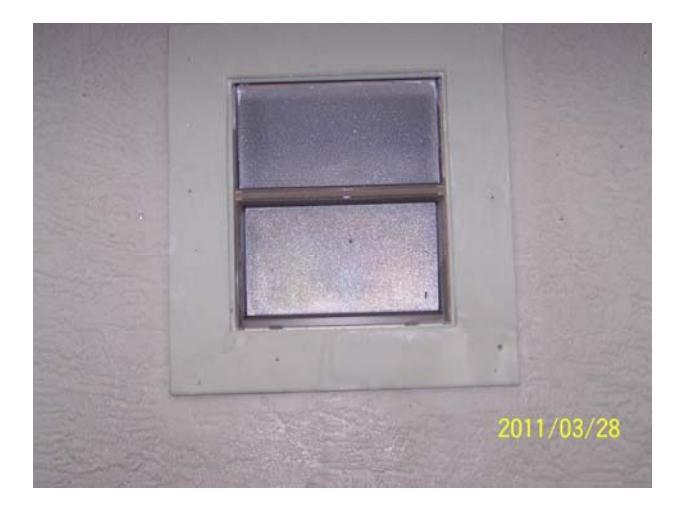
No screen - main bath

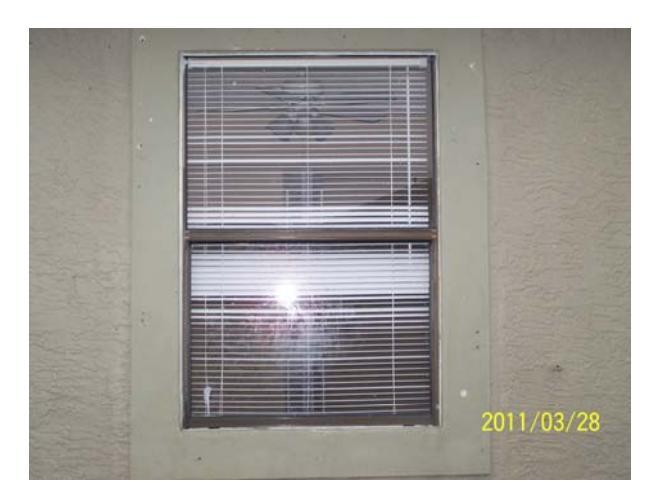
No screen – front guest bedroom

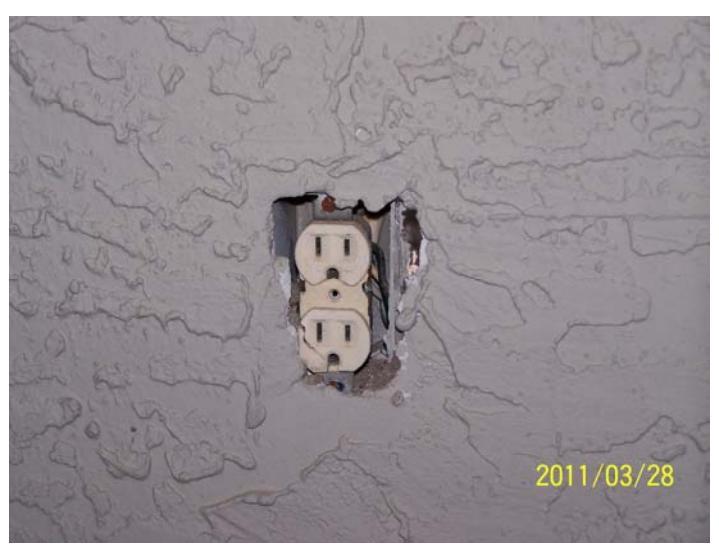
Electrical outlet plates missing on wall inside pool enclosure

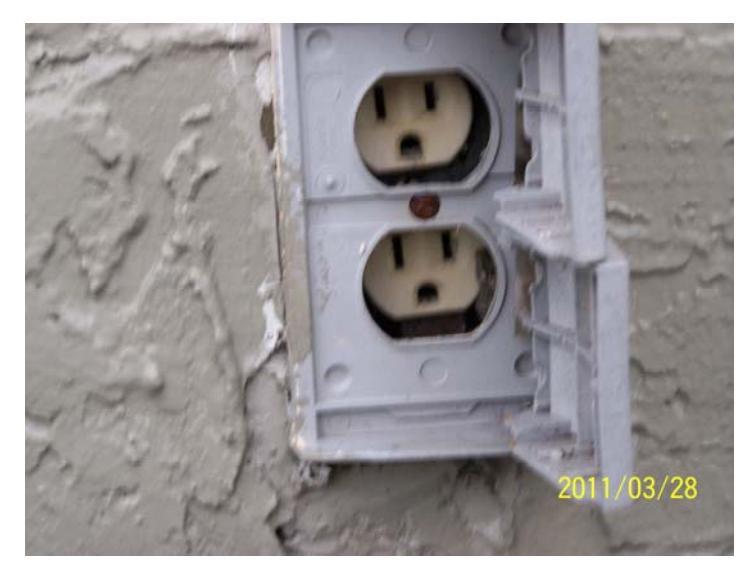
Electrical outlet recessed too far - near A/C unit

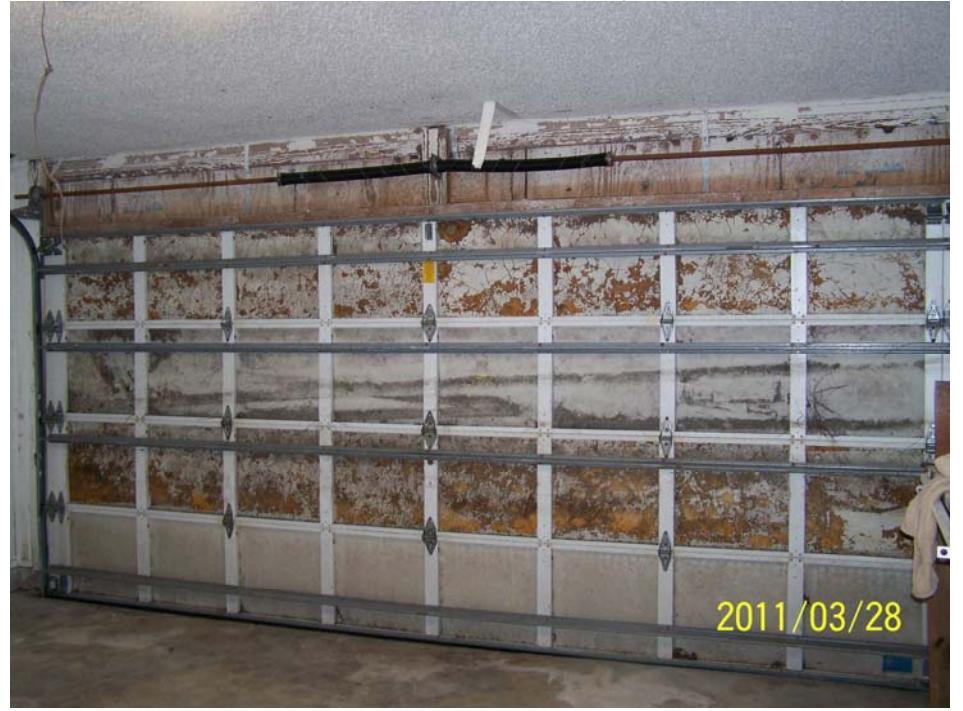
Garage door interior

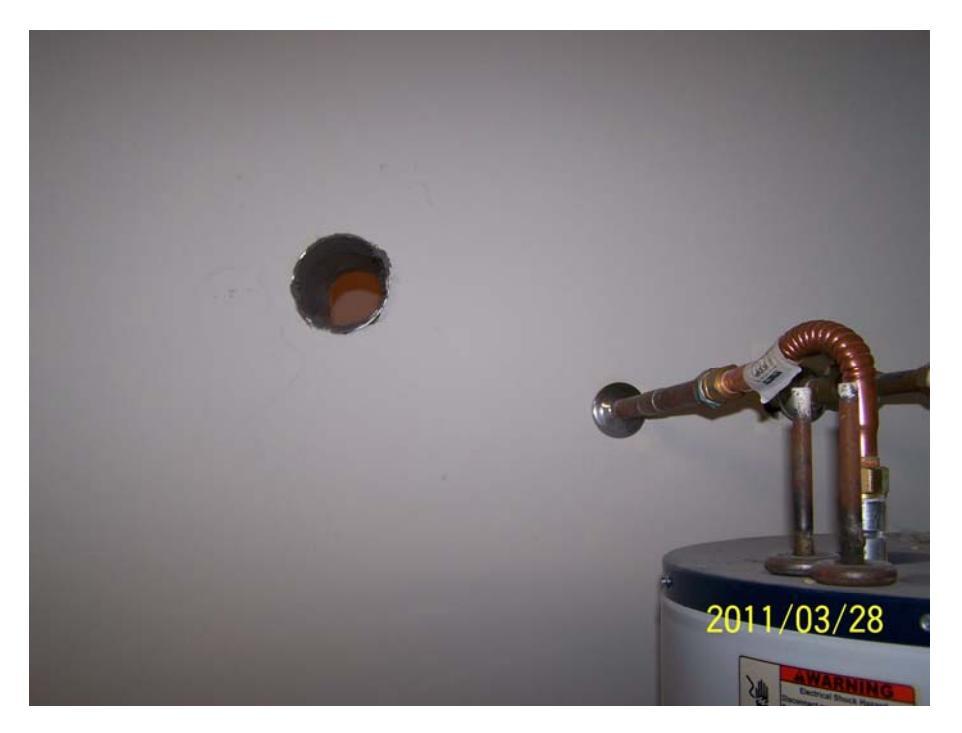
GENERAL CO	OMMENTS								
Firewall between garage and living has a (dryer vent) hole to laundry area - Potential Safety Hazard No automatic garage door opener. Loose wire hanging from ceiling next to electrical outlet. Metal garage door. Garage door panels on inside of the door have deteriorated in appearance. The only electrical outlet in the garage is 30A 125/220V outlet – under electrical panel. Termites were observed in the outer garage wall by an authorized professional inspector from Massey Services, Inc. Recommend professional treatment of termites and repair/replacement of termite damaged areas of the home.									
			This	s confidentia	l repor	t is prepar	ed exclus ©	2011 Florida	ohn & Jane Doe Building Inspector

Former dryer vent hole from laundry area to garage

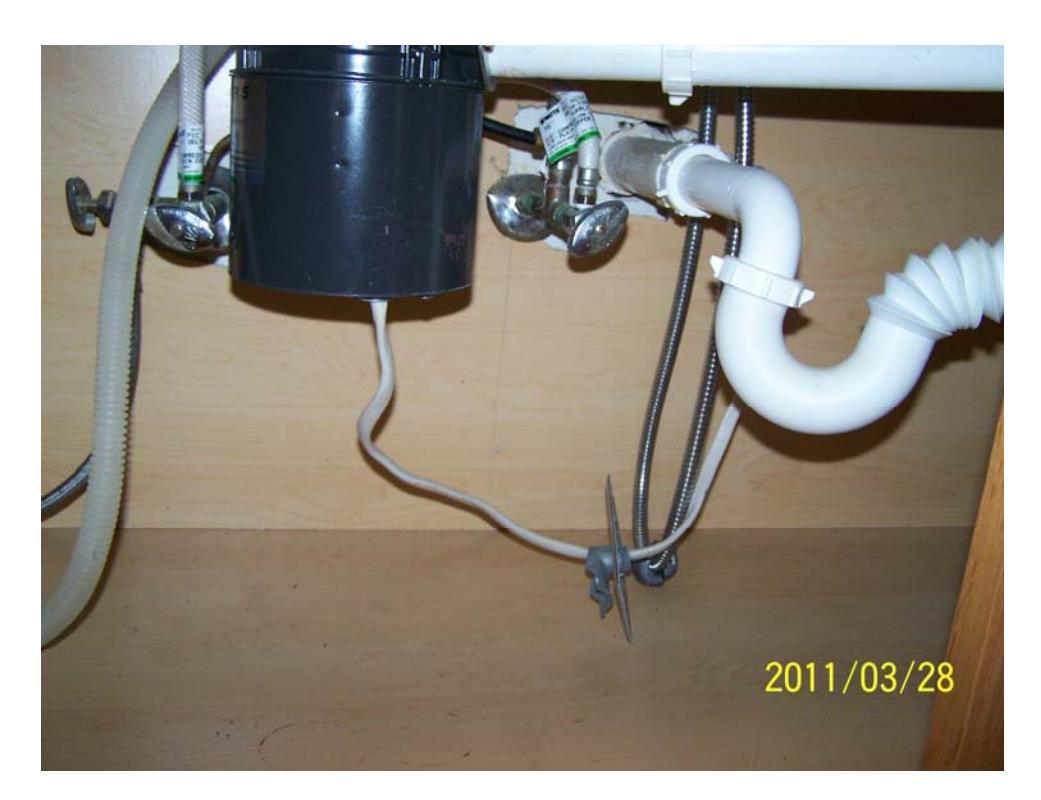
Garbage disposal wiring is incomplete – recommend rewiring for disposal.

Wiring for garbage disposal

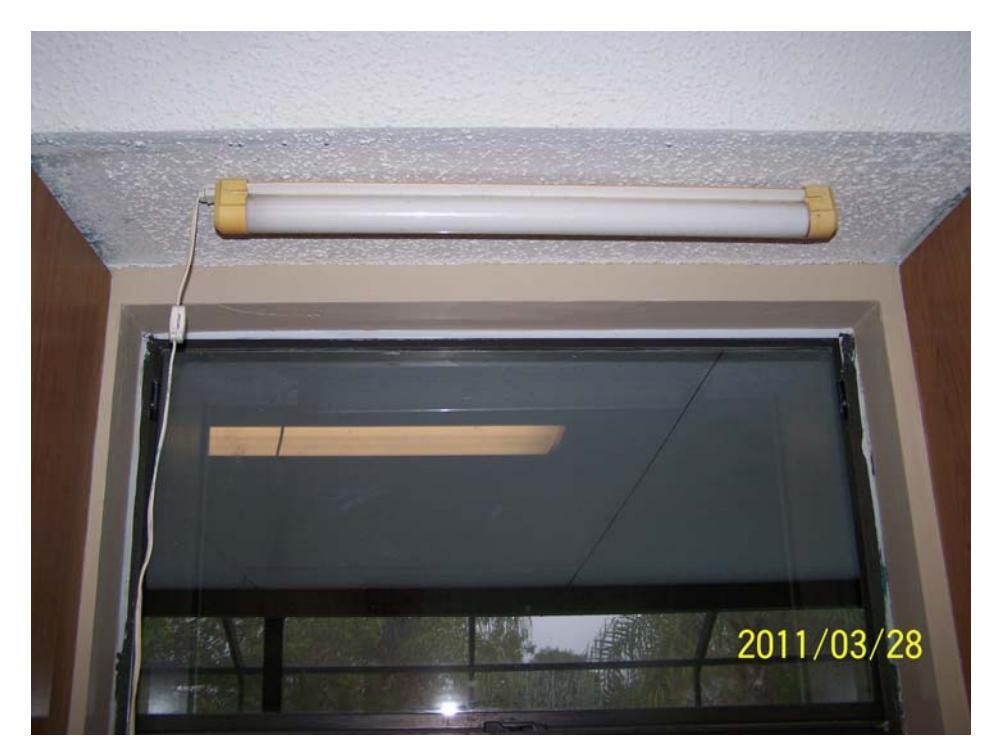
Light over sink is temporary – has a cord to plug into the wall socket – it does work.

Kitchen sink overhead light

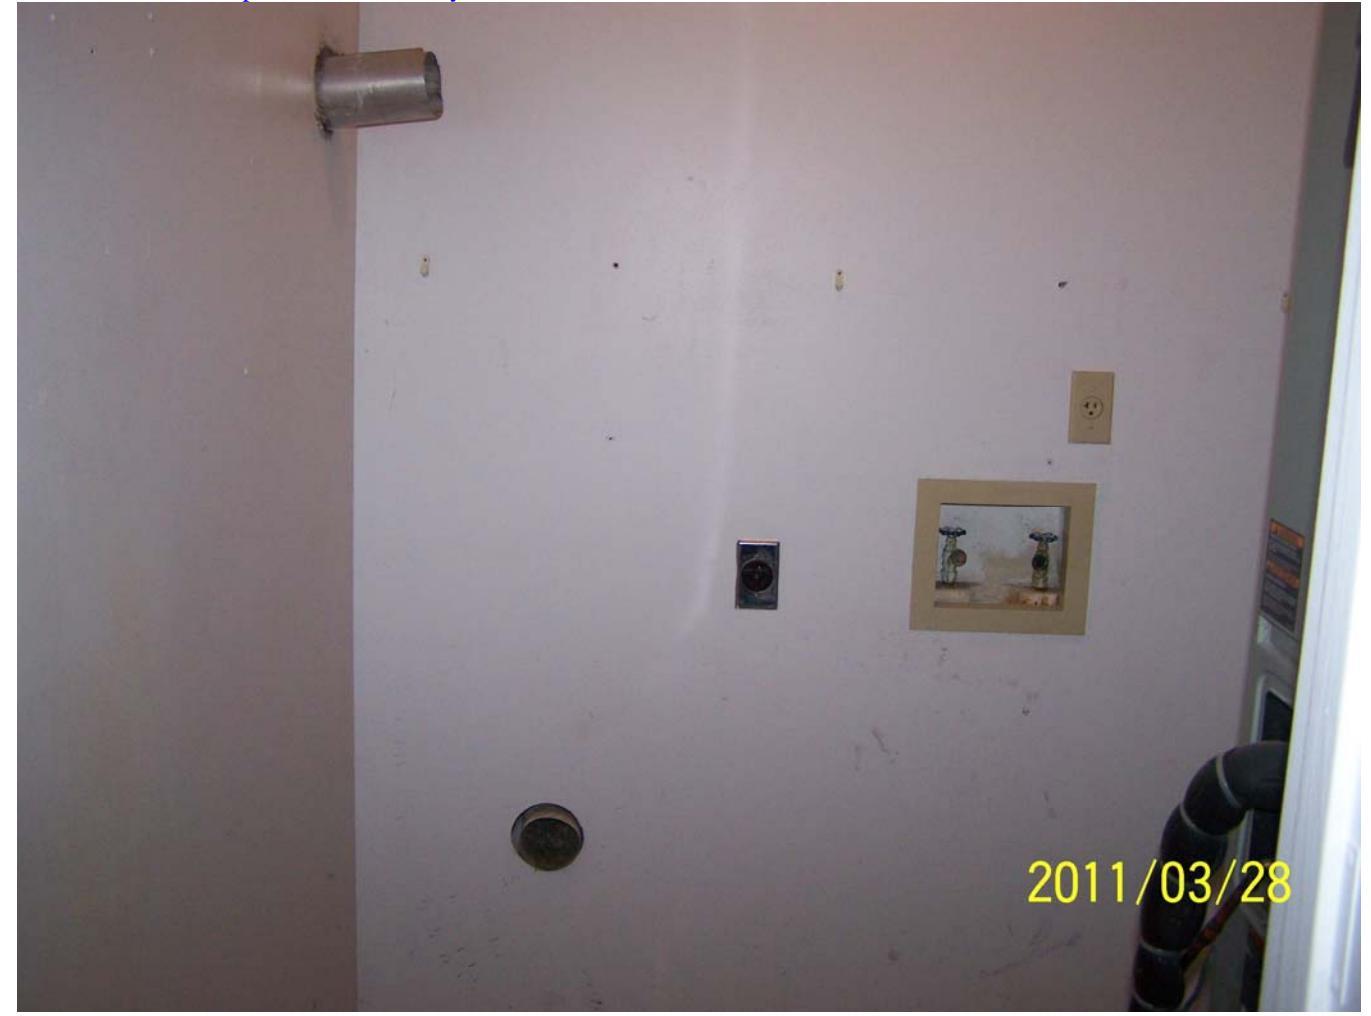
Dryer should be vented. Recommend periodic cleaning of dryer vent system once repaired. It appears that the previous dryer was vented through the wall to the garage as well as through the wall and upward to the attic – recommend repair and vent the dryer to the outdoors.

Two holes in walls for dryer vent

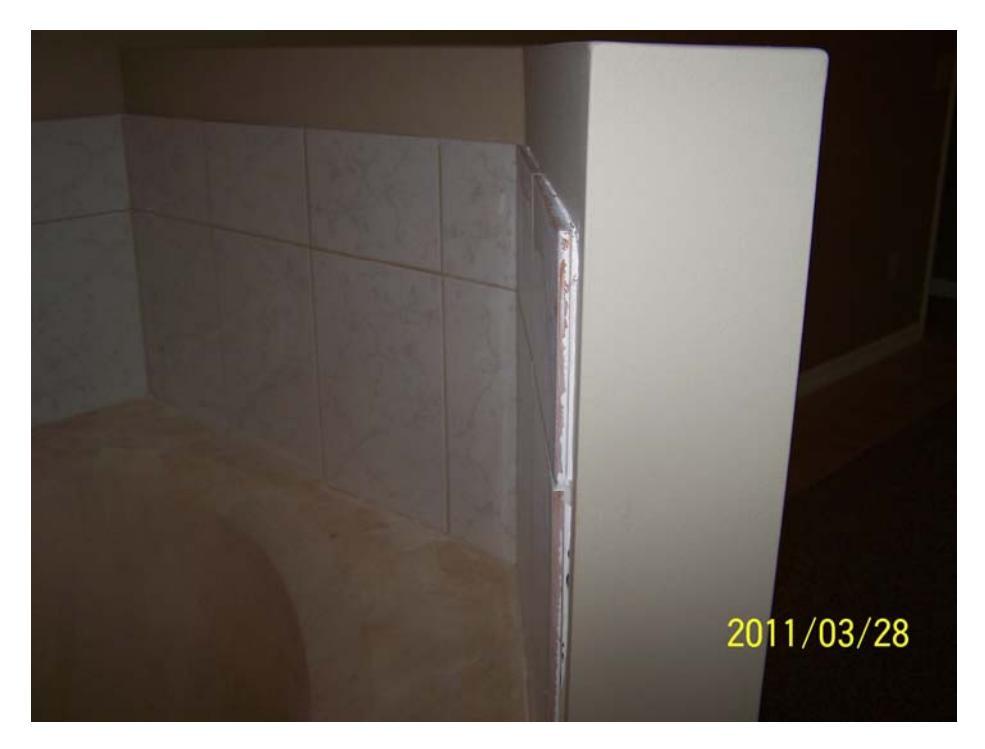
Unfinished tile work at soaking tub - master bath

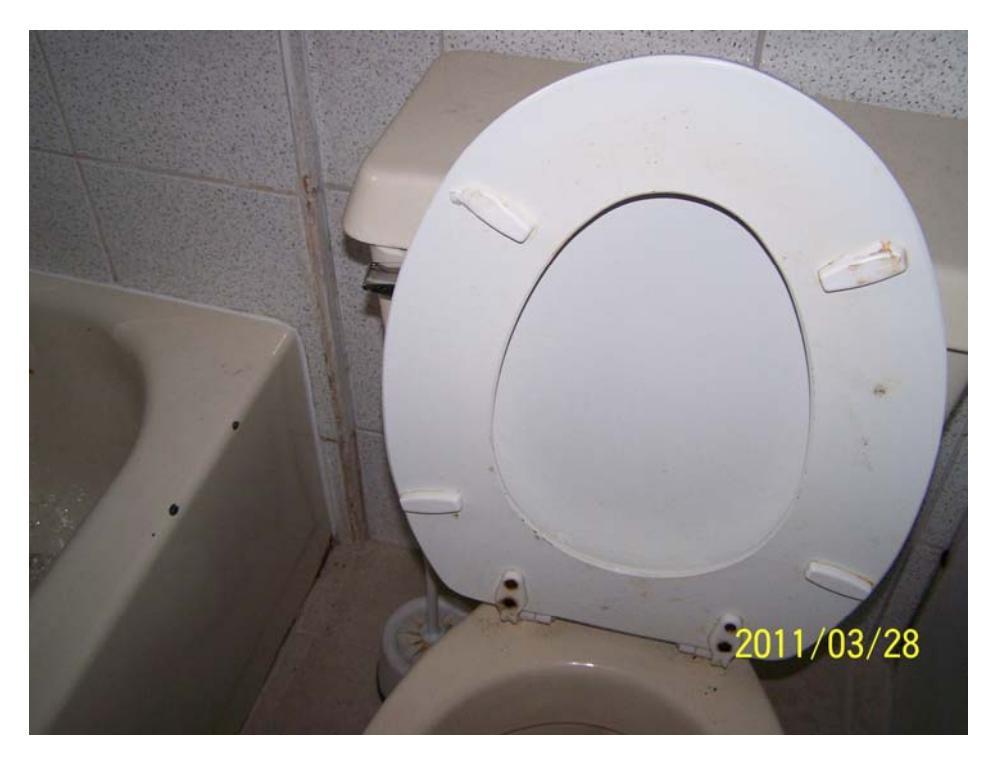
Tub chips and toilet seat - guest bath

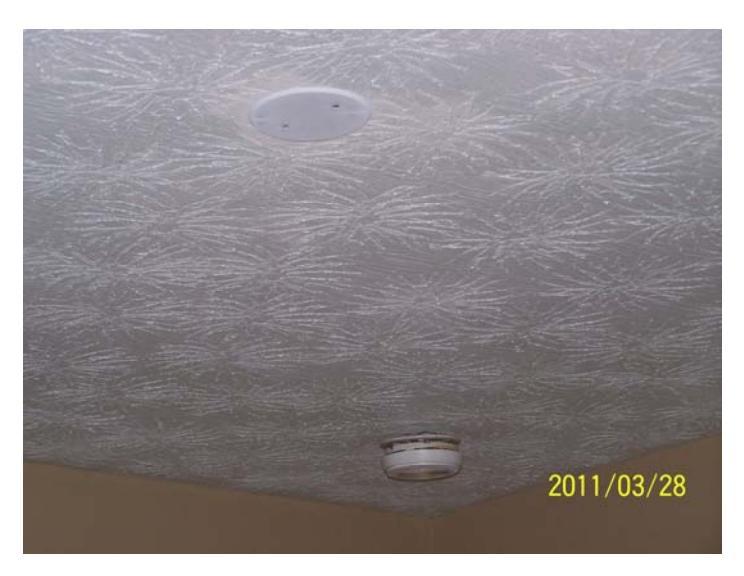
No ceiling fan or light in dining and living areas – cover is over electric boxes in ceiling.

Ceiling over dining area - loose smoke detector outside of master bedroom

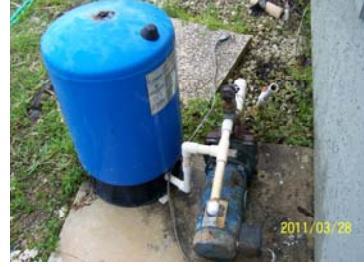
Blue tank and pump by A/C unit not connected – water faucet does work and emits water when turned on.

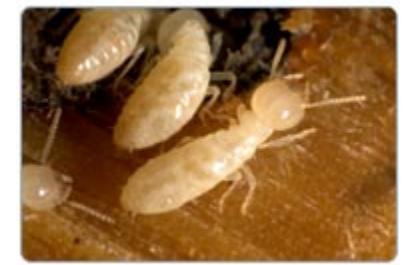
Termite inspections by others revealed that there are termites in the outer garage wall. Termites were observed in the outer garage wall by an authorized professional inspector from Massey Services, Inc. Recommend professional treatment of termites and repair/replacement of termite damaged areas of the home.

Typical termites
