BRDR250TECH

# Remanufacturing the Brother DR-250

This new family of multifunction machines was released to replace the now discontinued Brother HL 720. Like the HL720, these machines use separate drum and toner units. Similar looking in appearance to the DR200, the new DR-250 uses different drum gears and employs molding differences in the cartridge prevents the cartridges from being interchangeable.

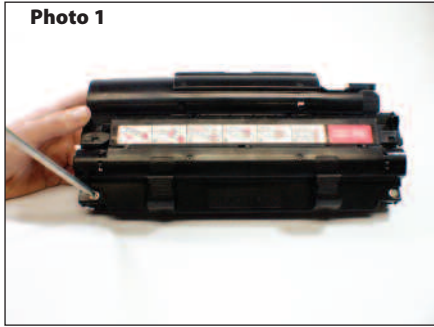
**Step 1**

Remove the two Philip screws from the top of the drum unit.

(See Photo 1)

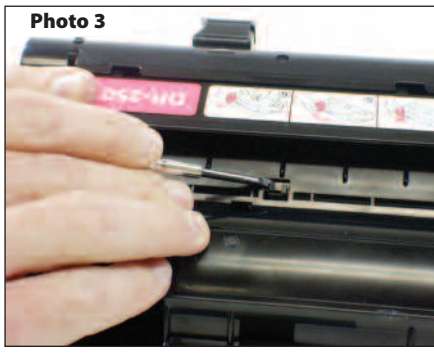
Photo 4

Step 3: Using a small flat blade screwdriver, release the two locking clips on the back of the cartridge. (See Photo 4)

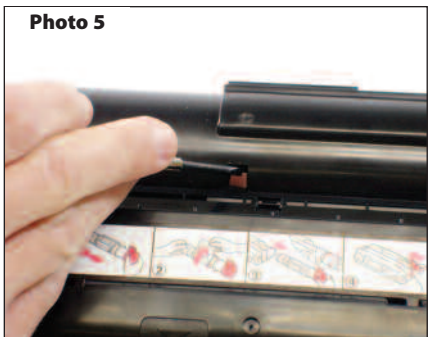
Photo 5

**Step 4**

Next to the locking tabs located on the top of the cartridge there are two slots where you can see the metal toner filling cover. Using a screwdriver push the cover down (towards the drum) till the guide tab is exposed.

(See Photo 5)

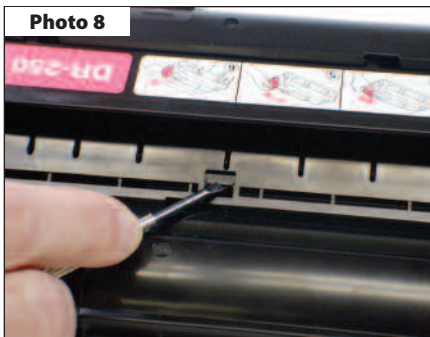
Photo 8

**Step 6**

Using a flat blade screwdriver release the two locking tabs from the top of the cartridge.

(See Photo 8)

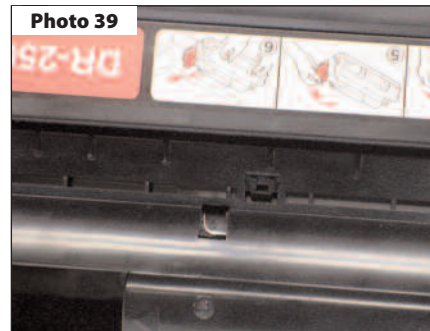
Photo 39

**Step 36**

Slide the toner fill cover plate up so the top of the plate covers the guide tabs on the top section of the cartridge.

(See Photo 39)

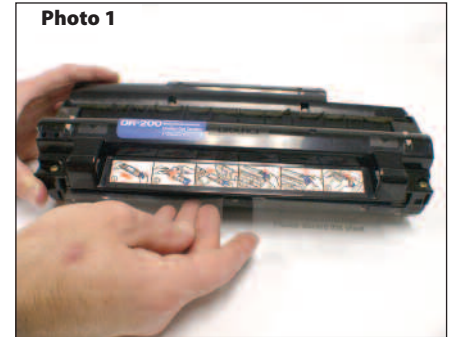
Photo 1

**RESETTING THE DRUM COUNTER****Step 1**

Install the jagged end of the clear reset sheet into the cartridge between the drum and transfer roller.

(See Photo 1)

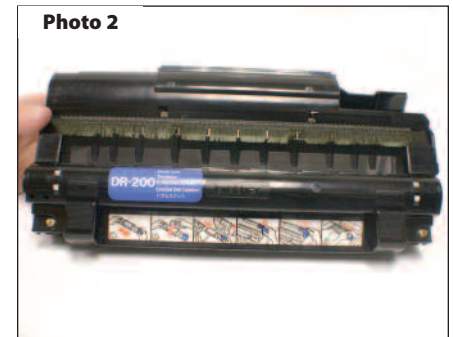
Photo 2

**Step 2**

Rotate the drum so the reset sheet is fed into the cartridge and the end of the sheet is flush with the end of the cartridge with the jagged end of the sheet sticking out the top of the cartridge. (See Photo 2)

**NOTE:** Once the sheet is fed through the printer, the machine will reset the drum counter.
