TurboChef Technologies Inc.

Field Service Bulletin

File: *FSB10036*

TurboChef C-Series ovens operational issue

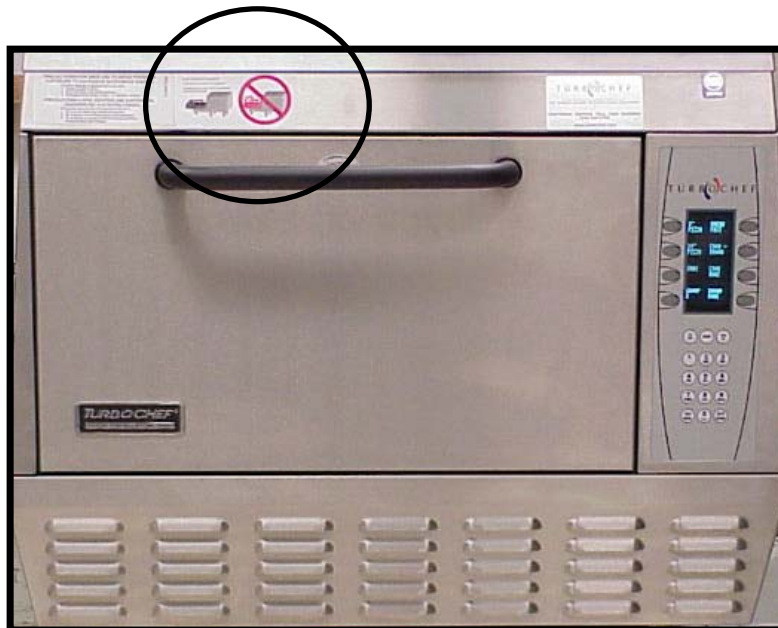
Incorrect (backward) installation of cooking platter causing door open and operational issues.

1. Prepare oven top trim surface next to top left sticker "Exposure to Microwaves" by cleaning and removing grease residue using Oven Cleaner.
2. Once you have cleaned the surface, peel back of new sticker and place next to existing sticker with a minimum of 1/4" clearance. See Figure 1 for overview and figure 2 for details.
