COGKNOW

D4.3.1

Field Test # 1 Report

WP 4 Field Testing

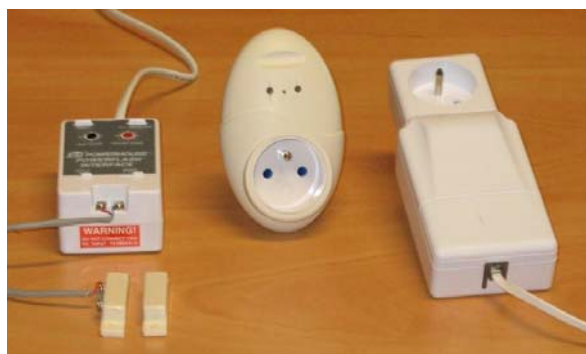
Figure 5: CSH door controller, door sensor, radio controller and X10 controller

The CSH consists of a sensor that could be placed on any door. The sensor communicates with the CHH. When the door was left open, the sensor sent a signal to the CHH which issued a safety warning to the user via the touch screen. The user could confirm (turn off) the safety warning by closing the door.

It was discovered that **X10** equipment does not work well with three-phase power distribution. The workaround was to ensure that the X10 controller, the on/off unit for the radio and the door sensor were all connected to the same phase group.
