1. Report No. FHWA/TX-08/0-4834-2	2. Government Accession No.	3. Recipient's Catalog No.	
4. Title and Subtitle Winter Maintenance Issues Associated with New Generation Open-Graded Friction Courses		5. Report Date February 2007

14. Sponsoring Agency Code	
15. Supplementary Notes Project conducted in cooperation with the Texas Department of Transportation and Federal Highway Administration. Project Title: <i>Cold Weather Performance of New Generation Open-Graded Friction Courses</i>

Winter Maintenance Issues Associated with New Generation Open-Graded Friction Courses

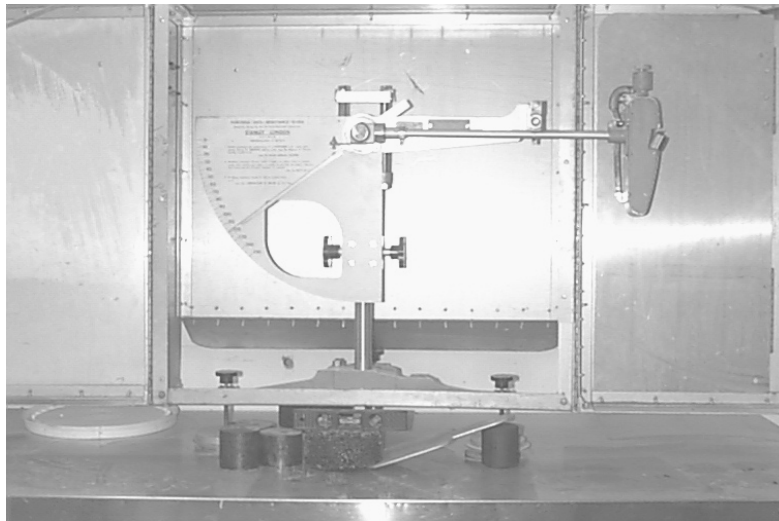
Figure 3.1: British Pendulum Tester

The British Pendulum Tester (8) is one of the simplest and cheapest instruments used in the measurement of friction characteristics of pavement surface. It is extremely versatile in its applications to many test situations and has received acceptance worldwide. The test device measures low-speed friction (about 10 km/h) and is commonly used to assess the microtexture of pavement surface. The values measured, BPN = British Pendulum (Tester) Number for flat surfaces and polish values for accelerated polishing-wheel specimens, represent the frictional properties obtained with the apparatus and the procedures stated herein and do not necessarily agree or correlate with other slipperiness-measuring equipment. Figure 3.1 shows a British Pendulum Tester.

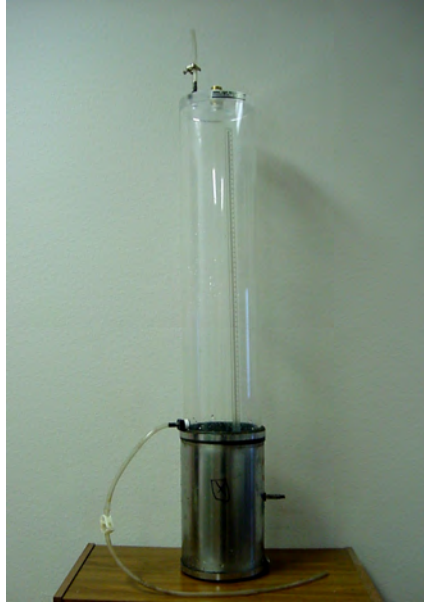
Figure 3.2: Permeameter

The Permeameter measures the permeability of porous asphalt road mixes under laboratory conditions. This apparatus works on the falling head principle, from which the falling head with time through a porous specimen is measured with a precise pressure transducer at very close time intervals (10 readings/s). Using the falling head data, the specific discharge through the specimen can be computed and the permeability of the material obtained from the velocity versus hydraulic gradient relationship (9). Figure 3.2 depicts an image of the Permeameter.

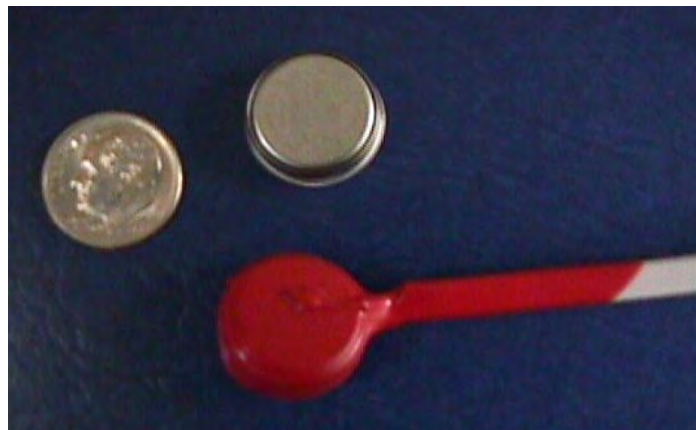
Figure 3.3: Dallas Semiconductor Thermochron

Thermochrons, or “i-Buttons,” are the size of a thick dime and contain a temperature sensor, a battery, a network interface, and computer memory. With a waterproof coating of epoxy or latex, they can be reliably embedded in asphalt or concrete pavement and log precise temperature data effectively for a period of up to 10 years, taking a reading every 30 minutes for 6 months at a time. The data are then uploaded through a simple twisted wire pair to a palm or laptop computer. Figure 3.3 shows the relative size of the Dallas Semiconductor Thermochron.

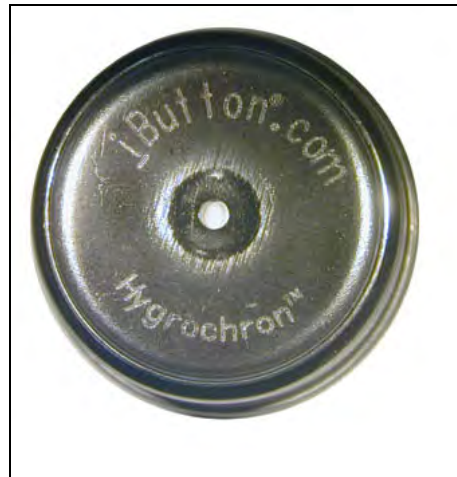
Figure 3.4: Hygrochron

Hygrochrons are similar to Thermochrons but with an added humidity sensor and moisture permeable membrane. They can measure temperature with about a 0.06°F resolution, along with relative humidity. Hygrochrons are self-powered and logging like Thermochrons, so no computer or external microcontroller is required for operation (10). Figure 3.4 shows a picture of the Hygrochron.

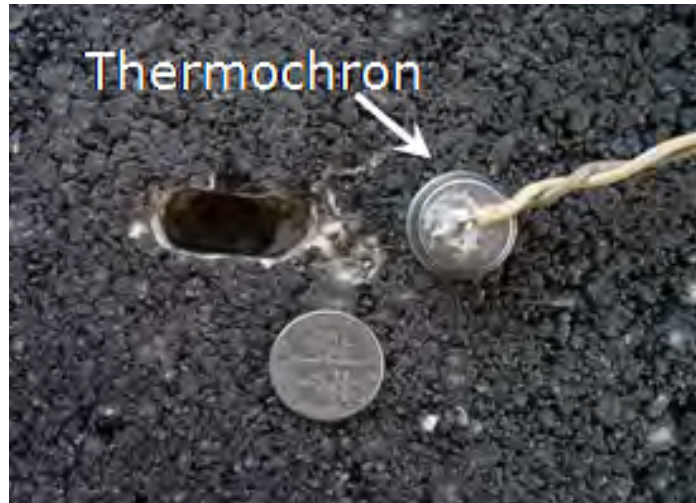
Figure 4.1: Dallas Semiconductor Thermochron i-Button.

The objective of this phase of the research was to develop a methodology for studying in-situ formation of black ice in permeable pavements. The two types of sensors chosen for the field work were the Thermochron and Hygrochron i-Buttons (Fig 4.1), manufactured by Dallas Semiconductor, a subsidiary of Maxim Corporation. The Thermochrons measure and log temperature; the Hygrochrons measure and log relative humidity.

The Thermochron i-Button is a self-contained, dime-sized computer and temperature sensor that is capable of logging 2,048 (8,192 with the expanded model) temperature readings and storing them for as long as 10 years. The devices can be programmed to begin logging at a preset date and to stop at a specified second date. Because of these features and because they require no external device to capture the data, they can be reliably embedded in asphalt or concrete pavement at any depth. The data is then uploaded through a simple twisted wire pair to a palm or laptop computer.

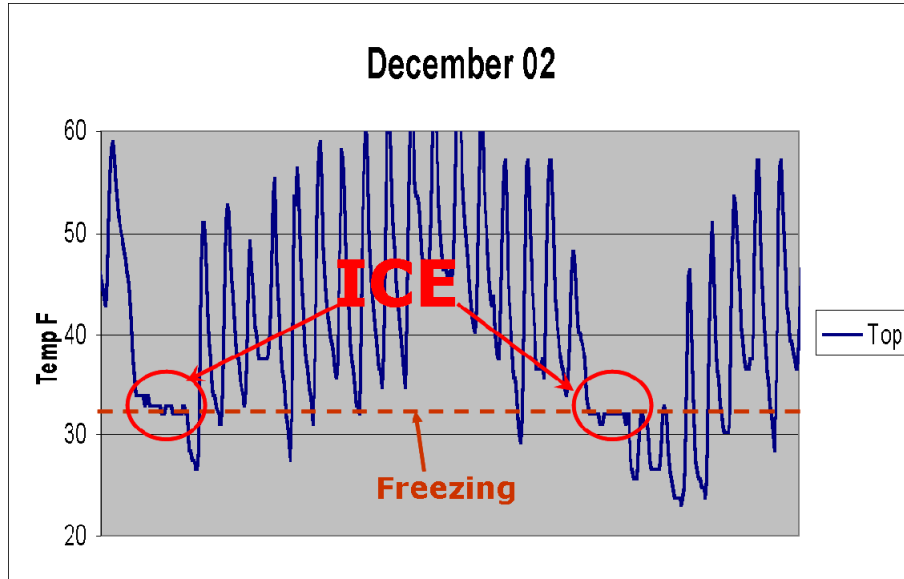
Concurrent research, Project 0-1778 (12), was conducted in North Texas to measure winter temperatures at several depths in existing concrete pavement. In this case, the devices were retrofitted into the pavements by drilling and sealing with quick set epoxy. The purpose of this experiment was to determine the minimum internal temperatures of the concrete during the winter season. Data from the 3 years of the field study also indicated that the presence of ice on the pavements could easily be detected (Fig 4.2).

Figure 4.2: Ice on CRCP, Amarillo, Texas

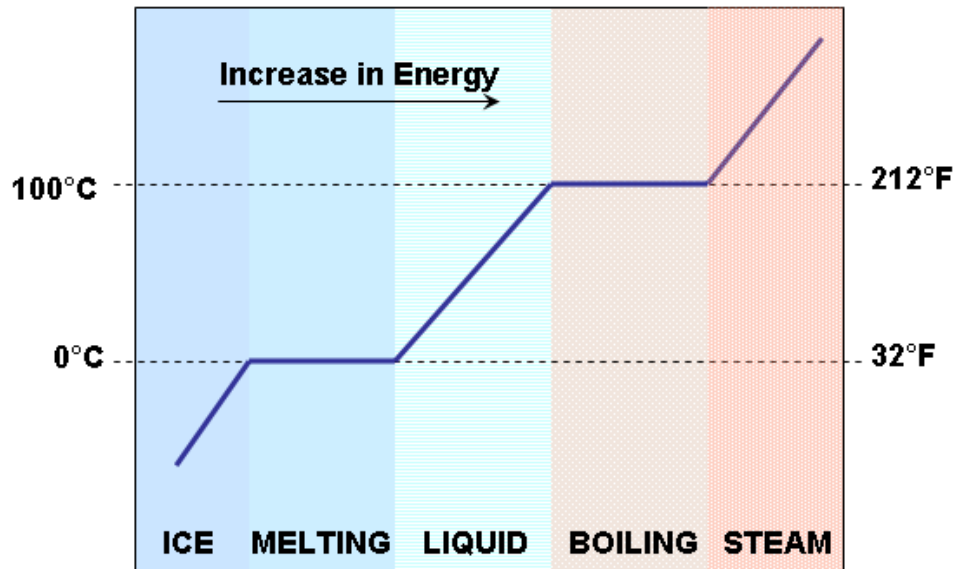
The specific latent heat of fusion of a substance is the amount of heat required to convert a unit mass of the solid into the liquid (or vice versa) without a change in temperature. The specific latent heat of fusion of ice at 0°C is $\frac{335\text{kJ}}{\text{kg}}$. This means that to convert 1 kg of ice at 0°C to 1 kg of water at 0°C, 334 kJ of heat must be absorbed by the ice. Conversely, when 1 kg of water at 0°C freezes to give 1 kg of ice at 0°C, 334 kJ of heat will be released to the surrounding area. During freezing, this energy is released while the measured temperature of a porous pavement remains constant at 0°C until all the water has changed phase from liquid to solid and vice versa for thawing. This characteristic temperature plateau (Fig 4.3) can be readily detected by the embedded sensors and is positive proof that ice is present if the plateau does not appear in an analogous ambient measurement taken away from the pavement.

Figure 4.3: Phase change temperature plateaus illustrating latent heat of fusion in water

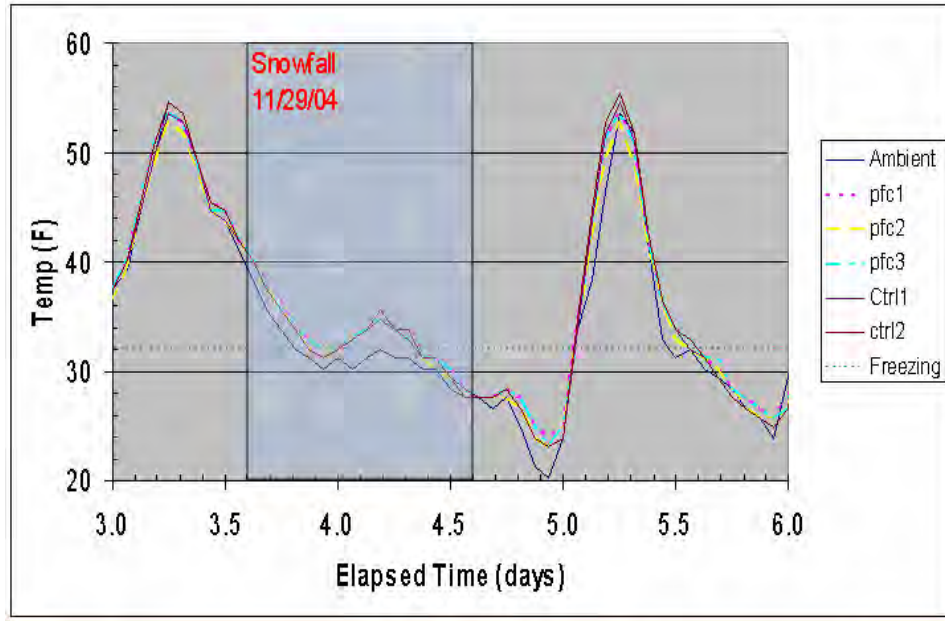
One such freezing events, which took place on November 29, 2004, is illustrated in Figure 4.4, with a plot showing the temperatures recorded by the three sensors embedded in the NGOGFC pavement (pfc1, pfc2, and pfc3), the temperatures from the sensors in the control section, and the ambient sensor temperatures. The onset and duration of the snowfall event superimposed on the chart was obtained from NCDC precipitation records.

Figure 4.4: Snowfall event at Amarillo test section, November 29, 2004

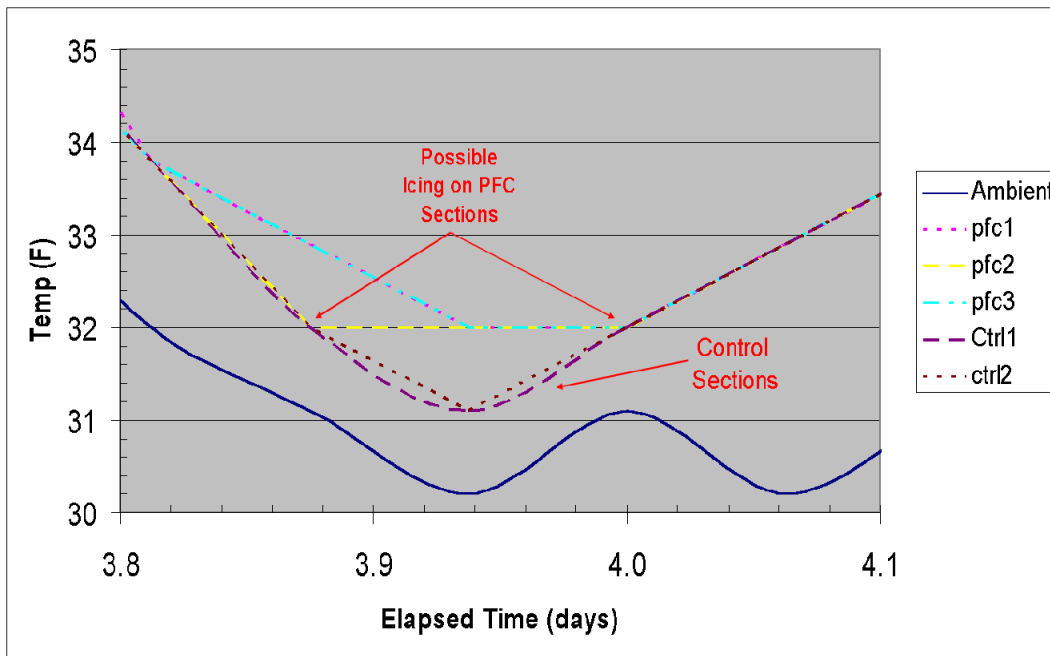
The focus of the chart is narrowed even further in Figure 4.5, to show the individual data points from all the sensors during this first freeze event. As expected, the three NGOGFC sections show a brief temperature plateau at exactly 32° F (latent heat being released as the water freezes), whereas the two control sections do not. This confirms that the NGOGFC surfaces are more susceptible to the development of black ice than the conventional, dense-graded pavements.

Figure 4.5: Possible evidence of black ice in NGOGFC section in Amarillo, November 29, 2004.

The remaining freeze events with precipitation and those in the subsequent winter season were examined for similar evidence of black ice. Some appear similar to Figure 4.5 above; others do not. The reason is that there was no freezing or thawing that took place during the precipitation event, i.e., there was no change of phase.

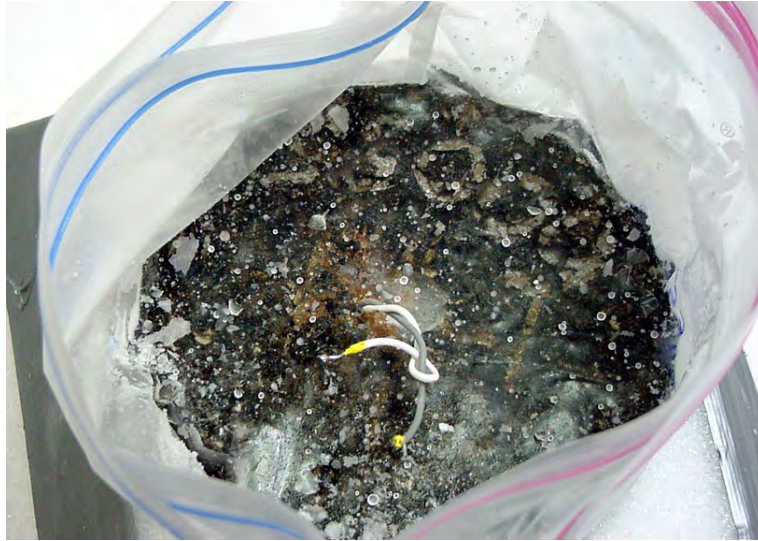
To further study the development of black ice in NGOGFCs and validate the detection methodology in the laboratory, two samples were prepared from the most commonly used mix designs from the northern part of Texas. These 6-in. diameter specimens, insulated on all sides with Styrofoam except the top to simulate field pavement and saturated at different levels, were placed in a deep freezer and then frozen and thawed repeatedly to reproduce black ice formation as it occurs in the field. Thermochrons and Hygrochrons were inserted at the top and the bottom of the specimens to allow for precise logging of temperature and humidity. The onset, depth, and duration of black ice formation were recorded for each specimen. De-icers and anti-icers were applied as well. Figure 4.6 shows a picture of black ice that formed in one of the specimens. Notice the plastic bag in which the specimen is placed to retain water and the wires to download the sensors' data.

Figure 4.6: Black ice formation in one of the NGOGFC laboratory specimens

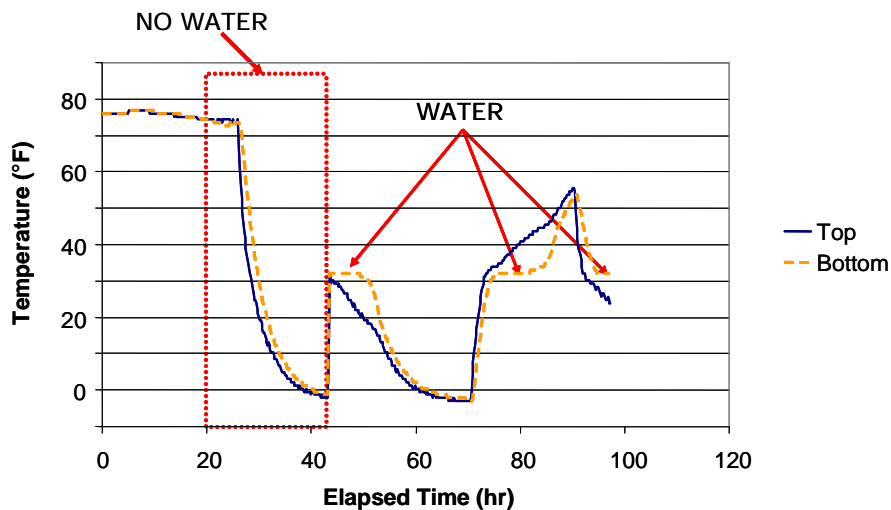
To illustrate the usefulness of the sensors in the detection of black ice, temperatures during the freeze-thaw cycles, with and without the presence of water, are shown in Figure 4.7 for one of the specimens. During the first part of the experiment, the sample was placed in the freezer and no water was added, while the temperature dropped; at approximately 43 hours, water was added up to half of the height of the sample. The temperature plateaus shown for the bottom sensor indicate that, according to the concept of latent heat of fusion, black ice formed at the bottom, but not at the top of the specimen during the ensuing cycles.

Figure 4.7: Example of freeze-thaw cycles with black ice formation in the presence of water in one of the laboratory samples

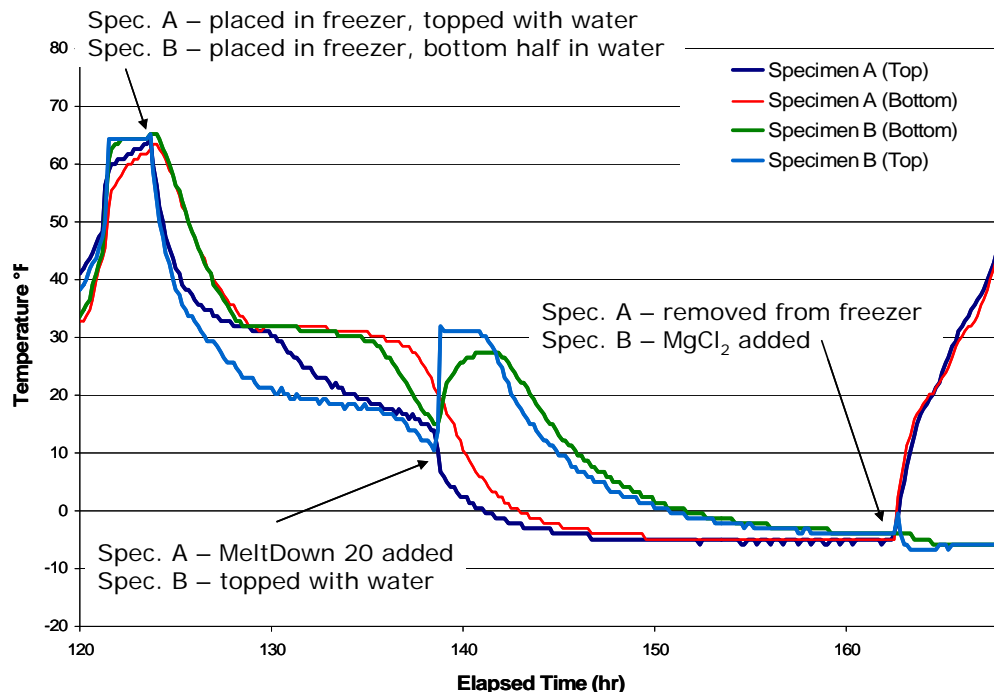
A similar effect can be seen when the magnesium chloride was added, but it is not as prominent because of the extremely low temperature at which the de-icer was added in this case.

Figure 4.8: Temperature changes in both specimens with the application of de-icing or anti-icing chemicals

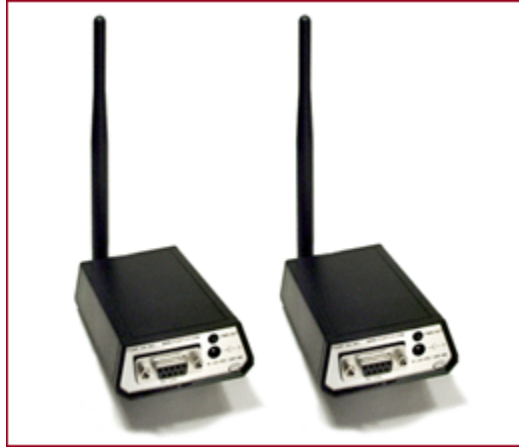
Figure 4.9: Transceivers for the wireless network

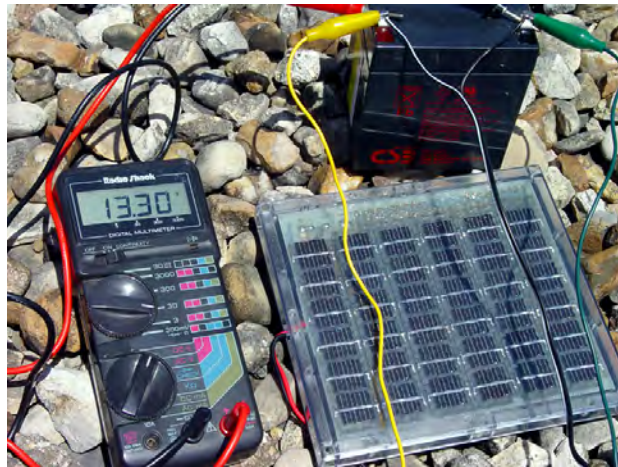
Figure 4.10: Solar panel, meter, and battery

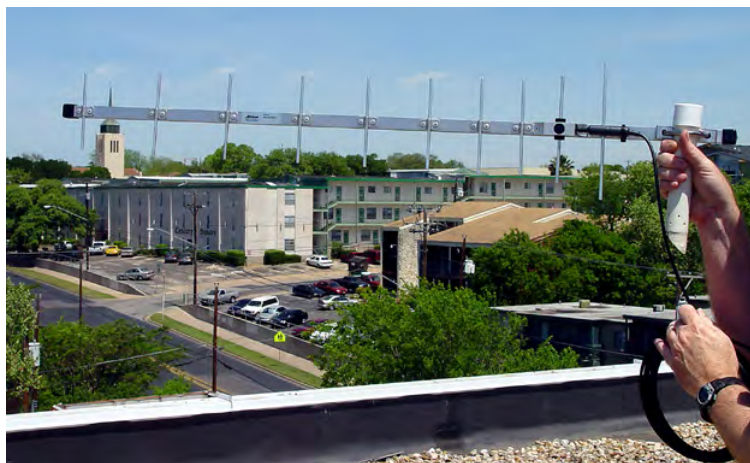
Figure 4.11: Yagi directional antenna with 22-mile range (line-of-sight)

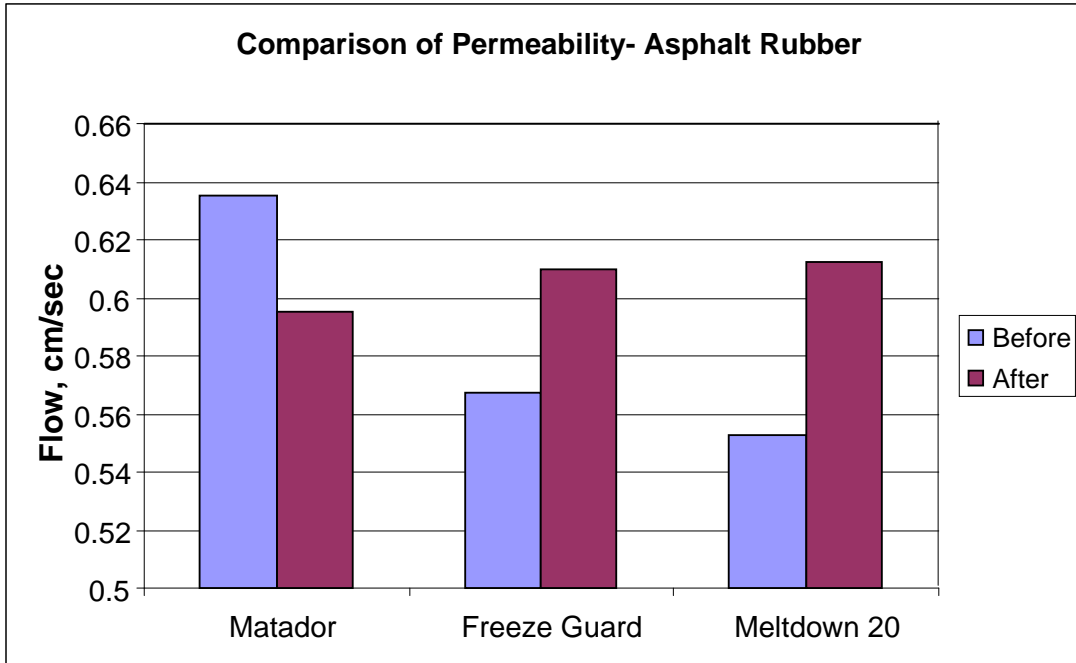
Figure B.1 Comparison of Permeability with Asphalt Rubber Binder.

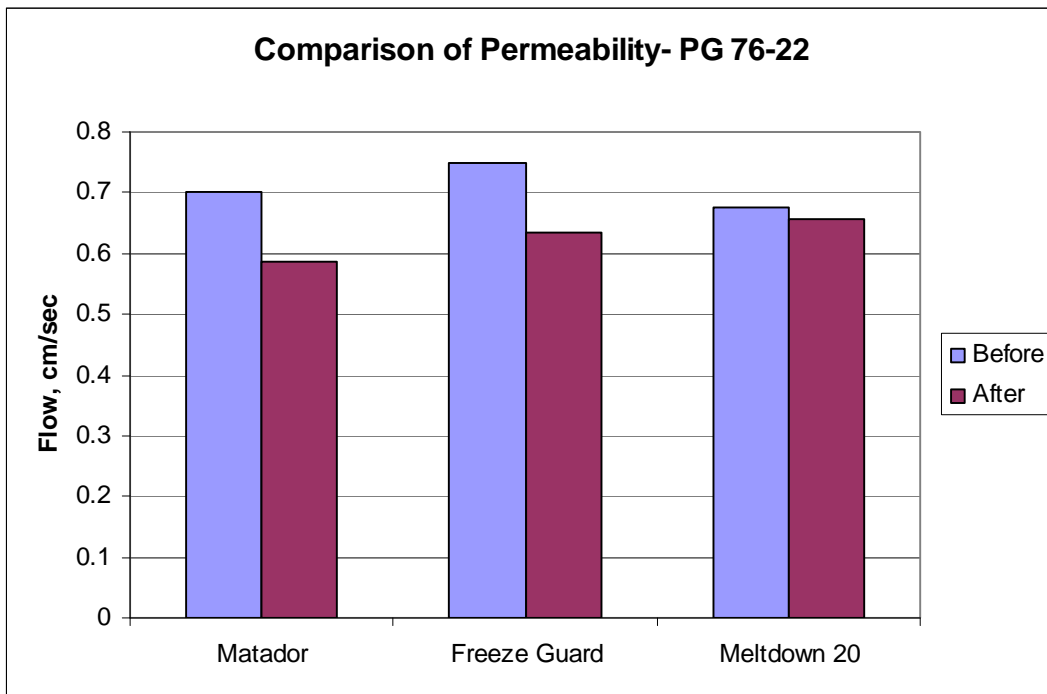
Figure B.2 Comparison of Permeability with PG 76-22 Binder

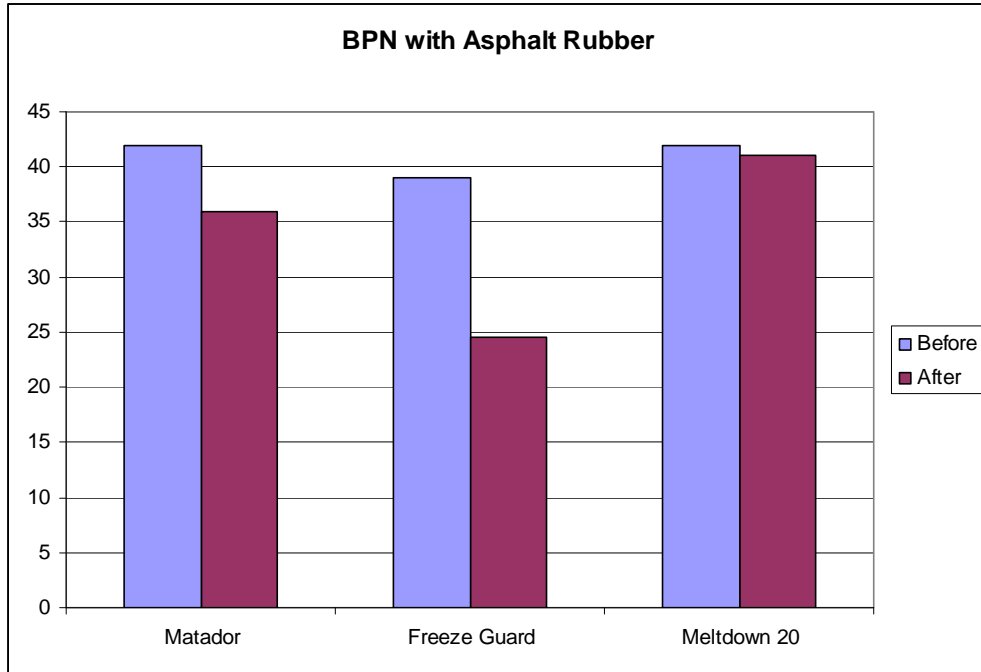
Figure B.3 British Pendulum Number Comparison with Asphalt Rubber Binder

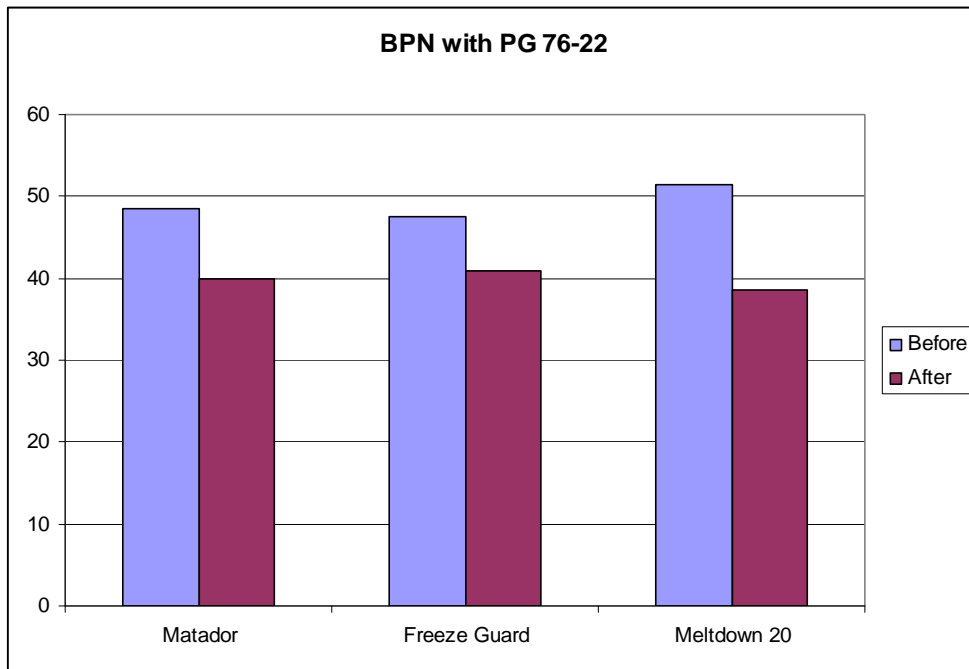
Figure B.4 British Pendulum Number Comparison with PG 76-22 Binder

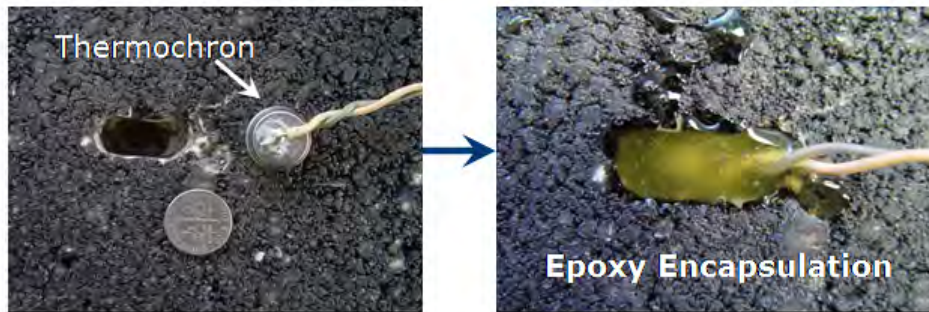
There are three main components to the ice detector. The first is a series of Thermochron and Hygrochron i-Buttons, which will be located in the field. Up to 98 Thermochrons may be installed just below the surface of the pavement, plus at least one Thermochron and one Hygrochron nearby to monitor ambient conditions (a total of 100 devices). All of the i-Buttons may be connected using one pair of 12 gage twisted wire cable because each i-Button has a unique internal address and can share communication with the others. Figure D.1 shows detail of an embedded Thermochron held in place with epoxy; the twisted pair wire would lie in a shallow trench cut in the pavement. Figure D.2 shows a set of three test and two control buttons plus an ambient Thermochron and Hygrochron from an existing installation in the Wichita Falls District.

Figure D.1. Thermochron embedded in asphalt pavement

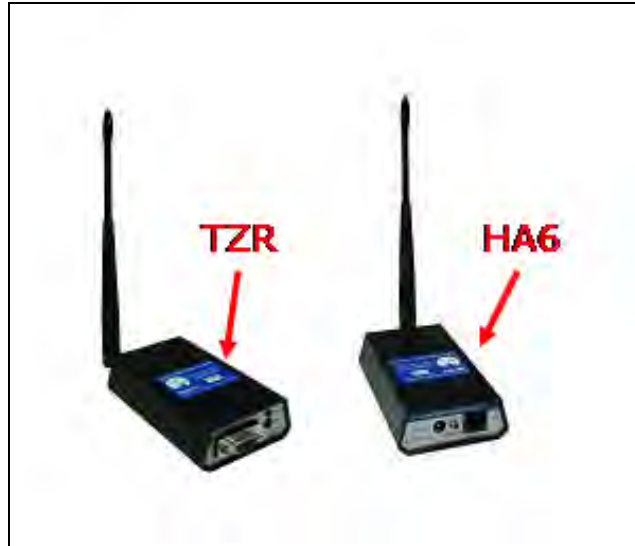
The second component of the ice detector is the control box, which will be mounted on an existing or purpose installed pole near the roadway. The control box will contain an HA6 transceiver connected to the i-Button network and a sealed lead-acid storage battery to power the HA6. A photovoltaic panel will be mounted above the control box to charge the battery during daylight hours. The HA6 is a low power device, consuming 200 ma when actively transmitting but only 20ma when quiescent, which is most of the time since the HA6 will be placed in “query” mode. This allows the device to operate at full power only when instructed by the remote operator to transmit data or receive commands. Figure D.3 shows the HA6. The HA6 has an RJ-11 (telephone) jack on the front panel to connect to the i-Button network.

Figure D.3. TZR and HA6 transceivers

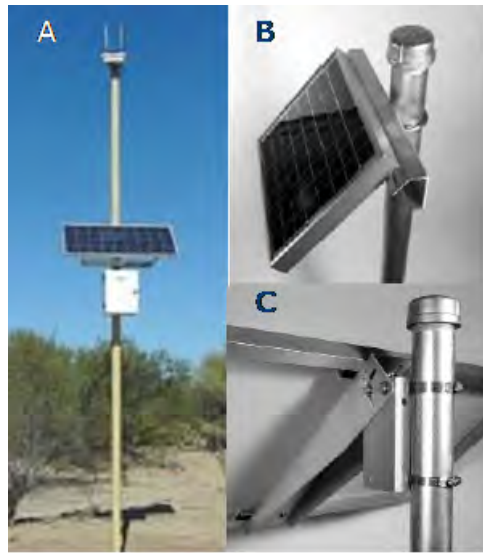
Figure D.4 shows the completed assembly (minus high gain antenna) and details of the solar panel attachment. The solar panel and holder clamp to the post using two U-bolts as shown. The solar panel must be pointed to the south and angled for optimal sun exposure. A table is available from the manufacturer showing the optimal sun angle and also the necessary battery amp-hour capacity, which depends on the installation location, the current draw of the radio, and the duty cycle. Figure D.5 shows a contour map used in this process. As can be seen, most of western Texas is in a high solar radiation zone that, taken together with the very low amp draw of the HA6 transceiver, requires only a fairly small battery in the control box. The ThermoChron and HydroChron have internal batteries and will continue to operate and store data even if the control box battery is completely discharged. Should that happen, the HA6 will resume functioning and can transmit all stored data when the battery is recharged, requiring no operator intervention. The HA6 will operate on any voltage between 6 VDC and 24 VDC.

Figure D.4. Control box and solar panel mounted on pole.

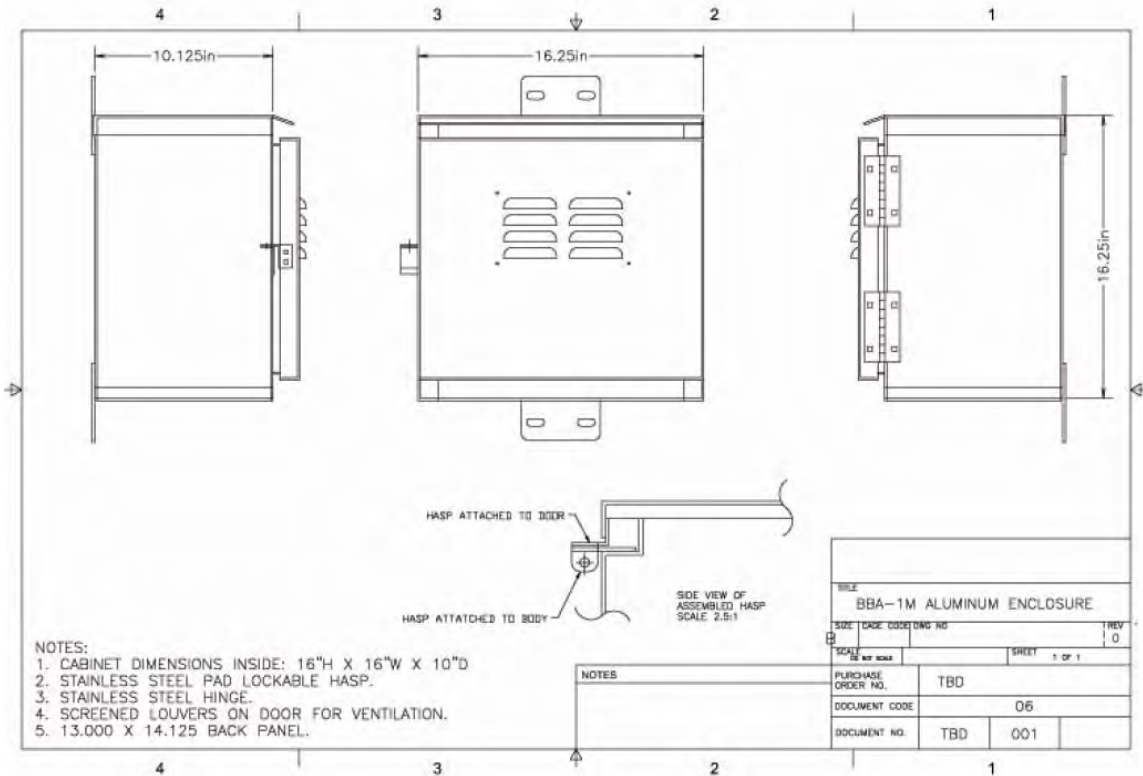
Although any sturdy case for the control box can be machined to fit, purpose built boxes for remote solar powered instrumentation exist and are ideal for this assembly, because they are galvanized (fiberglass and aluminum are also available), vented, have a locking hasp and pre-installed pole mounts, and internal battery mounts and even include a weather-tight connector for RF antenna connection. Figure D.6 shows the layout of one such commercially available enclosure.

Figure D.6. Diagram of a purpose built remote solar powered instrumentation box

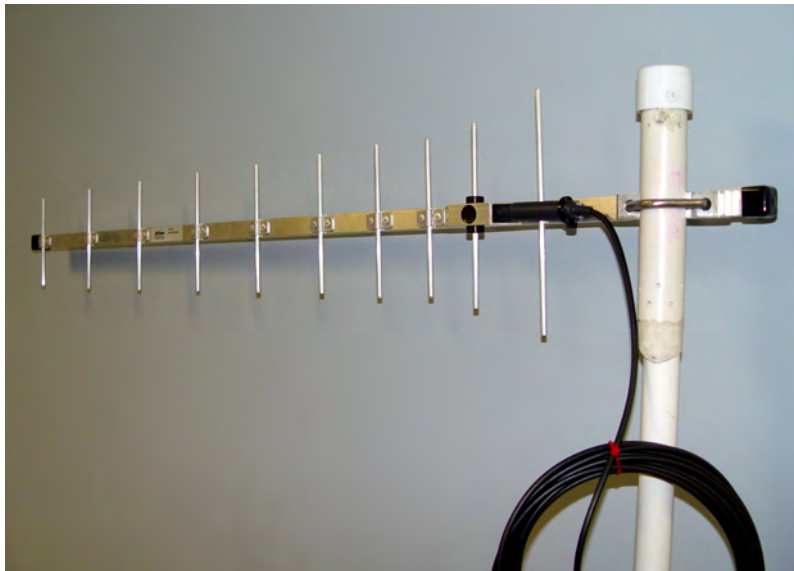
Best performance requires careful aiming of the antenna. Using a handheld GPS device for pointing works fairly well but reading the RF signal strength at the receiver while the field crew (in cell phone contact) rotates the antenna is optimal.

Figure D.7 High gain YAGI antenna showing U-bolt for pole mounting.

The last item to consider is the antenna for the device. The standard, omni-directional whip antennas that come with the transceivers are unity gain and limited by their 200 ma current draw and FCC regulations to a range of approximately 6 miles. This is useful for testing in the office and during assembly but probably not adequate in most situations to communicate between a distant roadway section and the TxDOT office that will monitor the equipment. Fortunately, a 900 MHz directional YAGI antenna is readily available for this purpose (Figure D.6). The connector is the same and the antenna comes ready built with pole mounts attached.

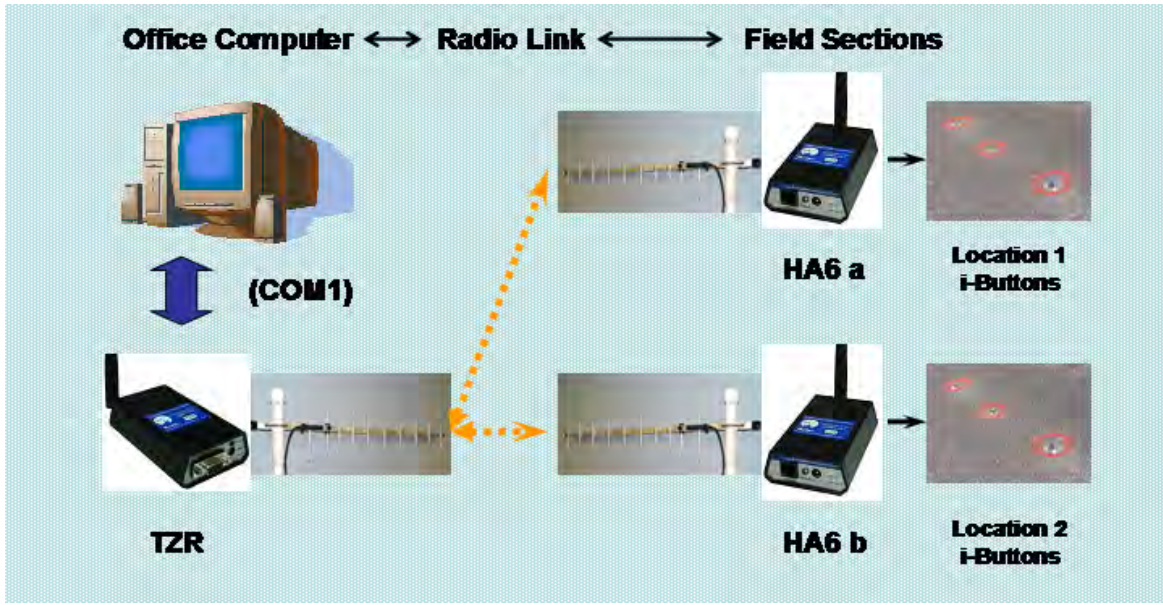
Figure D.8 shows the connectivity concept for up to 2,600 i-Buttons tied to twenty-six field boxes.

Figure D.8 Network topology for ice detection systems
