RIO TINTO IRON ORE – ROBE VALLEY – MESA A

MURDOCH UNIVERSITY

# Investigation, Elimination and Documentation of VSD Faults Causing Downtime at Mesa A

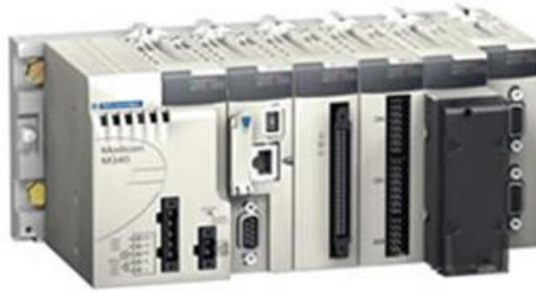
The time taken to perform these steps is known as the scan time of the PLC. The scan time is an important consideration when selecting a PLC. The PLCs used at Mesa A were made by Schneider, a model line called Modicon M340 (see Figure 11). The advantage of this model is that it comes in a series designed for harsh environments with dust and higher normal operating conditions, which makes it suitable for mine site use. The Modicon series is also expandable. This means that if more inputs or outputs are needed they can be added to the limit of the main processor module, these are given in the specification of the PLC and it usually relates to memory availability and processor capabilities, (the module that executes the program). Additional modules exist for analogue I/O, which outputs a signal 4-20mA or 0-5V depending on the module, this is useful for devices which are not just on/off devices, such

Figure 11 Modicon M340 PLC with I/O Modules (Australia Automation 2013)

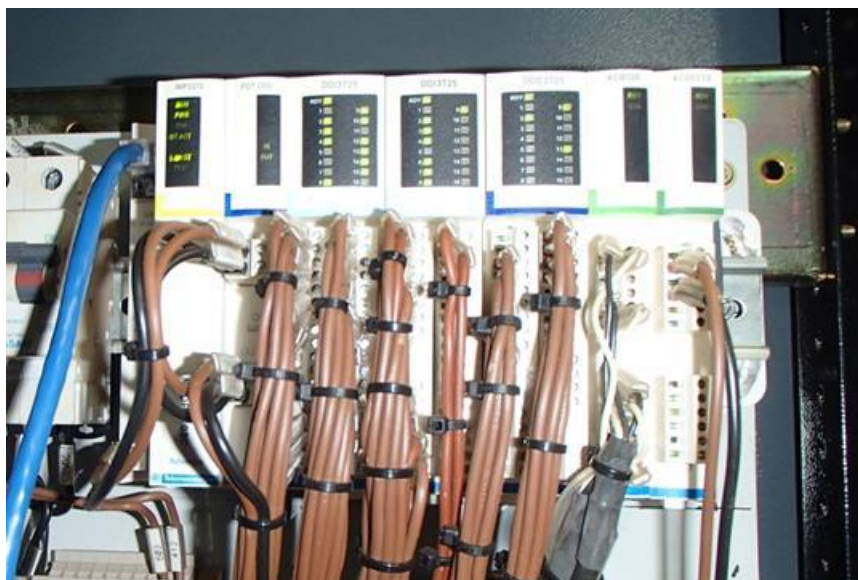
Another advantage is when devices are not near the PLC itself. The Modicon series allows for what is called Remote I/O. At Mesa A the Remote I/O used is the Advantys (Figure 12). A remote I/O module is installed near the device to be controlled, all the required inputs and outputs are terminated into the Advantys module. The module is connected via a single cable (usually Cat 6 although sometimes fibre optic) to the PLC. If there were no Remote I/O modules then either more PLCs would need to be installed or the I/O would have to be run back to the PLC which may be a long distance. The long distance presents the problem of cost of the cable and also loss of signal over large distance. The remote I/O module enables the data to be transferred quickly and reliably to the PLC with just one cable. At Mesa A the protocol used between Remote I/O and the PLC is Modbus TCP/IP. As a result the input and output signals can be sent and updated quickly.

Figure 12 Advantys Remote I/O Module in VSD Sync Cabinet

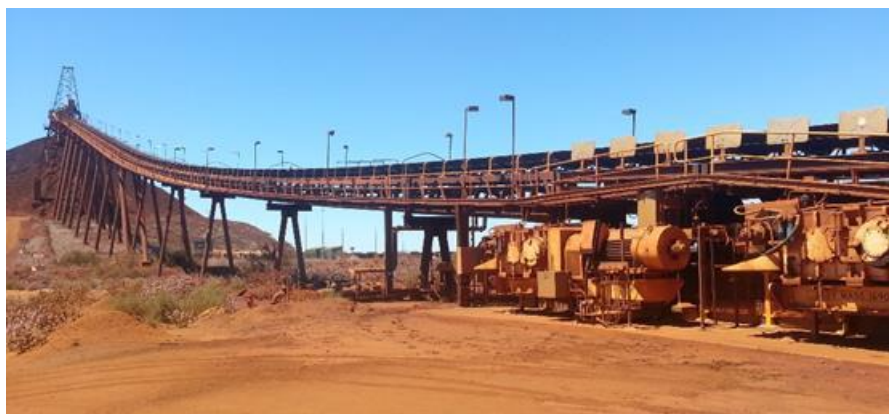
The conveyor belt that transports the crushed ore from the secondary crusher to the stockpile is called CV102 and is in part shown in Figure 20. The motors that are visible in the bottom right are the motors that drive the belt. These are called CV102MO1 and CV102MO2 or MO1 and MO2 for short in this report. The motors are 710kW 3.3kV 4 pole squirrel cage induction motors constructed by Falk.

Figure 20 CV102 (Second Half) Including Drive Motors MO1 and MO2

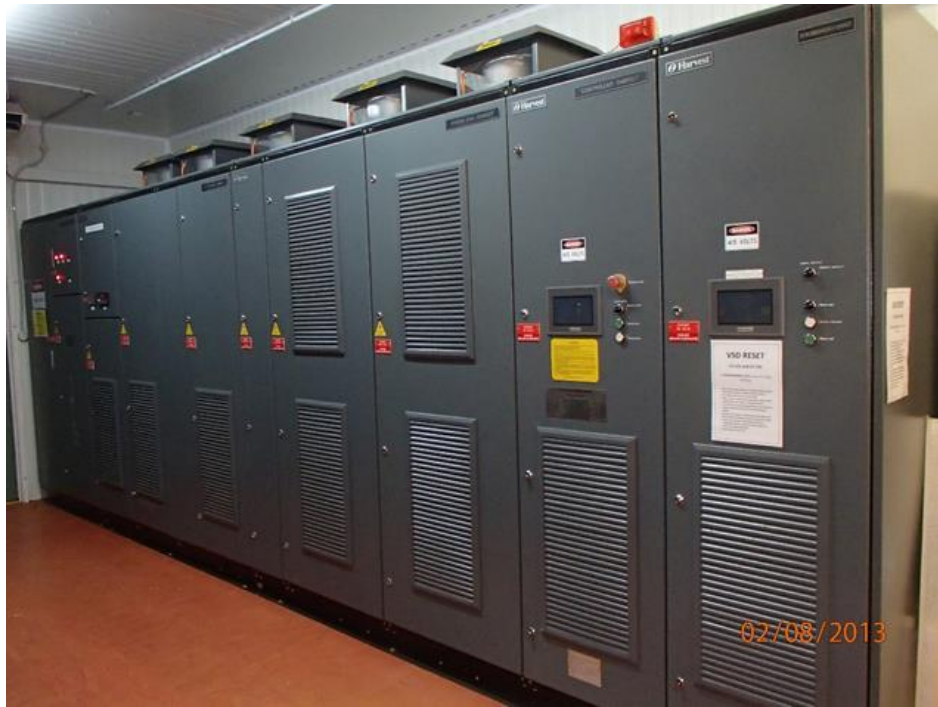
The speed and torque as well as the starting and stopping of the motors is controlled by two VSDs and a Synchroniser. MO1 has its own VSD named CV102MO1VSD, MO2 has its own VSD, named CV102MO2VSD. The synchroniser (CV102VSDSYNC) is not a VSD in the technical sense but throughout the documentation provided by the manufacturer is referred to as a VSD and so this is done throughout the report. The synchroniser plays a vital role in the correct operation of the motors MO1 and MO2. The role of the synchroniser (sync) VSD is to ensure that the load of driving the belt is shared equally between the two motors. By having the load shared equally the wear on the motors is less and the motors are able to run more efficiently. These VSDs were constructed by Leader & Harvest, a Chinese company that specialise in the construction of VSDs. The external cabinets of the VSD are shown in Figure 21.

Figure 21 CV102 MO1 VSD and VSD Synchroniser Cabinet

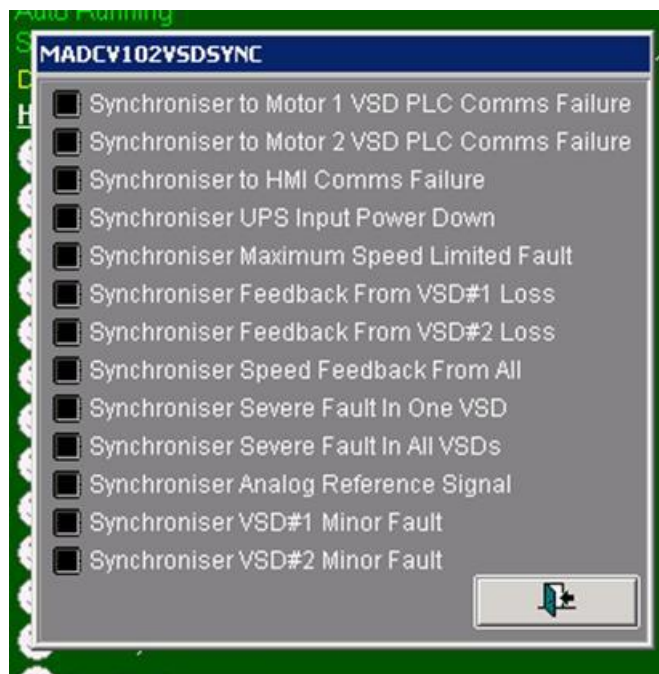
Mesa A mine site uses Citect, the SCADA system produced by Schneider. Operators and Maintainers of the plant rely on Citect to control and monitor the plant. Information from Citect is used as the first step in fault finding problems with the plant as Citect provides alarm and other information that is useful for determining the cause of problems. At the beginning of the project only some information was available on the VSD as shown in Figure 40. The page provided the alarm summary but did not identify the causes of the alarms.

Figure 40 Alarm Summary Citect Mimic

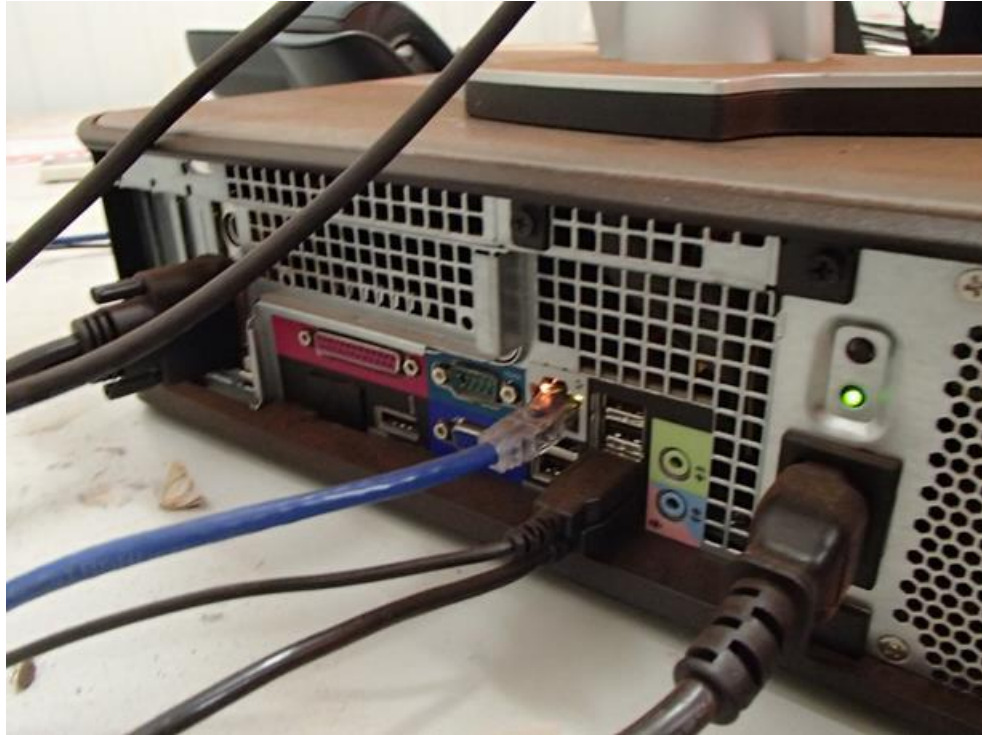
that there are no spare Ethernet connection points available on the PC so a way around this is needed.

Figure 45 PC Connection Availability
