# OPERATING EXPERIENCE SUMMARY

U.S. Department of Energy  
Office of Health, Safety and Security  
OE Summary 2009-03  
March 31, 2009

## Trackhoe Tips Over from Momentum of Rapidly Swinging Boom

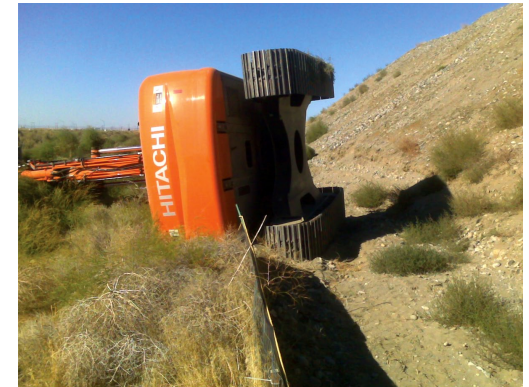
The operator had to raise the trackhoe boom nearly to its full extent to reach the brush located on the upper portion of the spoils pile. After he picked up the brush, he rapidly swung the boom to drop it on the other side of a fence. The rapid swinging of the boom apparently caused enough momentum to tip the trackhoe over.

Investigators learned that extra attachments had been installed on the boom of the rented trackhoe. They believe that the extra weight on the boom from the attachments, the slight tilt that caused one set of tracks to sit 1.5 feet higher than the other, and the rapid swinging of the boom created enough momentum to cause the trackhoe to tip over. Figure 1-1 shows the trackhoe on its side, and Figure 1-2 shows a mobile crane setting it upright following the accident.

**Figure 1-1. Trackhoe on its side post-event**

The contractor was required to address this event by developing a plan that responded to management concerns and included information about how they will impose better work controls, including the following.

- Identifying equipment limitations and communicating them to workers before work begins.
- Documenting on-the-job evaluations of equipment operators before they begin work.
- Developing pre-job planning with hazard recognition and mitigation.

- Demonstrating how adequate field supervision will be provided for each task.

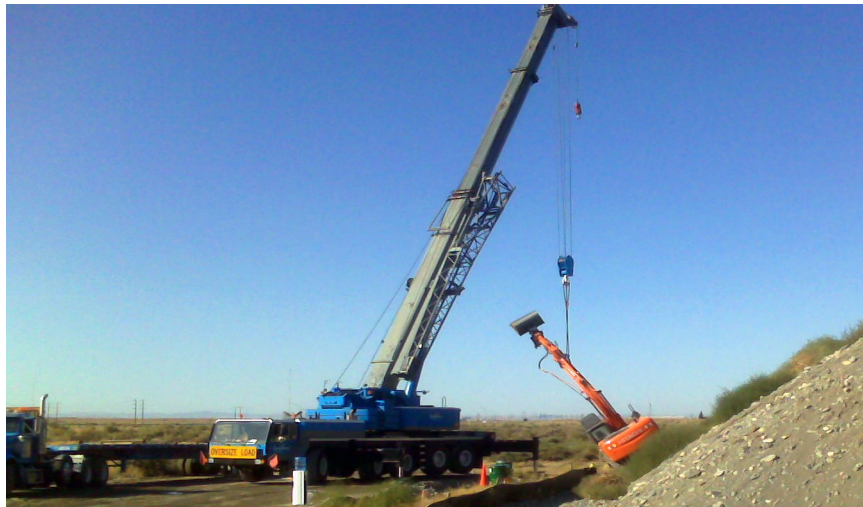
**Figure 1-2. Mobile crane lifting trackhoe upright**

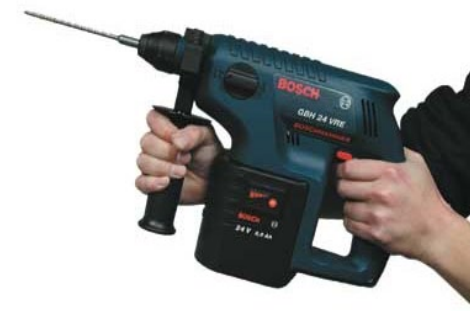
Investigators determined that the worker did not use the manufacturer-supplied auxiliary handle (see Figure 3-1) as required and that his supervisor did not properly instruct him to secure the work piece and use the auxiliary handle.

**Figure 3-1. Example of drill with auxiliary handle (on the front of the drill)**

*When using powered hand-held tools it is important to ensure that all manufacturer-required auxiliary handles are used and that all instructions in manufacturer operating manuals are followed. It is also important to remain focused on the task at hand and to avoid becoming complacent or overconfident.*
