## 1981 – 1985 300SD 722.3 and 722.4 Transmission Adjustment Guide

**Revision 03**

Created by Peter Keun (aka Mahone Bay [www.benzworld.org and www.mercedesforum.nl/forum/]) Updated – January 2014

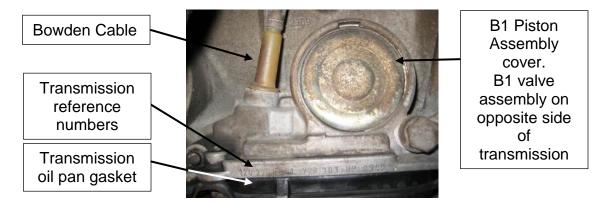
You will need a wire brush and a flashlight (torch for those of you in the UK). On the edge of the alloy casting just above the thick black oil pan gasket and close to the bell housing are the reference numbers. Give this area a good scrub with a wire brush and you should see a numbering sequence like this;

126 2700801 722.303 02 054545

Vehicle	Transmission	Vacuum	Serial
Туре	Туре	Modulator	Number
		Туре	
126 270 08 01	722.303	02	054545

722.0	3 speed
722.1	4 speed / 4 bolt pan
722.2	4 speed / 4 bolt pan
722.3	4 speed / 6 bolt pan / large case
722.4	4 speed / 6 bolt pan / small case
722.5	5 speed overdrive

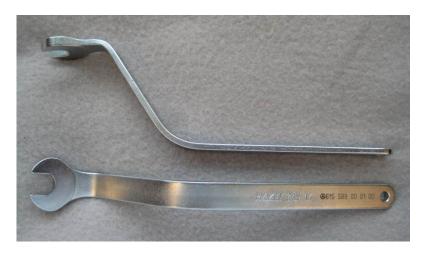
- A good metal divider capable of measuring a distance of up to 20 cm (8"). You will need this to accurate measure each shaft in your linkage system.
- 4. Procedure for adjusting the valves on your vehicle. See Service Manual section 05 210, OR see link further down this page.
- 5. A good quality vacuum gauge.
- 6. A good quality vacuum pump (i.e. MityVac).
- Two 14mm open end wrenches. The Mercedes ones are the best as they have the correct offset. Plan B would be to modify a set of wrenches. You'll need access to someone with welding equipment (Oxy Acetylene) to heat and bend. The MB part number 615 589 00 01 00 (not cheap at €23.67 each incl. 18.5% VAT tax [~\$30 US] but saves time and skinned knuckles). See picture below to see the Mercedes items.

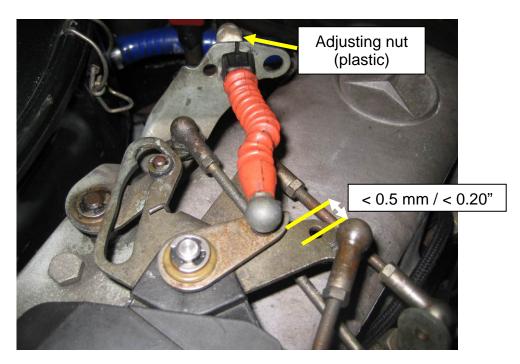
When you are satisfied that the linkage is as it left the factory move to the Bowden cable to the transmission. This is the cable on top of the valve cover next to the air filter housing and has the rubber accordion bellows on it. This cable tells the transmission how far down you have pushed the accelerator. In other words, it will tell the gearbox to downshift under part or heavy throttle. Not to be confused with the kick down switch under the accelerator pedal – that one looks after full throttle downshifts.

This Bowden cable also has an influence on the downshift into first gear when slowing to a stop. If the cable is too loose the transmission assumes you are almost at a stop and downshift. This is often the cause of a harsh downshift into first.

The cable should have a slight amount to no free play  $(0.0 - 0.5 \text{ mm} / 0.0 - 0.20^{\circ})$ . This is difficult to feel so check and double check that you are feeling play in the cable and not pulling the cable or moving the throttle linkage. **(NOTE** – see Update on page 29)

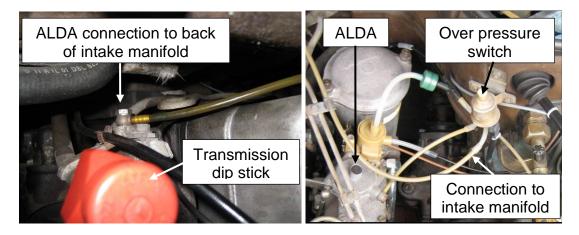
Clean your ALDA (German acronym for Automatische Lade Druck Anreicherung) valve connection to the intake manifold. The ALDA valve ensures the correct fuel mixture during turbo boast. Basically a 'pressure sensor'.

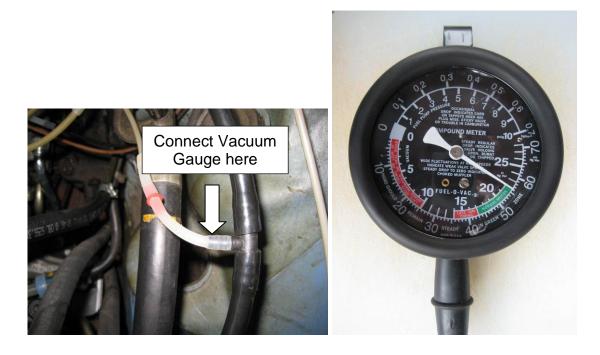
Get out your vacuum gauge and connect this to the port on the hose running from your vacuum pump to your brake booster. This pipe is about 15mm (1/2") in diameter and close to where it goes through the heat/noise shield by the fuse panel you will see a plastic T connector. The smaller hose heading towards the engine is for the Vacuum Control Valve (VCV). Disconnect the small hose and connect the vacuum gauge. Start the engine and note the reading. You should see around 530 to 560 mmHg (21 to 23") of vacuum. If you do not, start checking the hose for leaks. Could be that your vacuum pump needs a rebuild. Do not proceed any further if you do not have a decent and relatively steady amount of vacuum – the needle will bounce for 10 or 15 seconds before giving you a steady reading. See picture below.

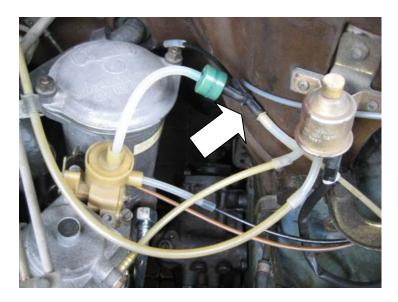
Now check the Neoprene hose connections. These will be inline, 3 way and 4 way connectors (see picture next page). These tend to dry out and crack with age. Replace as required, your MB dealer still carries these. Plan B would be to replace the lines with good quality Neoprene vacuum hose or better yet Silicone hose (3 mm / 1/8" ID). This will allow you to use standard vacuum Ts

and connections as well as eliminating some connections (plastic tube to Neoprene to component fitting). NOTE – in the picture below I have modified the connections with Silicone hose plus the EGR valve is not connected.

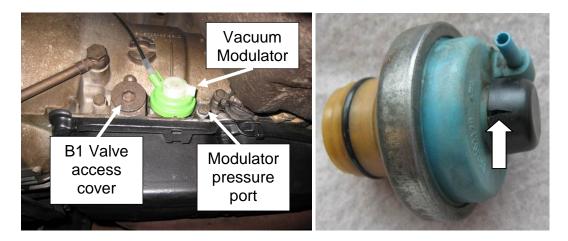
Don't forget to check the vacuum connection to the Vacuum Modulator on the driver's side of the transmission, just above the oil pan and just behind the bell housing (see picture). You have plastic tubing to Neoprene hose to modulator fitting connection plus, and this is important, the little black plastic cap over the Vacuum Modulator adjuster. If this is split or damaged (see picture), it can cause a vacuum leak.

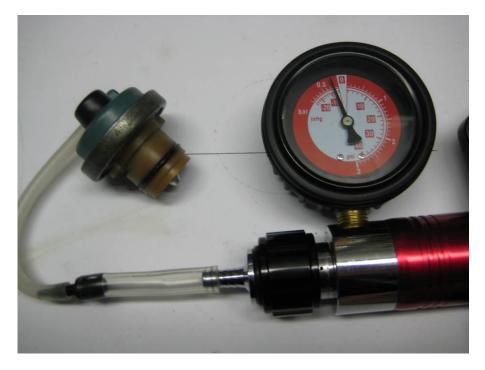
This is where your vacuum pump (MityVac or similar), comes into play. With the engine shut off you can connect the pump up to the line going to the Vacuum Modulator, pump a few strokes to ~250 mmHg (~10"), and see how long it maintains that level of vacuum. A leaky modulator will show up quickly. A good modulator will hold a vacuum for a while (I have not seen specs for the leak down). See picture on the next page.

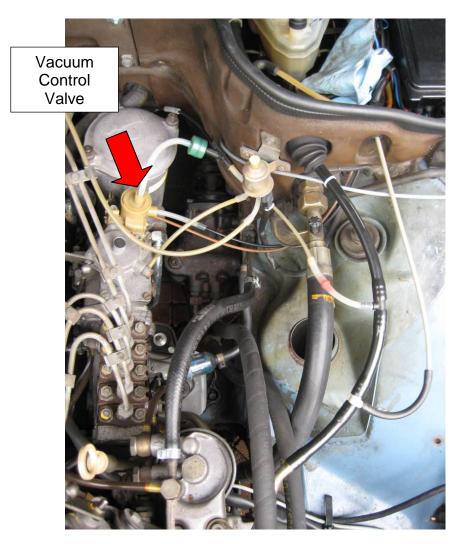
Vacuum to the Vacuum Modulator on the transmission is controlled by the Vacuum Control Valve or VCV (see picture below). Its sole purpose is the bleed vacuum at a controlled rate. It does this through a special diaphragm valve and a connection to the throttle linkage. When you open the throttle the diaphragm is opened and vacuum bled off. The further you open the throttle the less vacuum available to the Vacuum Modulator.

The best method is to do this testing under the hood – VCV removed from the Injection Pump and preferably laying on a flat surface. This will allow for easy and accurate adjustment.

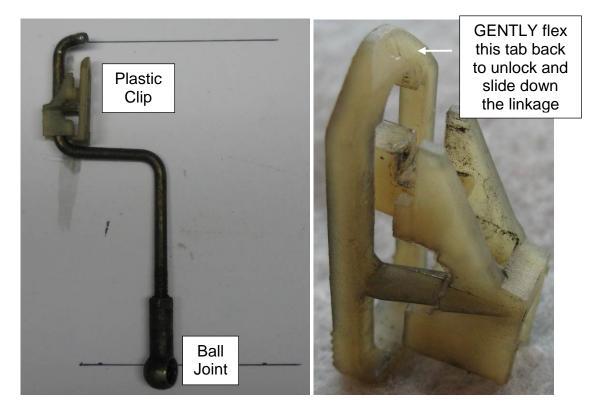
With a large blade slot screwdriver gently pop the ball joint end of the VCV linkage from the Injection Pump linkage. Some of you may prefer to do this using the plastic clip on the linkage arm next to the VCV. However, this clip is very fragile and easily broken – the design is not the best.

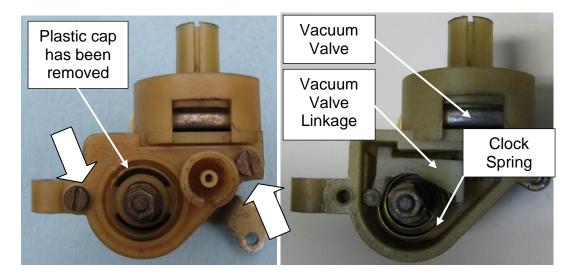
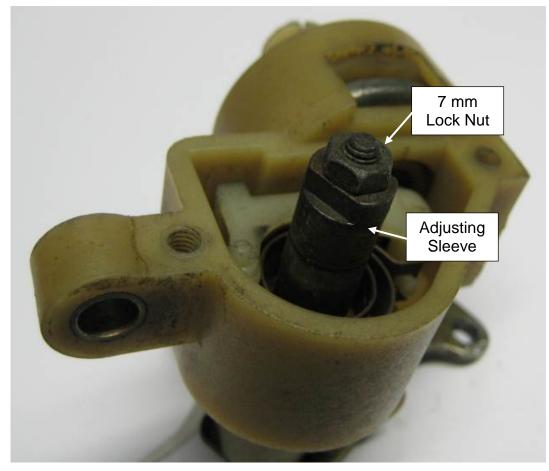
Remove the two slot head screws on the one side of the VCV. This will gain you access to the adjustment mechanism. Grab a 7 mm open end or box end wrench as well as a small Vise Grip or other type of locking pliers. The locking pliers are required to GENTLY turn the adjusting sleeve to obtain the correct vacuum reading. This adjusting sleeve does not act directly on the vacuum valve linkage but does so through the clock spring as seen in the picture below. Note, the plastic cap over the adjustment nut/sleeve has been removed.

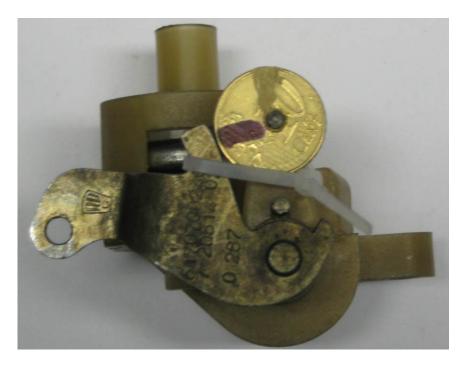
Now attach the coin to the roll pin and with a tie wrap or piece of wire lock the linkage against the coin. You can now proceed with adjusting the vacuum.

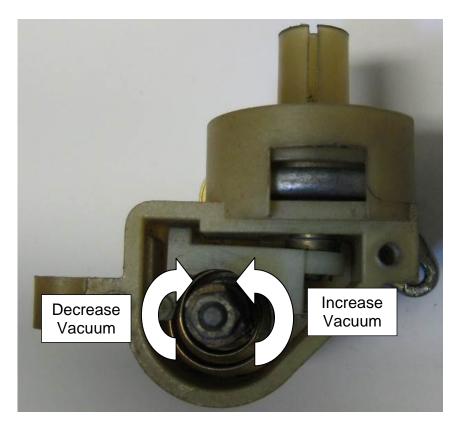
Take the locking pliers and clamp these firmly but not too hard onto the adjusting sleeve. Slightly loosen the 7 mm lock nut. You want just enough friction to prevent the clock spring from moving the adjusting sleeve during your adjustments. **Clockwise decreases** the amount of vacuum, **counter clockwise increases** vacuum.

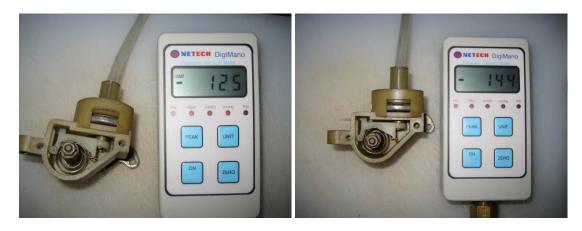
Connect the vacuum lines to/from the VCV in the way it would be if installed in the vehicle. Ensure the vacuum damper (if fitted), is installed and connect your vacuum gauge to the connection normally reserved for the line to the Vacuum Modulator. You want to measure the vacuum as it would be delivered to the Vacuum Modulator under normal driving conditions.

In my case I initially set the vacuum at 125 mbar (5") but found the shifts too firm. So I took the MB recommended specification of 145 mbar (4.7") as indicated above MB. If you are curious, the piece of test equipment I'm using

in these pictures is from my place of work. It is a reference device I'm evaluating to test blood pressure monitors. It's not inexpensive; ~\$767 (US).

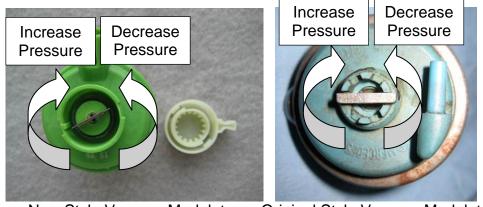
In the picture below you will see that once the plastic or Neoprene cap is removed a small silver bar is visible. This is actually T shaped and the horizontal portion of the T can be pulled out slightly and turned **clockwise to increase pressure** or **counter clockwise to decrease**. Using a pair of needle nose pliers you can VERY GENTLY pull on the silver bar just enough to pull it clear of the housing surface. Then either use the T handle to adjust or a small slot head screwdriver (the T handle can be removed to use a screwdriver). Think of the adjustment as a fine screw thread, you may have to make more than one full turn in either direction. In the new style Vacuum Modulator the cap in the right of the picture acts as the lock for the T handle. In the old style the T handle is pushed down to lock it between the notches. The black Neoprene cap keeps everything in place.

New Style Vacuum Modulator

Original Style Vacuum Modulator

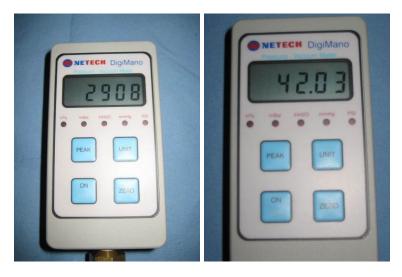
As mentioned, use the T handle or a small slot screw driver to adjust the modulator pressure. Adjust the pressure to the specification for your transmission. In my case this is 2.9 bar or 42 psi. (The picture on the left shows 2908 mbar = 2.9 bar).

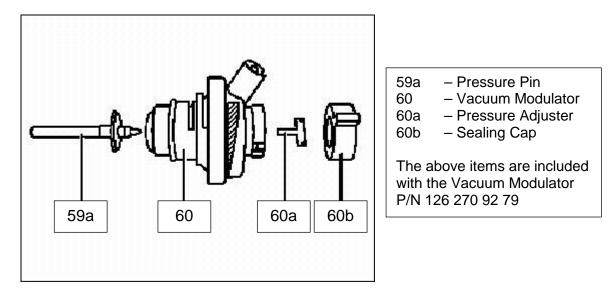
As of 08/92 all 722.3 and 722.5 transmissions have been manufactured with an upgraded Vacuum Modulator.

The plastic Sealing Cap (60b), for this Vacuum Modulator (60), is a change from the previous Neoprene cap. The T shaped Pressure Adjuster (60a) design is the same as previous however with the Sealing Cap (60b) installed the adjustment range is now limited to a pressure reduction of 0.2 bar (~2.9 psi).

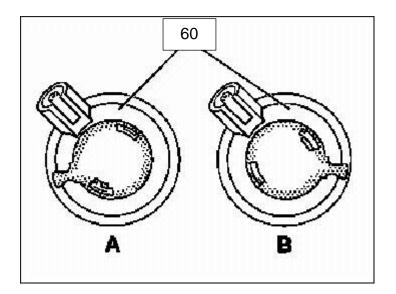
- A Initial modulator pressure setting.
- **B** Modulator pressure reduced by ~0.2 bar (~2.9 psi).

The revised Pressure Pin (59a) MUST be used with this Vacuum Modulator.

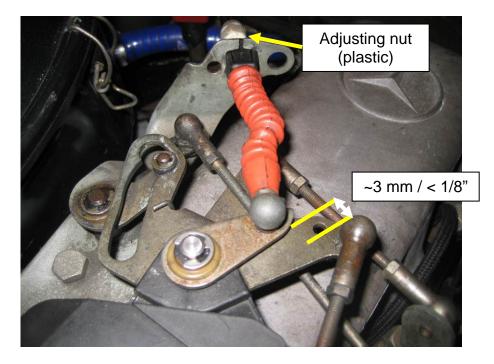
Before I tried the modified vacuum restrictors I decided to change the shift points. The Bowden cable between the throttle linkage and the transmission is typically adjusted with almost no play ~0.5 mm (0.20"), so I increased this to ~3 mm (slightly less than 1/8"). This causes the gearbox to shift earlier which works well as the engine has more than enough torque to overcome this.

NOTE – adjusting this Bowden cable can be touchy. Make sure you are adjusting the slack in the cable. The tension of the internal gearbox linkage is very light so it is easy to misadjust the linkage. Double and triple check the play.

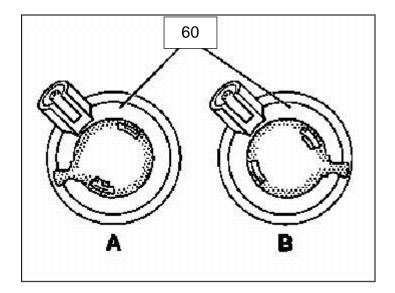
If you find the shifts a touch to firm or soft there is a minor adjustment that can be done via the Vacuum Modulator. The new style allows one to adjust the pressure by 0.2 bar / 2.9 psi.

- A Initial modulator pressure setting.
- ${f B}$  Modulator pressure reduced by ~0.2 bar (~2.9 psi).
