Kawasaki SERVICE INFORMATION

Category Factory Directed Modification	
Model KVF750-A1/B1	
Serial No. DC8971A/2A	Date Dec. 13, 2005

Tie-rod End Ball Separation (RECALL)

REVISED

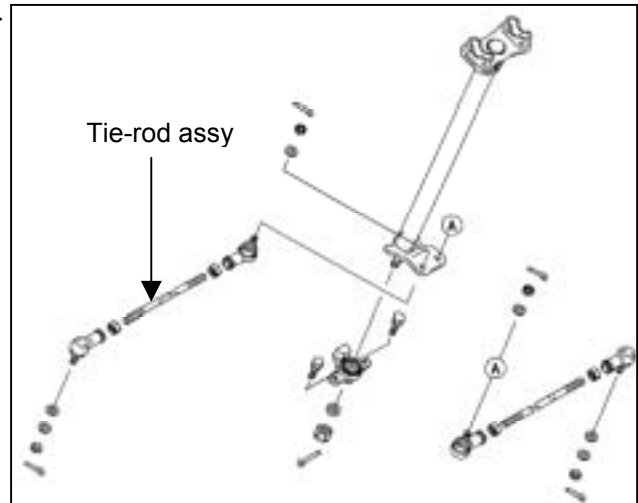
Tie rod separation caused by either wear or impact can occur during operation. This can disconnect the front wheel from the steering control, and could result in an accident with risk of injury or death to the ATV operator.

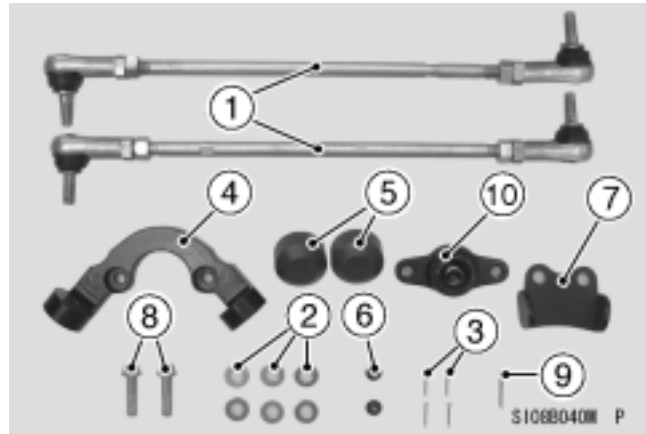
- (1) Rod-Assy, Tie
- (2) Washer, 10.2×20×1.5
- (3) Pin-Cotter, 2.0×15
- (4) Holder-Damper
- (5) Damper
- (6) Nut, Lock, 6mm
- (7) Bracket, Steering
- (8) Bolt, 8×35
- (9) Pin-Cotter, 3.0×25
- (10) Joint-Ball

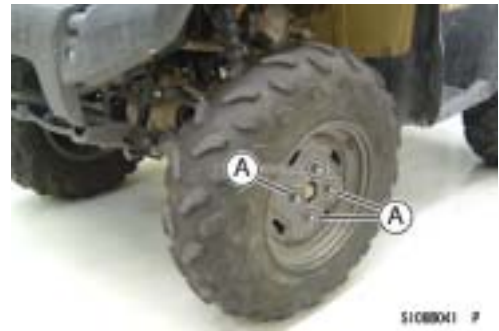
- If necessary, clean the area around the knuckle and suspension arm so that the work area is clean.
- Place the vehicle on a flat surface.
- Loosen the wheel nuts [A] at both sides.

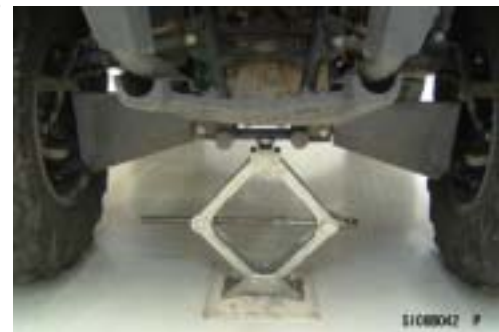
- Lift up the front wheels and remove the wheel nuts and wheels.

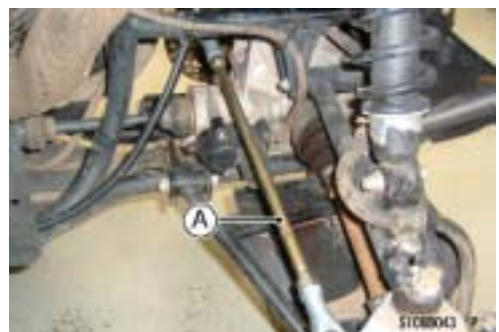
- Remove cotter pins, tie-rod end nuts, washers and tie-rod assy [A].

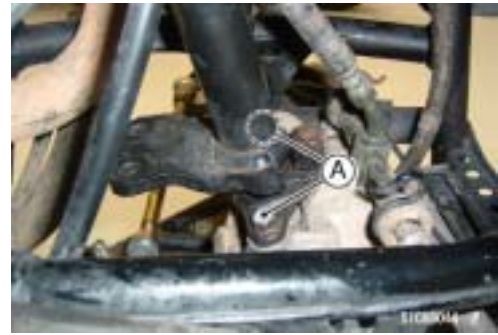
- Remove steering stem bearing joint bolts [A].
- Lift the steering stem.
- Remove cotter pin [A], steering stem bottom end nut [B] and collar [C].
- Remove steering stem bearing [D].

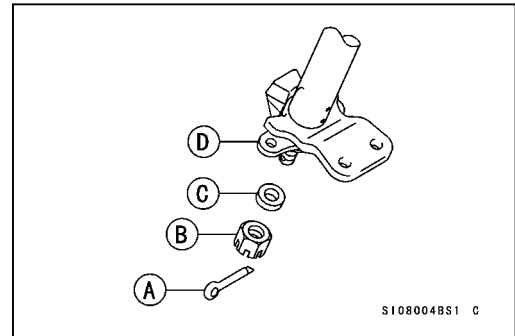
- Fill grease up the seal grooves in new steering stem bearing.
- Lift the steering stem and install the steering stem bearing.
- Install the collar.
- Tighten steering stem bottom end nut.

Steering Stem Bottom End Nut:

62 N·m (6.3 kgf·m, 46 ft·lb)

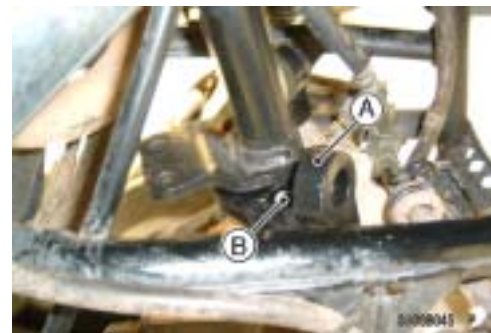
- Install new holder (damper) [A] on the steering stem bearing.
- Tighten new steering stem bearing and new holder with new joint bolts [B] (both sides).

Steering Stem Bearing Joint Bolts:

23 N·m (2.3 kgf·m, 17 ft·lb)

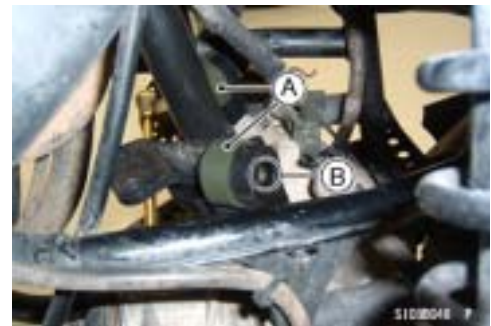
- Install new dampers [A] to the holder.
- Tighten dampers with new damper nuts [B] (both sides).

Damper Nuts:

8 N·m (0.8 kgf·m, 6 ft·lb)

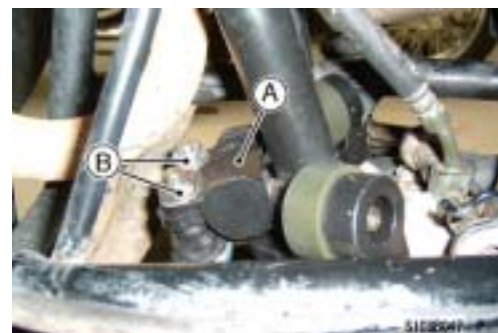
- Install new bracket [A] on the old bracket of the steering stem.

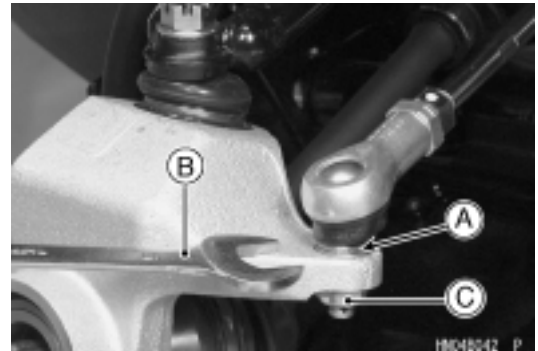
- Install new tie-rod assy and washers (refer to first illustration).
- Hold the flat surface [A] of the tie-rod end with a thin wrench [B], and tighten the tie-rod end nut [C].

Tie-rod End Nuts:

42 N·m (4.3 kgf·m, 31 ft·lb)

Be careful not to damage the rubber seal during installation. Hold the tie rod end shaft with a 17mm wrench while tightening the tie rod end nuts.

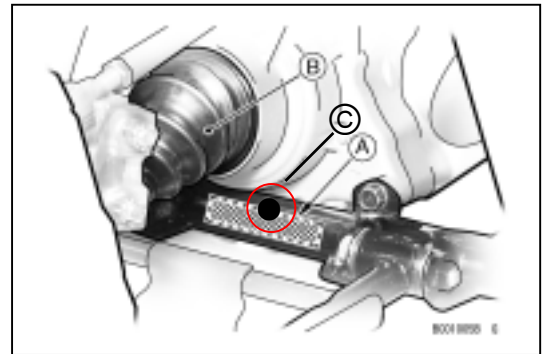
Make a small punch mark up the V.I.N. as a verification mark.

- A. V.I.N.
- B. Front Axis (left side)
- C. Punch Mark
