Applies To: **2006 Civic** – See VEHICLES AFFECTED

Engine Oil Leaks and Power Steering Fluid Leak

(Supersedes 06-020, dated June 20, 2006, to update the information marked by the black bars)

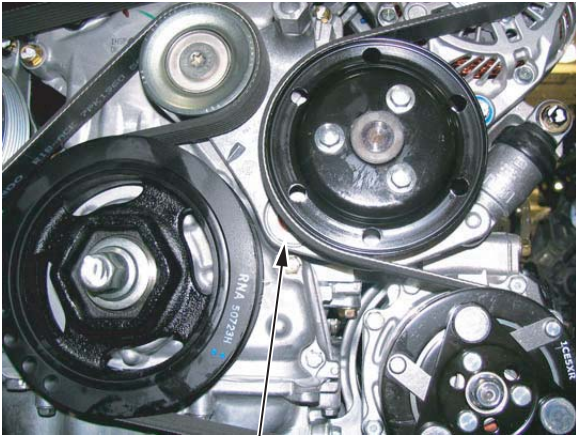
24-mm SEALING BOLT

- The 24-mm sealing bolt on the timing chain end of the engine.

REPAIR PROCEDURE A - REPLACE THE 24-MM SEALING BOLT ON THE TIMING CHAIN END OF THE ENGINE

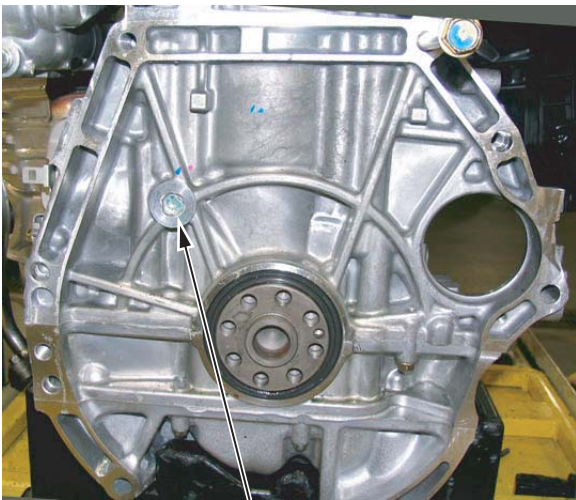
24-mm SEALING BOLT

- The 24-mm sealing bolt on the transmission end of the engine.

REPAIR PROCEDURE B - REPLACE THE 24-MM BOLT ON THE TRANSMISSION END OF THE ENGINE

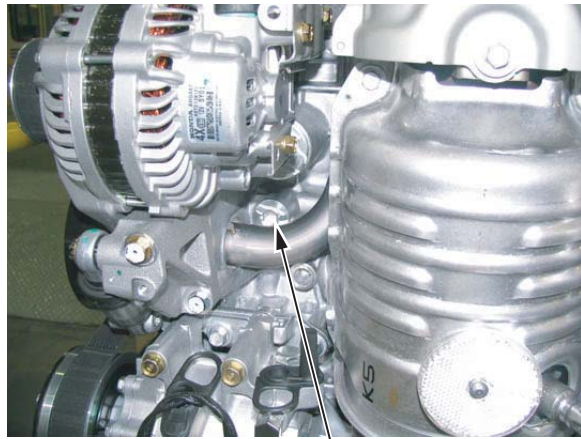
20-mm SEALING BOLT

- The 20-mm sealing bolt behind the alternator.

REPAIR PROCEDURE C - REPLACE THE 20-MM SEALING BOLT BEHIND THE ALTERNATOR

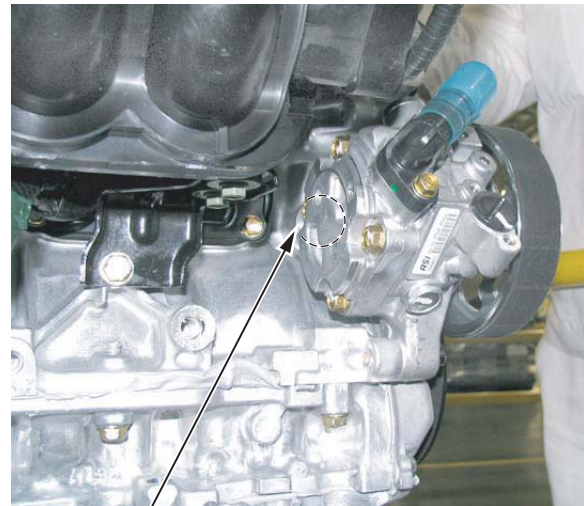
20-mm SEALING BOLT

- The 20-mm sealing bolt behind the power steering pump.

REPAIR PROCEDURE D - REPLACE THE 20-MM BOLT BEHIND THE POWER STEERING PUMP

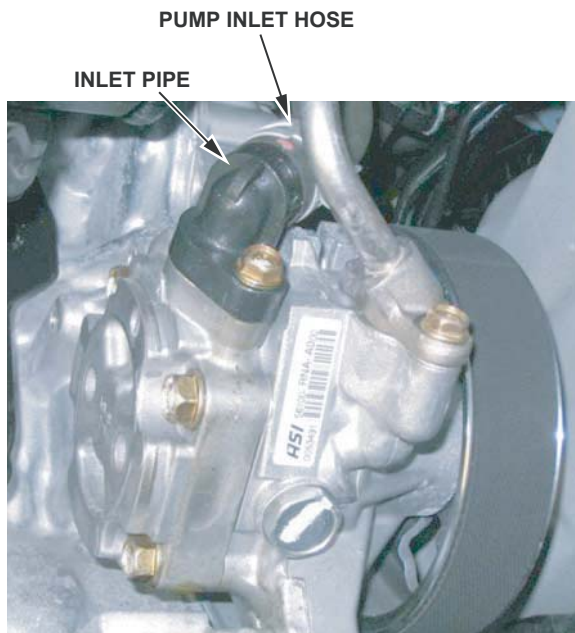
- The inlet pipe on the power steering pump.

REPAIR PROCEDURE E - POWER STEERING PUMP LEAK

NOTE: During an engine oil leak inspection, if you discover the power steering pump is leaking from the inlet pipe area, replace the inlet pipe, O-ring, and hose clamp.

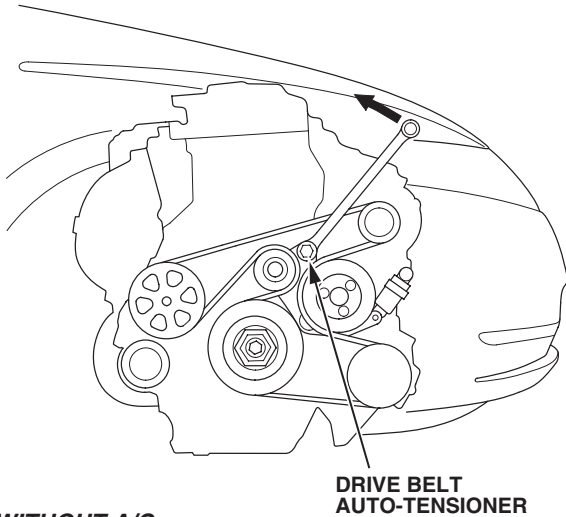
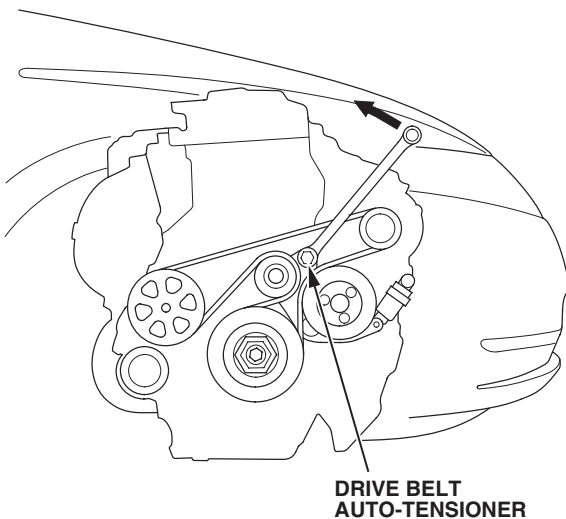
4. Remove the drive belt:
 - Set a long-handled, box-end wrench on the drive belt auto-tensioner from above the engine.
 - Slowly turn the wrench in the direction shown, then remove the drive belt.

NOTE: This is a hydraulic type auto-tensioner; you must turn the wrench slowly to avoid damaging the auto-tensioner.

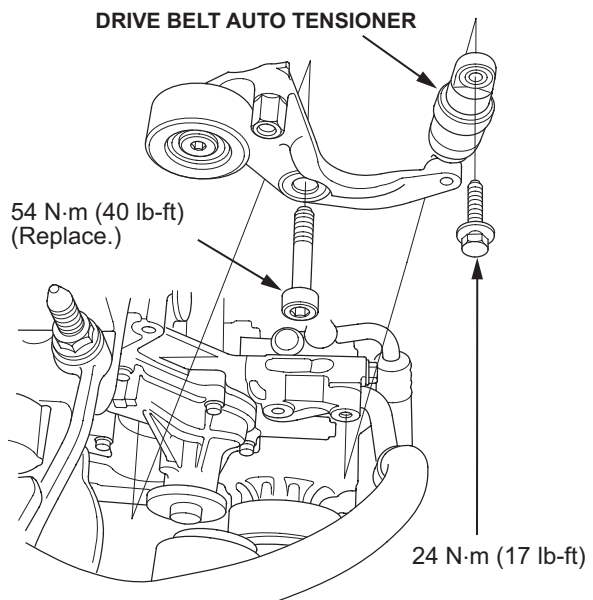
7. Remove the drive belt auto tensioner assembly, and store it vertically to prevent oil leakage that may change the dampening specification.

- Use a new bolt to install the drive belt auto tensioner.
- The bolt is located in a difficult location. Use Snap-on 8 mm hex socket (T/N FAM8E) and 3/8 flex ratchet torque wrench (T/N QD2FR75), or equivalent, to properly torque the bolt.

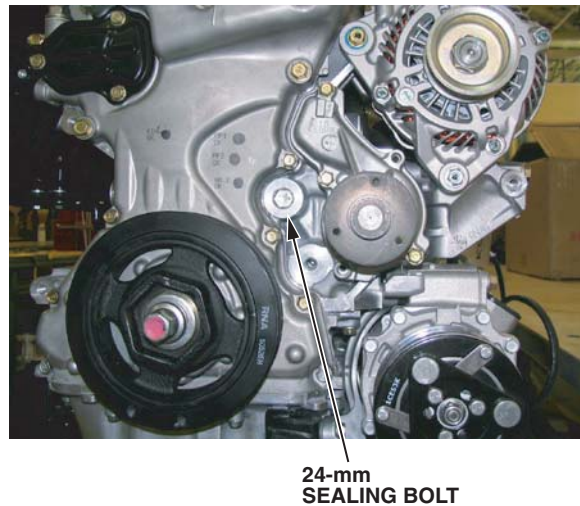
8. Remove the 24-mm sealing bolt and its washer.

9. Clean the sealer out of the block threads by running a pick tool or a toothbrush along the threads.
NOTE: Pull any material from the threads out of the engine block. **Do not** push it in.
10. Coat the sealing surface on the engine block with clean engine oil.
11. Install a new sealing bolt and washer. Torque the sealing bolt to **60 N·m (45 lb-ft)**.
12. Reinstall the drive belt auto tensioner, the water pump pulley, and the drive belt in the reverse order of removal.

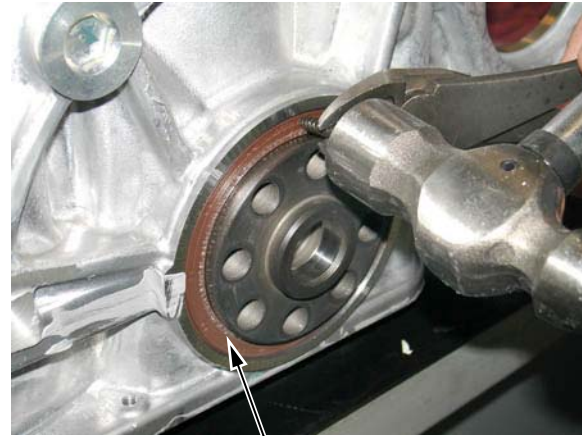
TRANSMISSION
END CRANKSHAFT
OIL SEAL

3. Remove the transmission end crankshaft oil seal:
 - If you can see the leak, mark the location with a paint marker before removing the seal.
 - Remove the seal:
 - Use a hammer to firmly tap a small, 4 x 20-mm Phillips-head sheet metal screw into the metal part of the seal. If you marked the leak location, make sure you tap the screw into the seal directly across from the paint mark.

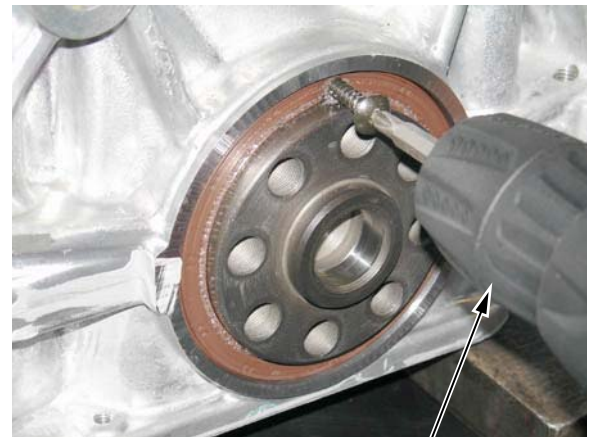
- Use a cordless screwdriver or another suitable tool to firmly drive the screw into the oil seal so it won't come out.

CORDLESS DRILL
(Carefully drive in the screw.)

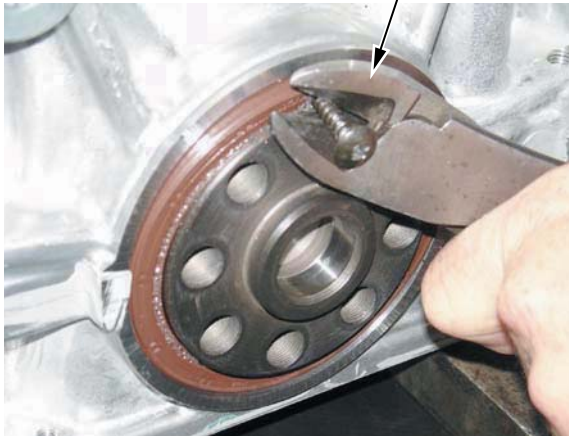
- Use a pair of diagonal cutters to grip the screw under its head. While carefully prying up with the cutters, grab the screw with your other hand and gently pull out the seal.

DIAGONAL CUTTERS
(Pry out oil seal.)

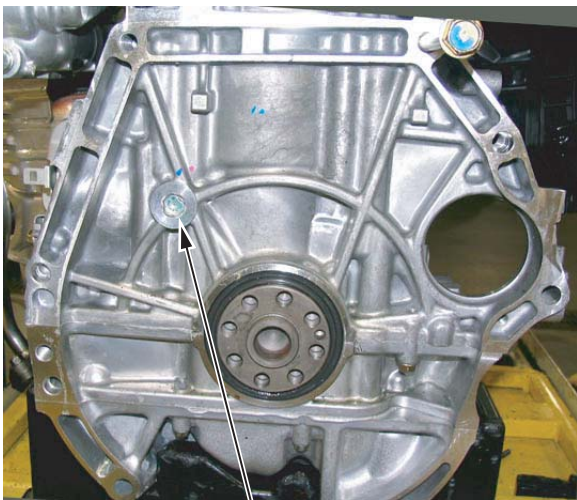
24-mm SEALING BOLT

- Clean the oil off the engine.
- Install a new transmission end crankshaft oil seal:
 - Refer to page 7-33 of the service manual, or
 - Online, enter the keywords **TRANS SEAL** and select **Transmission End Crankshaft Oil Seal Installation - in car** from the list.
- Remove the 24-mm sealing bolt and its washer.

- Clean the sealer out of the block threads by running a pick tool or a toothbrush along the threads.

NOTE: Pull any material from the threads out of the engine block. **Do not** push it in.
- Coat the sealing surface on the engine block with clean engine oil.

- Install a new sealing bolt and washer. Torque the sealing bolt to **54 N·m (40 lb-ft)**.
- Reinstall the transmission:
 - Refer to page 13-13 (M/T models), or 14-246 (A/T models) of the service manual, or
 - Online, enter keywords **TRANS INSTALL**, and select **Manual Transmission Installation** (M/T models) or **Automatic Transmission Installation** (A/T models) from the list.

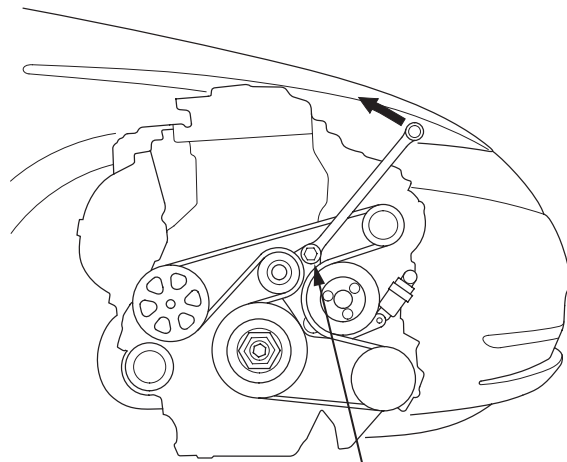
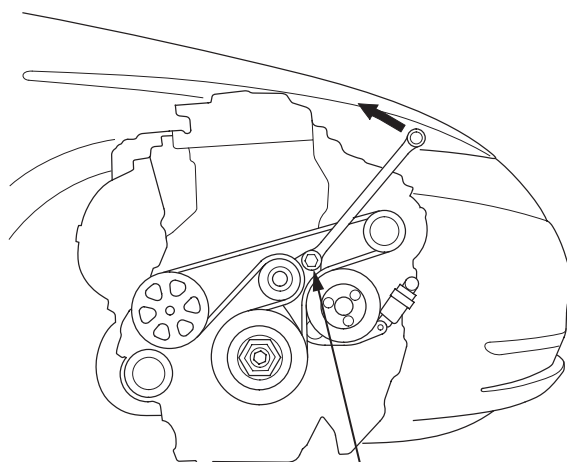
- Remove the drive belt:
 - Set a long-handled, box-end wrench on the drive belt auto-tensioner from above the engine.
 - Slowly turn the wrench in the direction shown, then remove the drive belt.

NOTE: This is a hydraulic type auto-tensioner; you must turn the wrench slowly to avoid damaging the auto-tensioner.

**DRIVE BELT
AUTO-TENSIONER**

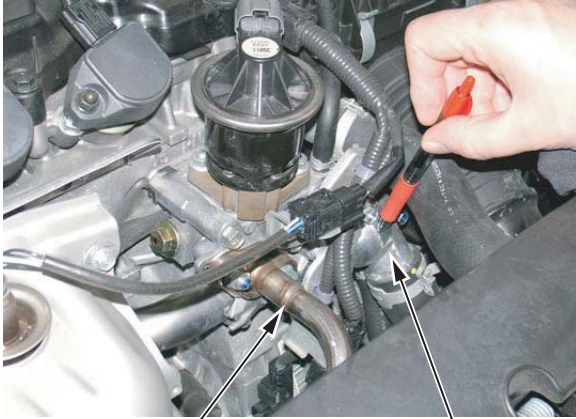
2. Remove the alternator. Do not disconnect its electrical connections, or damage the wires:
 - Refer to page 4-44 of the service manual, or
 - Online, enter keyword **ALT**, and select **Alternator Removal and Installation** from the list.
3. Drain the engine coolant.
4. Remove the EGR pipe from the thermostat housing.

EGR PIPE THERMOSTAT HOUSING

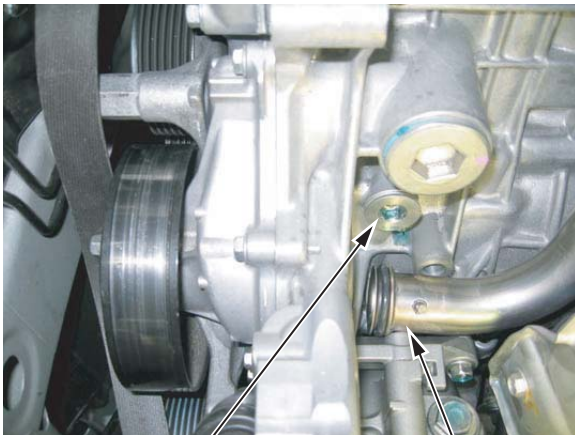
5. Remove the EGR pipe and thermostat housing from the cylinder head.
6. Disconnect the water pipe, then lower it so you can access the 20-mm sealing bolt.

20-mm SEALING BOLT WATER PIPE

7. Remove the original sealing bolt and its washer.
8. Clean the sealer out of the block threads by running a pick tool or a toothbrush along the threads.

NOTE: Pull any material from the threads out of the engine block. Do not push it in.
9. Coat the sealing surface on the engine block with clean engine oil.
10. Install a new sealing bolt and washer. Torque the sealing bolt to **34 N.m (25 lb-ft)**.
11. Reinstall the parts in the reverse order of removal.
12. Refill the radiator, then bleed the cooling system.

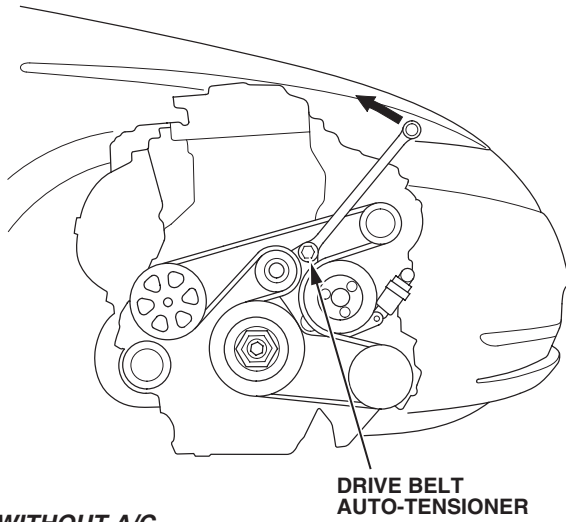
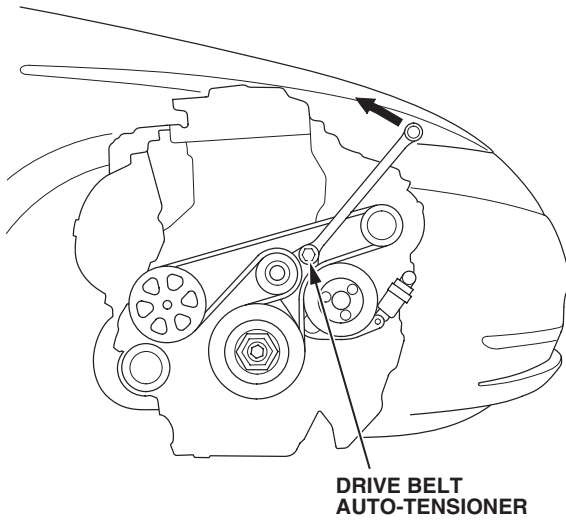
1. Remove the cowl cover.
 - Refer to page 20-229 of the service manual, or
 - Online, enter keyword **COWL**, then select **Cowl Cover Replacement** from the list.
2. Remove the drive belt:
 - Set a long-handled, box-end wrench on the drive belt auto-tensioner from above the engine.
 - Slowly turn the wrench in the direction shown, then remove the drive belt.

NOTE: This is a hydraulic type auto-tensioner; you must turn the wrench slowly to avoid damaging the auto-tensioner.

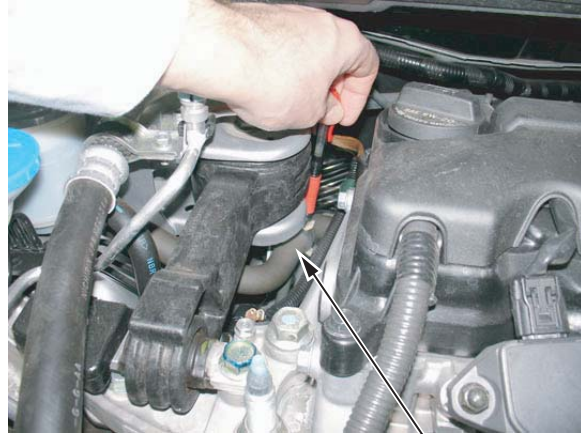
3. Disconnect the power steering pump inlet hose from its holder on the right inner strut tower.

**POWER STEERING
PUMP INLET HOSE
(Unclip.)**

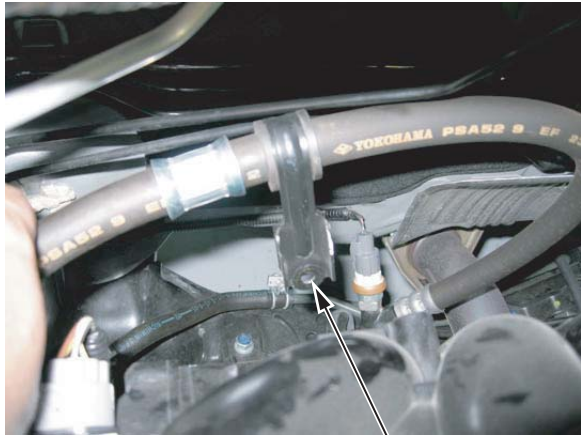
4. Remove the pump outlet hose bracket from the back of the intake manifold.

**PUMP OUTLET HOSE POWER
STEERING MOUNTING BRACKET
(Unbolt.)**

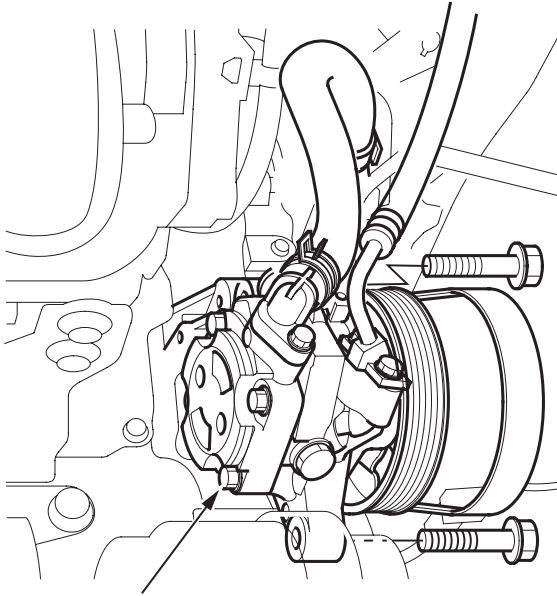
POWER STEERING PUMP

5. Remove the two power steering pump mounting bolts, then lower the pump so you can access the 20-mm sealing bolt.

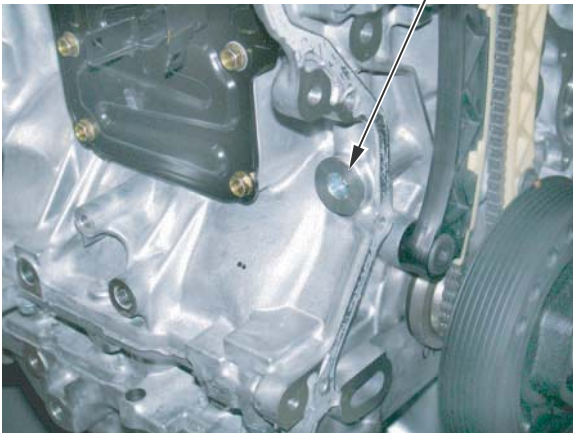
20-mm SEALING BOLT

6. Remove and discard the original sealing bolt and its washer.

7. Clean the sealer out of the block threads by running a pick tool or a toothbrush along the threads.
NOTE: Pull any material from the threads out of the engine block. **Do not** push it in.
8. Coat the sealing surface on the engine block with clean engine oil.
9. Install a new sealing bolt and washer. Torque the sealing bolt to **34 N·m (25 lb-ft)**.
10. Reinstall the parts in the reverse order of removal.

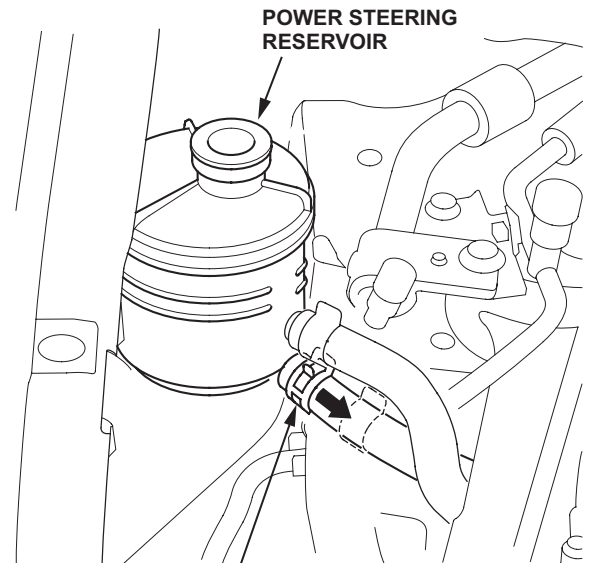
1. Drain the fluid from the power steering reservoir.
 - Refer to page 17-30 of the service manual, or
 - Online, enter keywords **POWER FLUID**, then select **Power Steering Fluid Replacement** from the list.
2. Squeeze the spring clamp, and slide it back on the pump inlet hose so it clears the reservoir spigot.

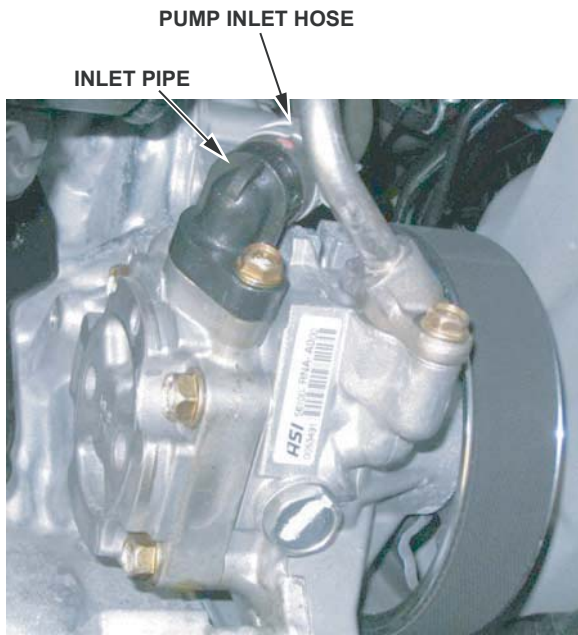
- Remove the 10-mm bolt that attaches the inlet pipe to the power steering pump.

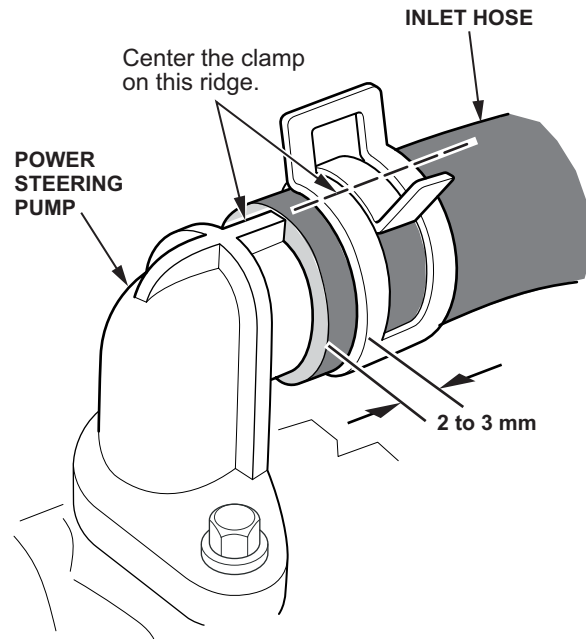
- On your workbench, replace the inlet pipe, O-ring, and hose clamp with new parts.

NOTE: The pump inlet hose is shown attached to the power steering pump to show the proper position of the clamp. Position the clamp directly in front of the ridge on the inlet pipe before installation. It is easier to set the clamp before installation.

- Attach the pump inlet hose to the reservoir.
- Install the inlet pipe on the power steering pump.
 - Raise the vehicle.
 - Install a new O-ring on the inlet pipe.
 - Coat the O-ring with clean power steering fluid.
- Install the 10-mm bolt. Torque the 10-mm bolt to **10 N·m (8 lb-ft)**.
- Lower the vehicle, then fill the reservoir.
 - Refer to page 17-30 of the service manual, or
 - Online, enter keywords **POWER FLUID**, then select **Power Steering Fluid Replacement** from the list.
