4x4 FRONT AXLE ENGAGEMENT

TROUBLESHOOTING GUIDE

**DIAGNOSIS AND REPAIR OF PROBLEMATIC
FRONT AXLE ENGAGEMENT SYSTEMS**

CHEVROLET/GMC • DODGE • JEEP

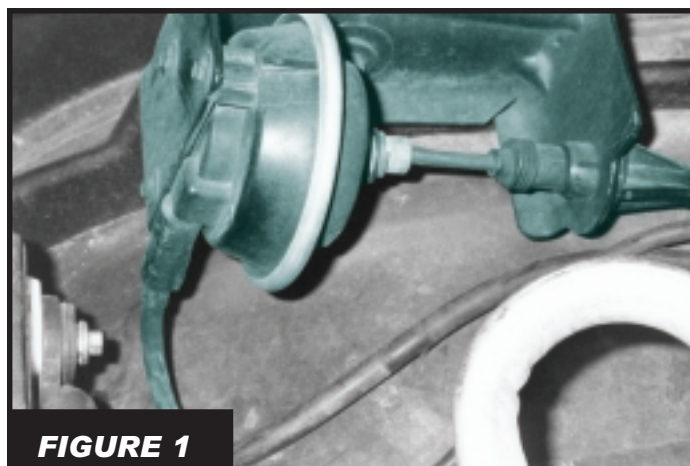
FIGURE 1

The OEM front axle actuator is a vacuum controlled cable system. Placing the vehicle in 4-wheel drive causes the vacuum port to activate the diaphragm plunger [Fig 1]. The diaphragm plunger pulls the cable attached to the shift fork in the front differential [Fig. 2]. This connects the freewheeling passenger side (right) front axle to the driven (left) front axle.

2. Check for presence of vacuum at diaphragm located either under or beside the battery [Fig. 1]. A simple method to locate the diaphragm is to follow the cable from the front differential to inside the passenger side engine compartment. If vacuum is present proceed to step 4. If vacuum is not present proceed to step 3.
