Установка гидроблока от FORD SCORPIO на Чирок.

Debugging the Milano/75 ABS System

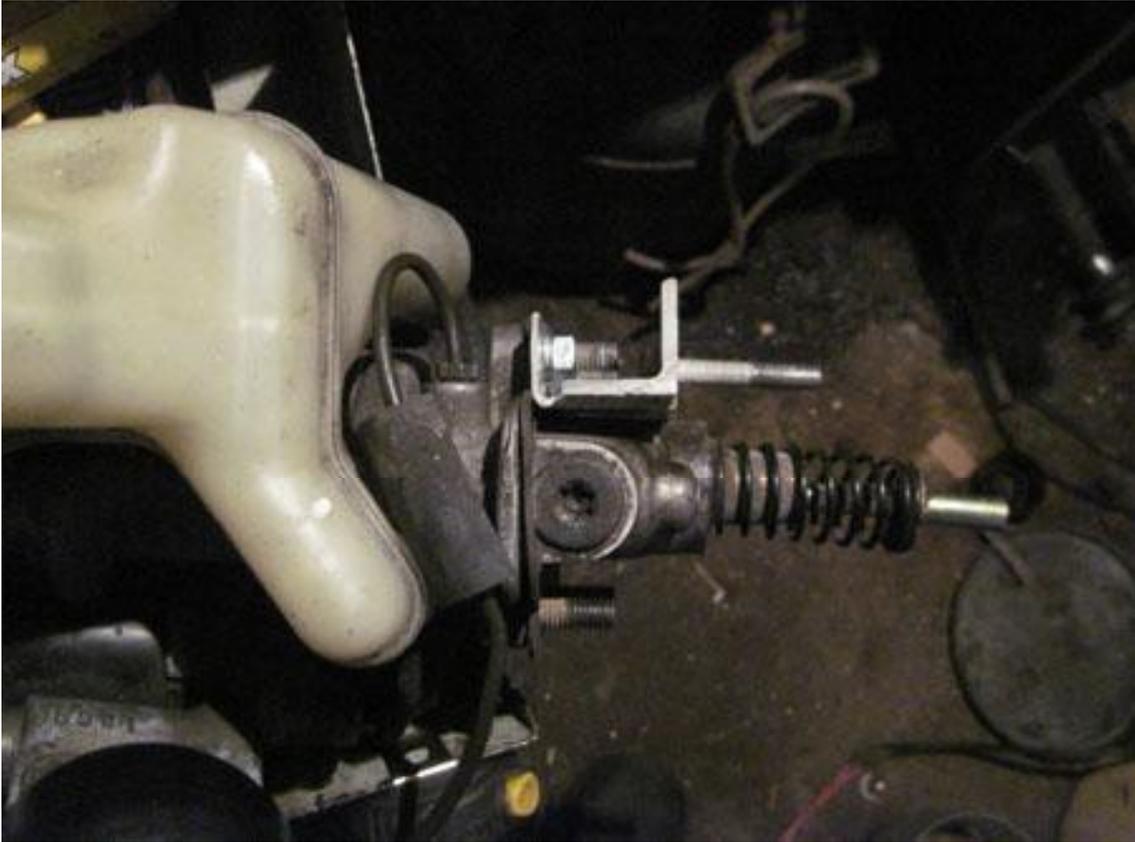
1. Объект установки

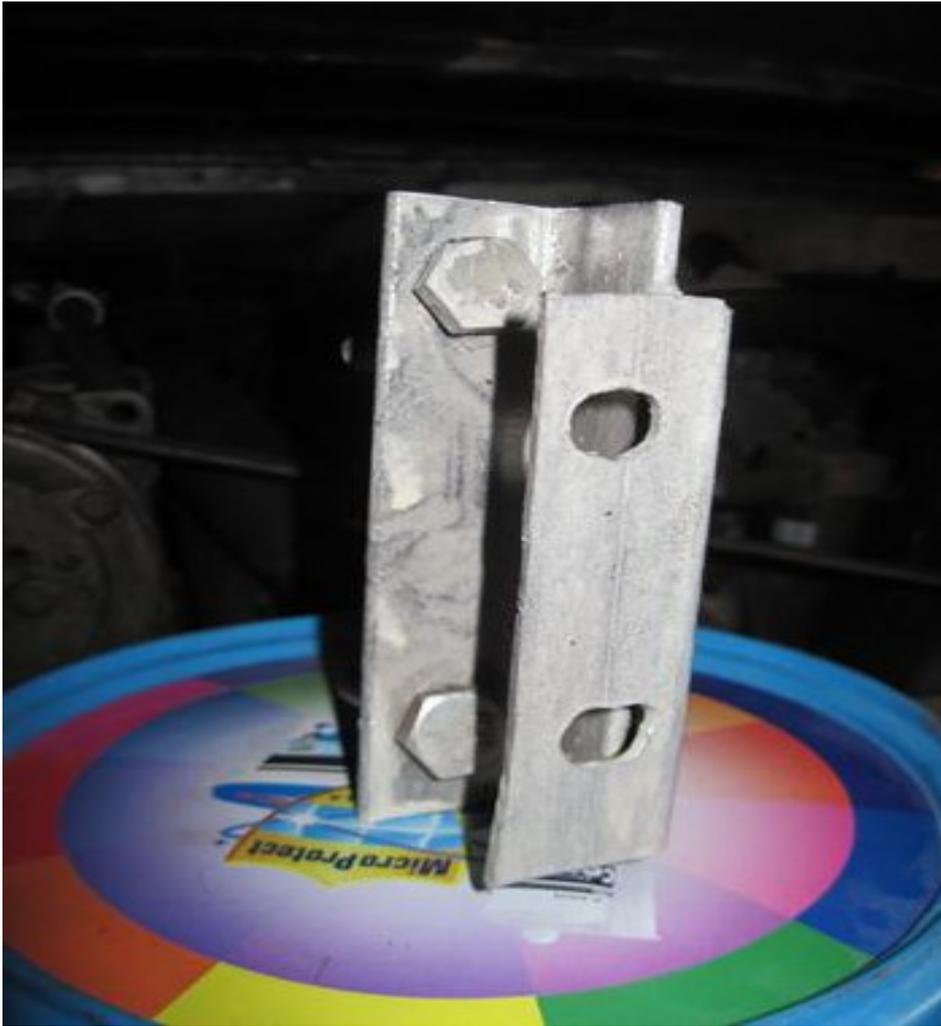
2. Переходная плита (2 штуки)

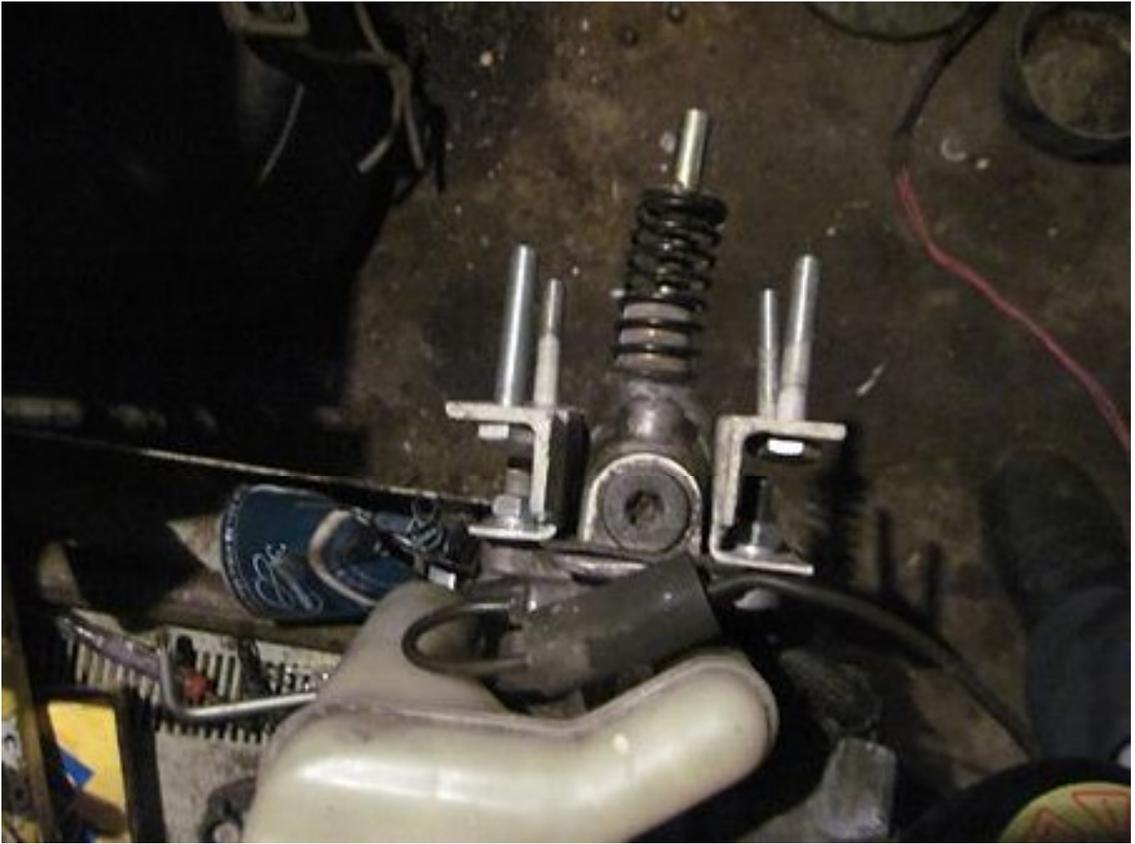
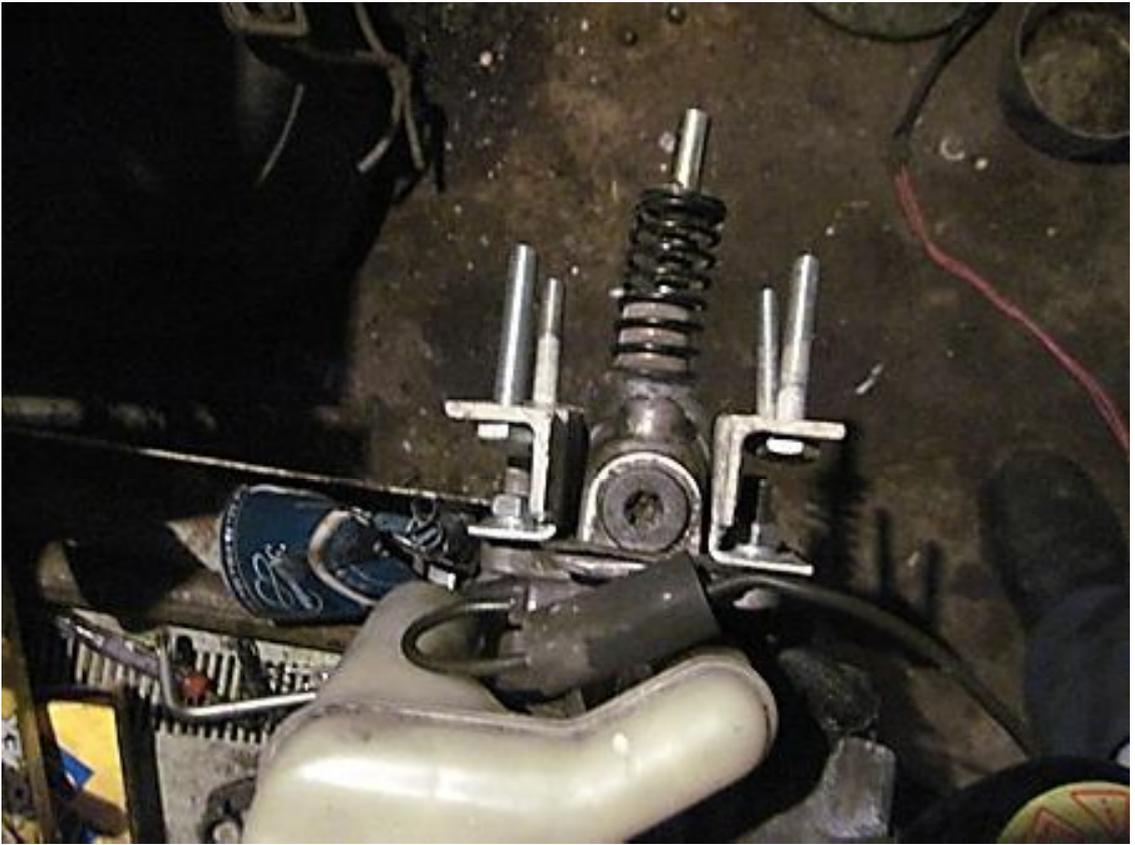
3. Переходная плита на гидроблоке

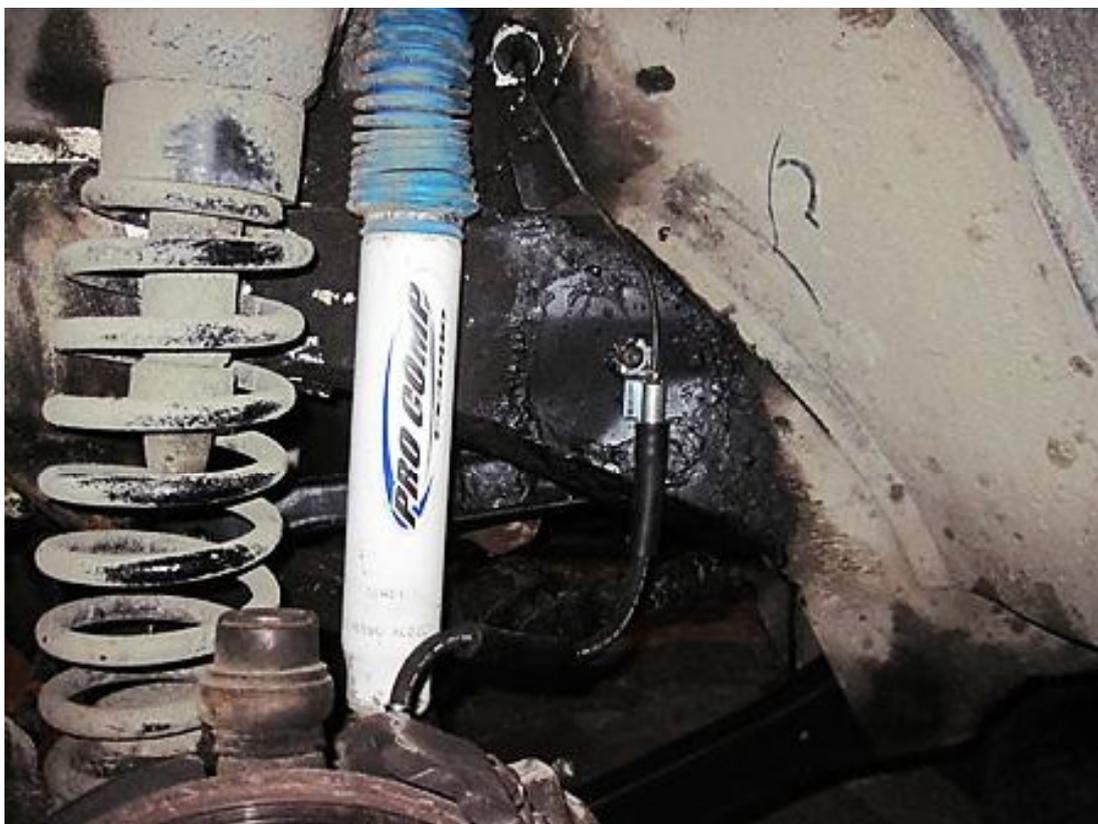
5. Переделка тормозной трубки по длине в связи с креплением тормозной шланги (может понадобиться)

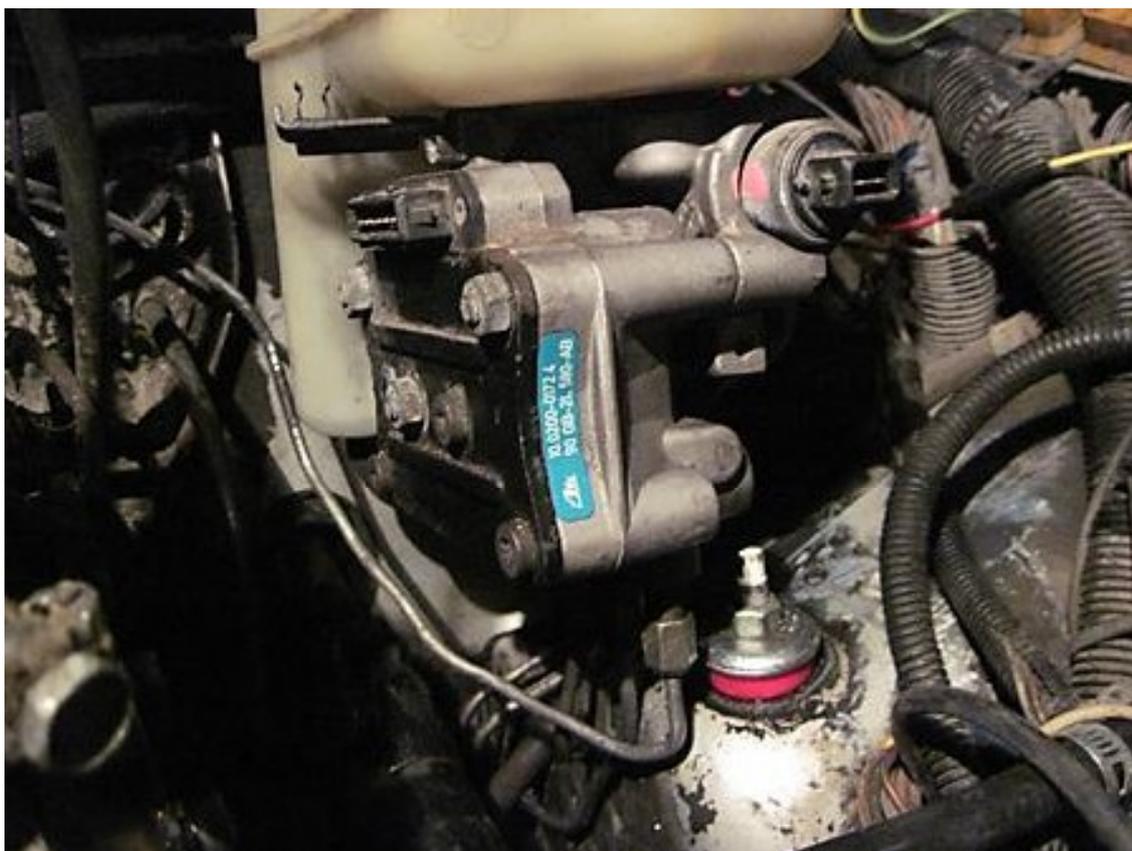
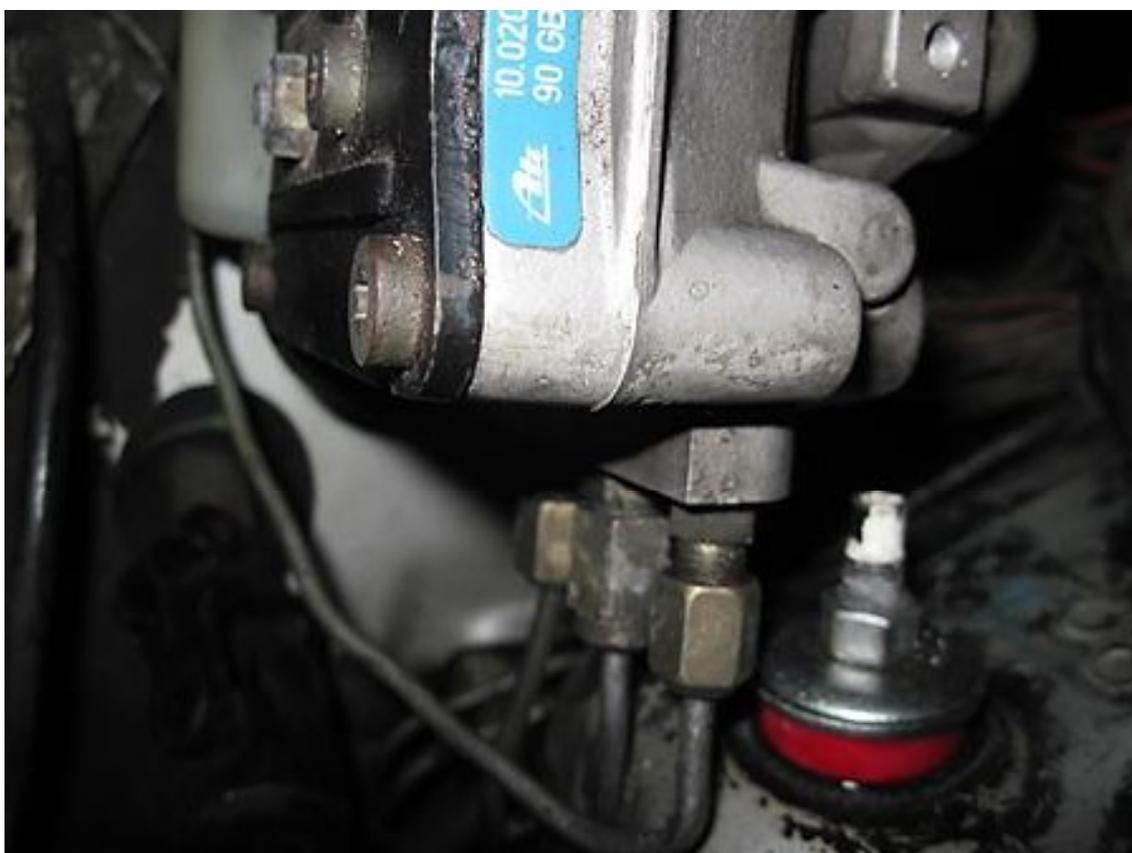
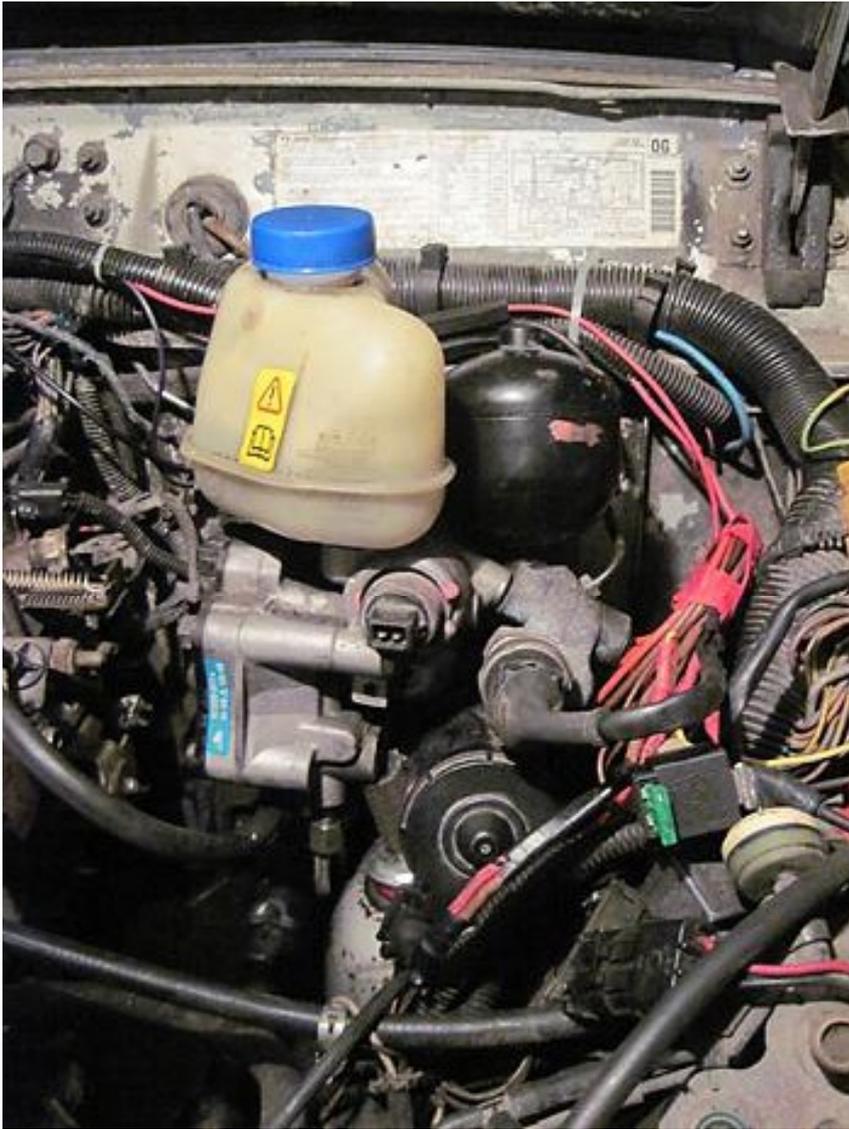
5. Подключение трубки правой стороны к блоку

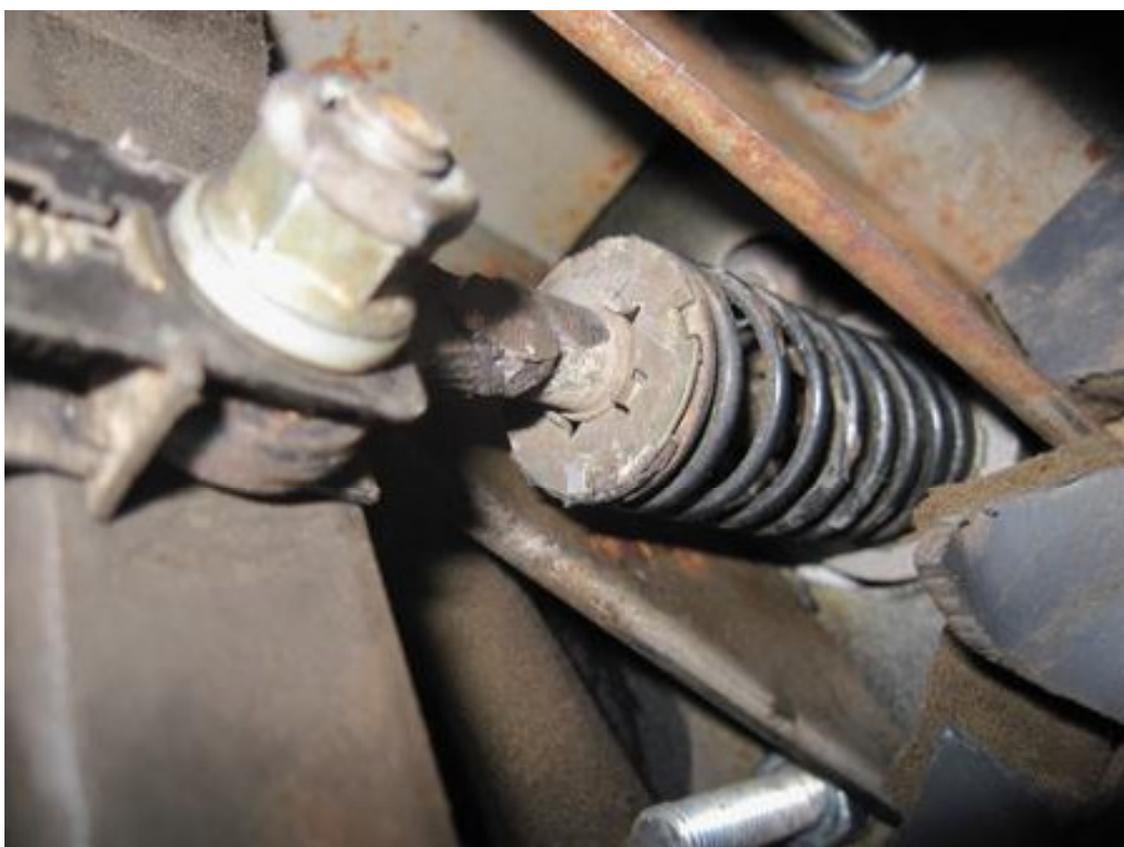
6. Педаль тормоза с переделанным ухом под гидроблок

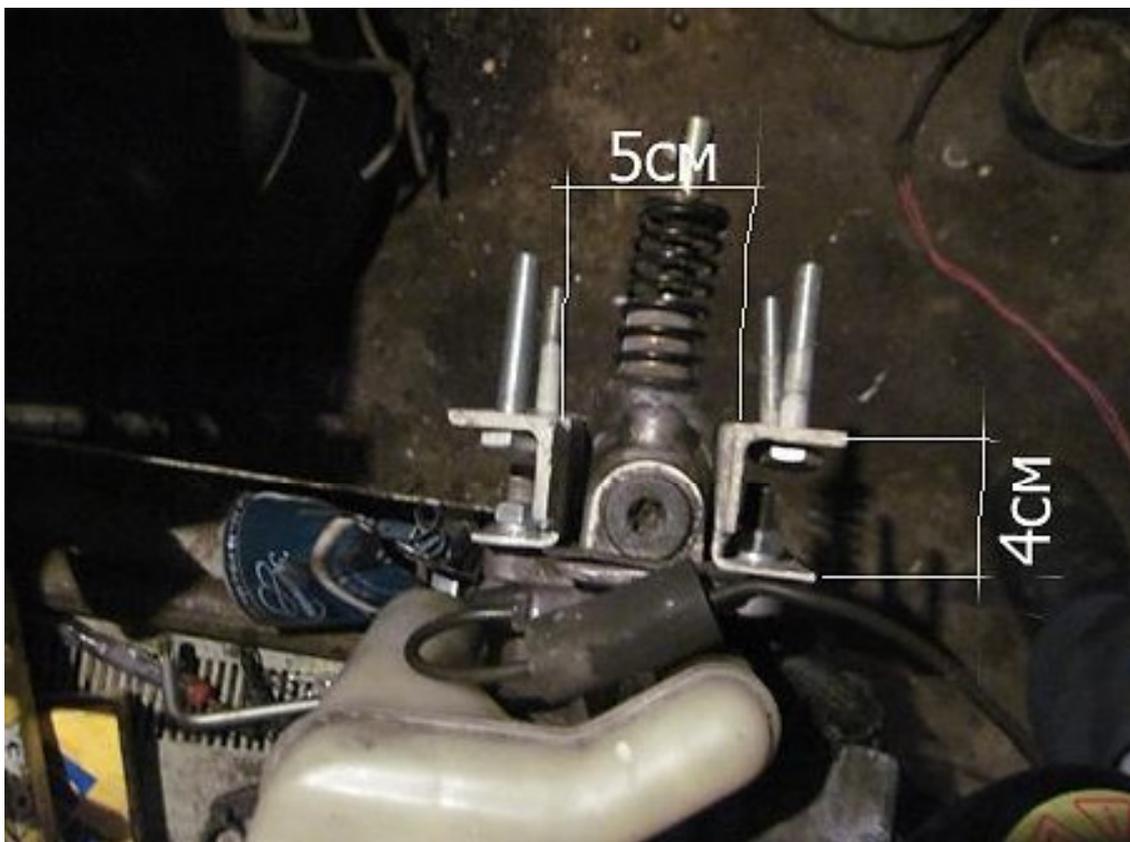
Размеры – габаритные и межосевые....

Переходная плита:
